CHAPTER 5

EVIDENCES AND PARAMETERS AFFECTING DEBRIS FLOW-FLOOD PROCESSES IN NAM KO YAI SUB-CATCHMENT

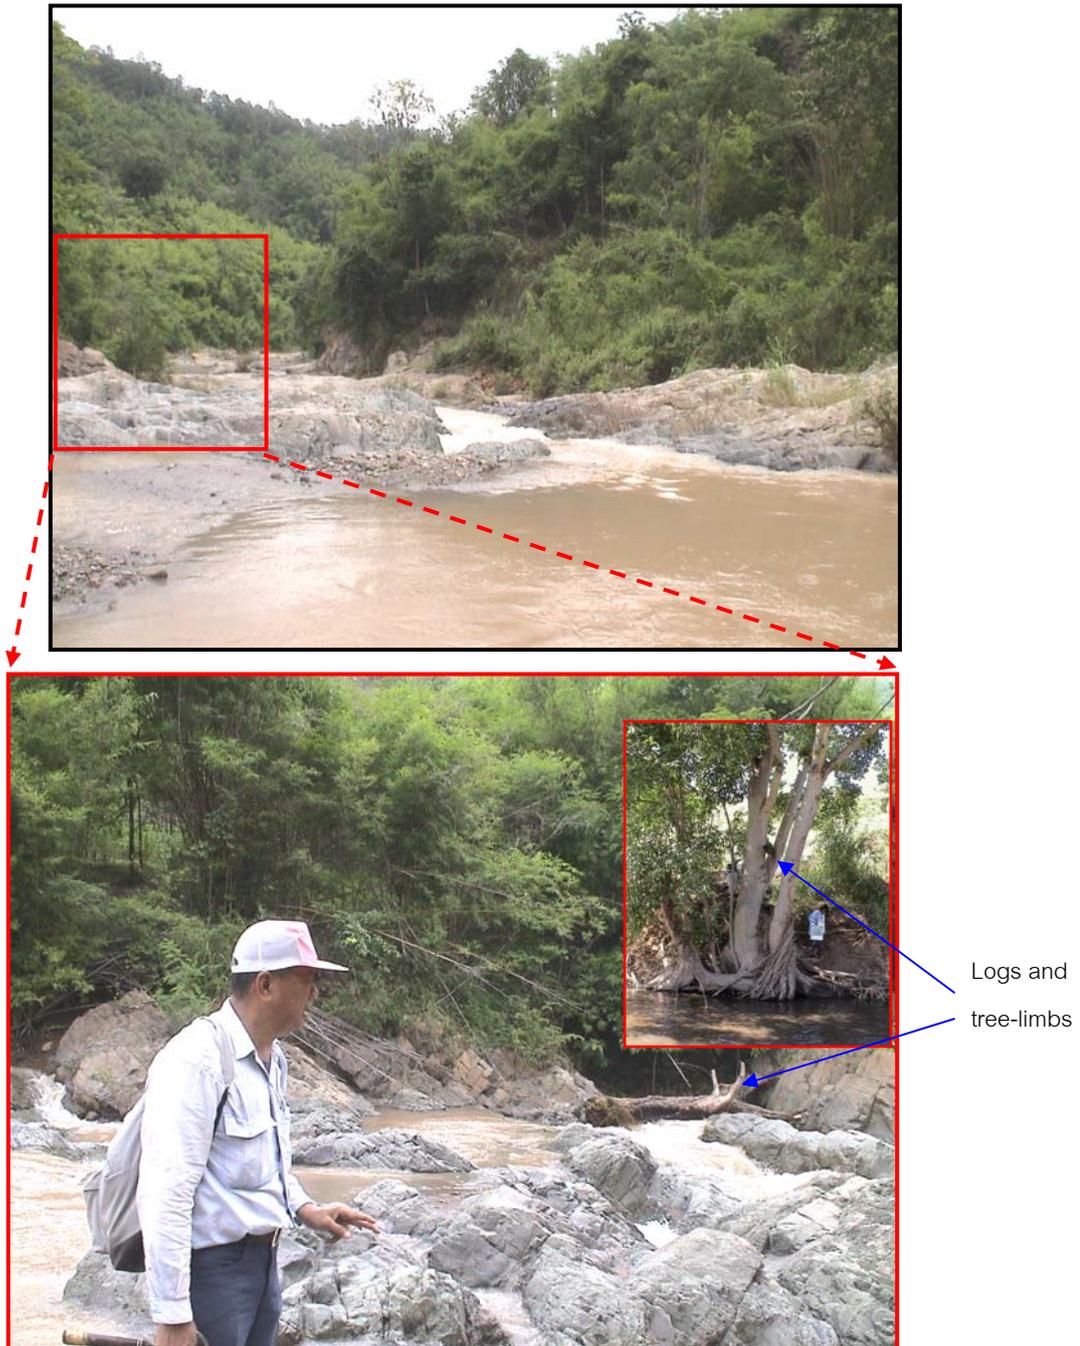
It was always suspiciously how the settlement on the alluvial fan was flooded with muddy water and high quantity of plant debris. One theory was that there could have been a natural landslide dam forming somewhere along the water course, followed by the failure of the dam to have the temporary impound water with debris to flow in a huge amount down below. If this theory was possible, there should be evidences of such dam somewhere upstream from the flooded village.

From the field investigations and orthophotograph interpretation, there was a specific location along the course of Nam Ko Yai stream in the central part of the study area that was looked suspiciously. Here the stream issues from a flat open land behind (upstream) to a very narrow V-shape channel with a sudden change of elevation at Tad Fa waterfall (Figure 5-2). It could be hypothesized that this specific location is suitable for an accumulation of sediments composed of plant debris, soils, and rock boulders to form a natural landslide dam of at least 10 m high (Figures 5-3, 5-4 and 5-5). A field check revealed fallen trees and vegetation traces. This probably indicated that the temporary natural dam was broken, sending the debris and water to flood further downstream, eroding the channel along the way, and finally dropping its loads on the alluvial fan at the canyon mouth.

Figure 5-4 Photographs (looking eastward direction) illustrating the configuration of Nam Ko Yai stream channel at location ND (referred to Figure 5-3) that is suitable for accumulated sediments for blockage a torrent stream and formed a natural temporary landslide dam. Note: The evidence of transported timbers was still found not only in the channel as a large one but also left as a smaller one at the higher level of the tree-branches (as shown in the inserted photograph that taken at the upstream of Nam Ko Yai stream, 2.5 km. far away from this point).

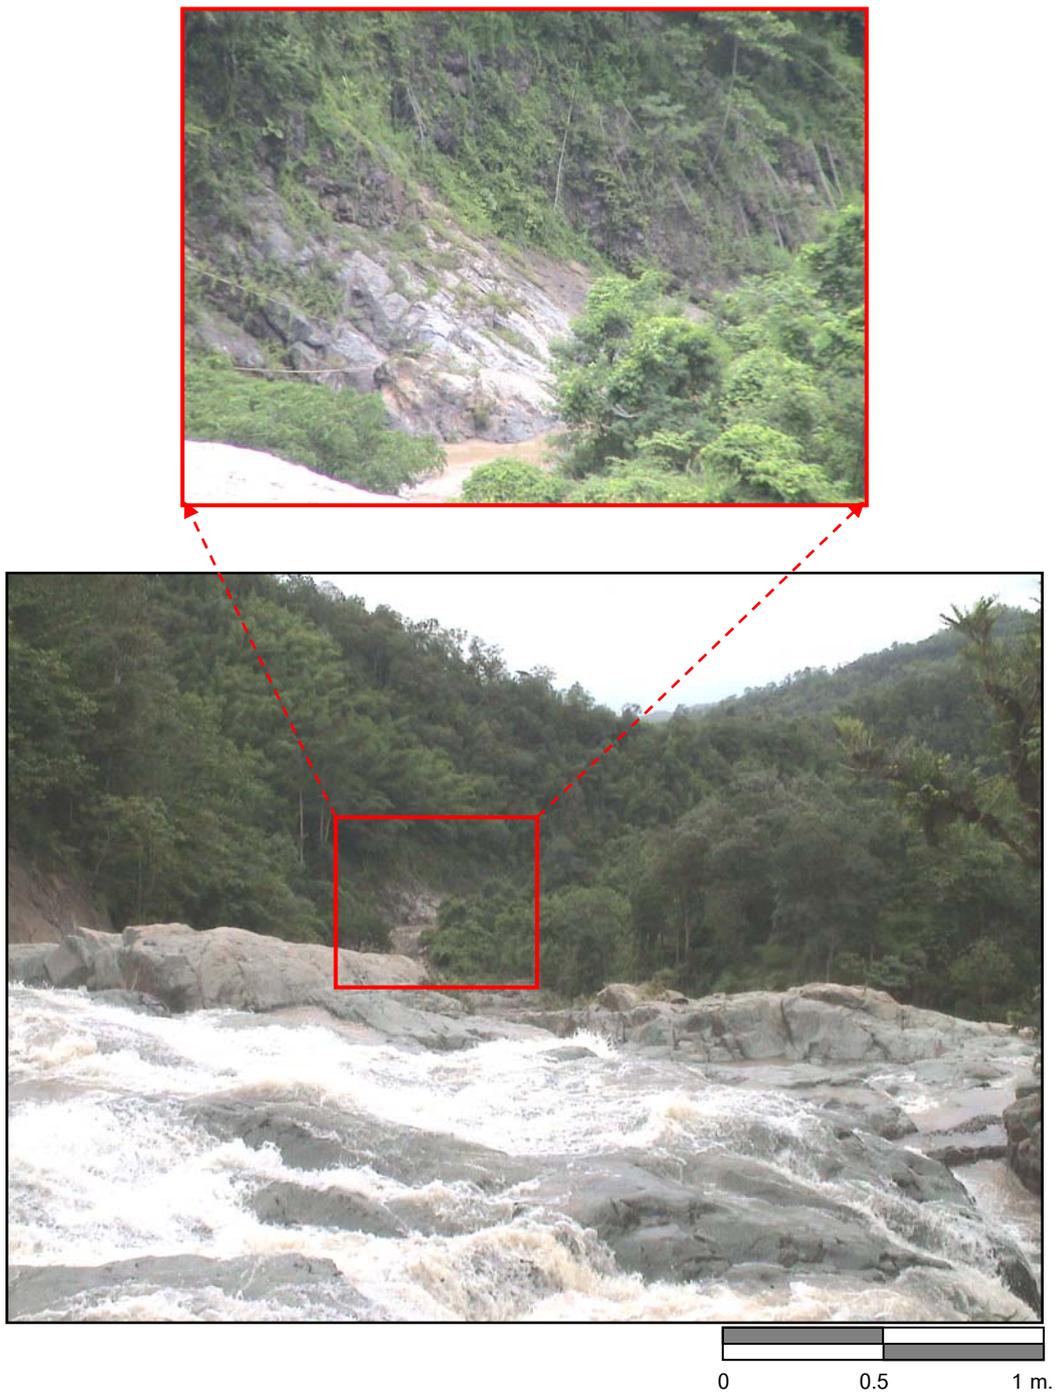
Figure 5-5 Photographs (looking eastward direction) showing the different relief of about 20 m between Tad Fa waterfall (location referred to Figure 5-3) and the downstream V-shape channel that is suitable for increasing water turbulent to form flow-flood occurrence.

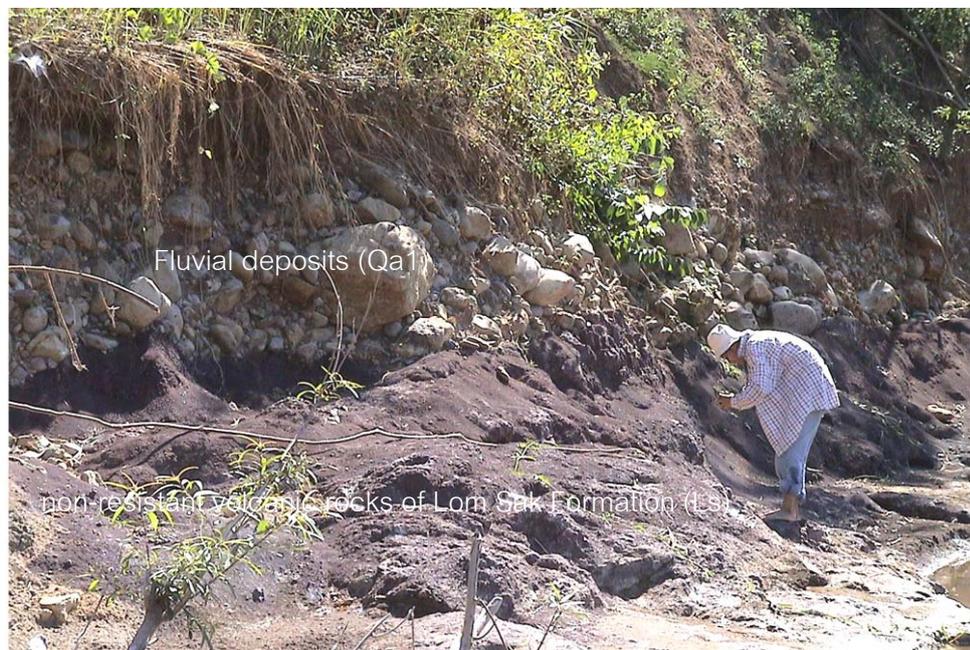
From the base rocks in the upstream from this suspected natural temporary dam location, it is interesting to note that lithology of Lom Sak Formation is mainly composed of non-resistant rocks of volcanic complex as shown in Figure 5-9. So the U-shape upstream of Nam Ko Yai channel is generally controlled by the soft and non-resistant volcanic rocks that are easily eroded as a flat area.

Figure 5-9 Photograph showing the soft and non-resistant volcanic rocks of Lom Sak Formation in the upstream from the suspected natural temporary dam location.

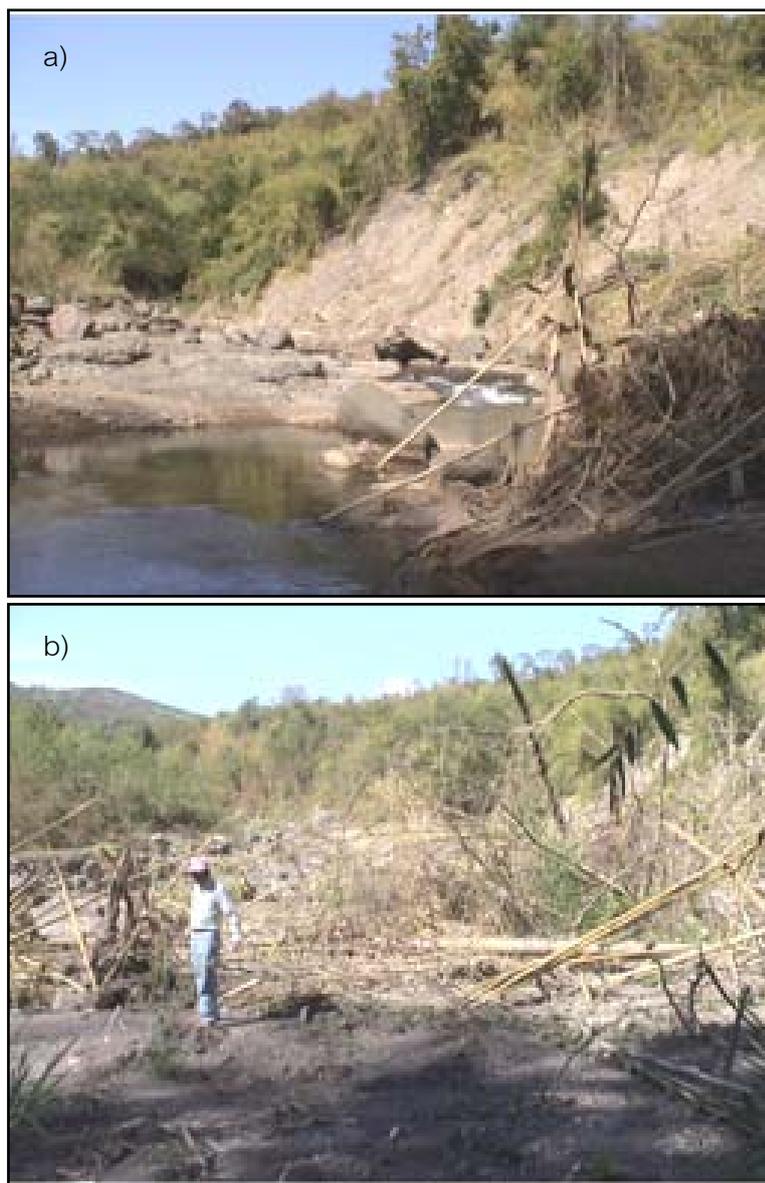
channel, especially in the outer-curvature bank of steep slope and incorporated them into the flow-flood. The evidences of 8/11 event could be observed in the field visit where Nam Ko Yai stream had a steep V-shape cross-section downstream. The traces of the erosional feature in the outer curving-bank were common. Some huge logs or intertwined bamboo clumps were left in the channel or up high on the tree splices as they were not all transported by the torrent stream flows (Figure 5-12).

Figure 5-12 Photographs illustrating a) the traces of erosional feature in the out curving-bank and b) huge logs or intertwined bamboo clumps after the 8/11 flow- flood event in Nam Ko Yai stream channel at location X in Figure 5-11.

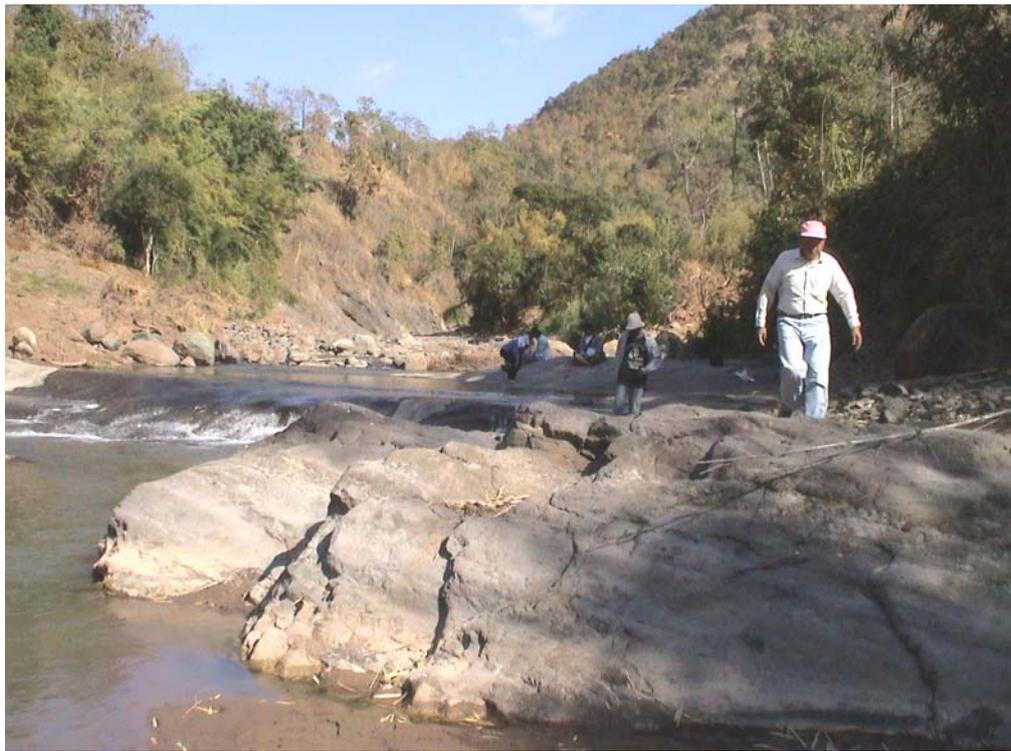
From the base rocks in the downstream from this suspected natural temporary dam location, it is interesting to note that lithology of Lom Sak Formation is mainly composed of high-resistant rocks of volcanic complex as shown in Figure 5-13. So the V-shape downstream with high sinuosity of Nam Ko Yai channel is generally controlled by these high-resistant volcanic rocks with some structural control of fracture lineaments as evidences by mainly channel straight change-directions and the topography.

Figure 5-13 Photograph showing general characteristics of the high-resistant volcanic rocks of Lom Sak Formation (Ls) in the downstream from the suspected natural temporary dam location.

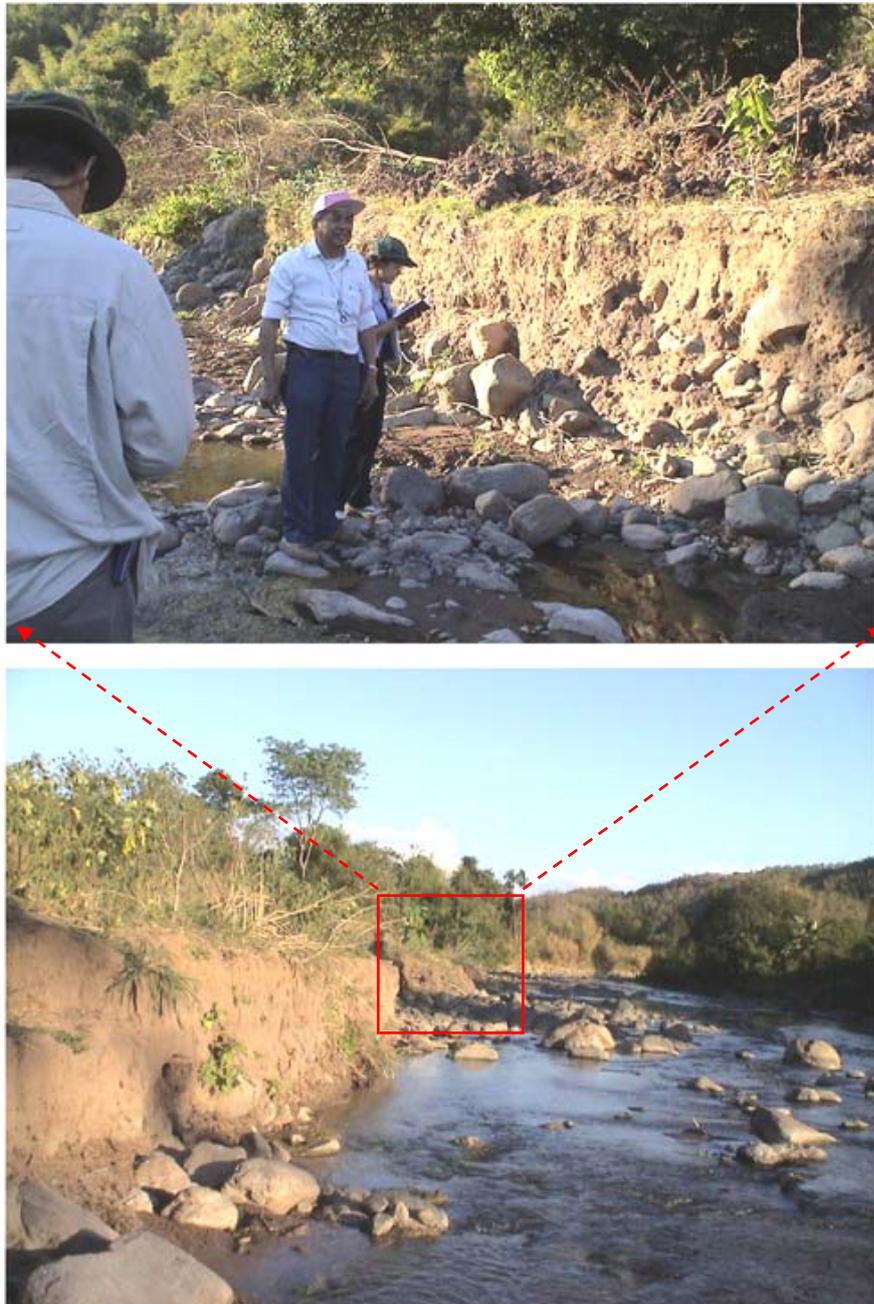
Besides, newly deposited large boulders were found in the channel lying on the green weeds, where the gradient of stream bed changes from steep to flat (Figure 5-14). Eroded soil banks were also common.

Figure 5-14 Photographs of the flat valley area with gentle slope in Nam Ko Yai stream channel at location Y in Figure 5-10 illustrating the rock boulder deposits along the bottom channel, as well as the erosional bank that prevailed the previous debris flow deposits with floating texture, unsorted, and unstratified characteristics of about 1.2 m thick.

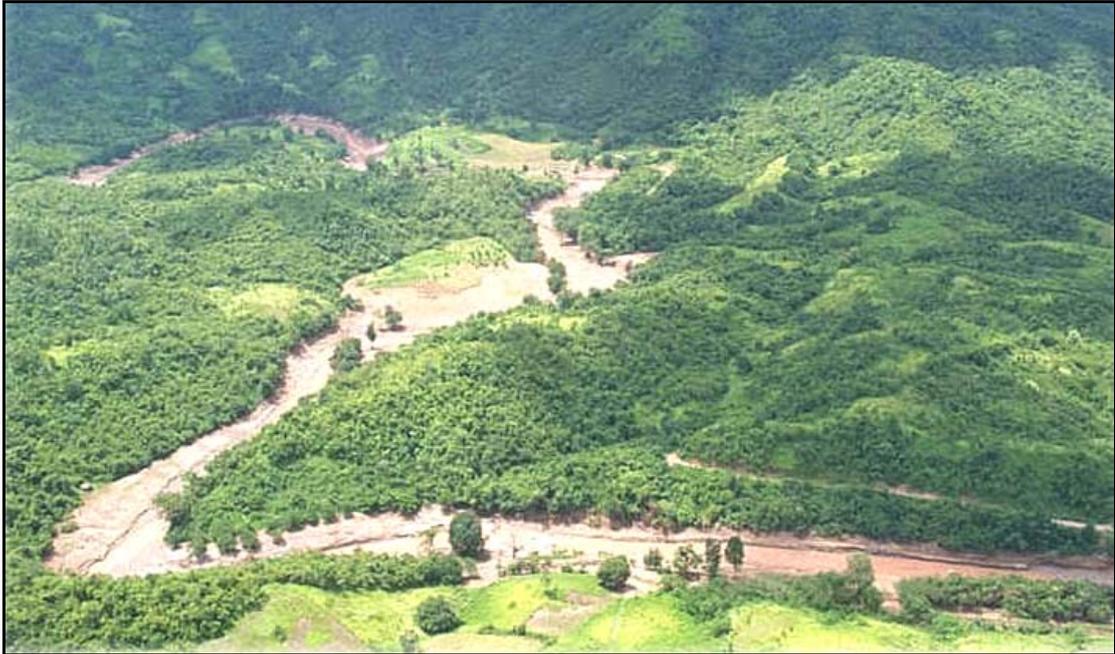
From the field evidences and oblique aerial photograph (Figure 5-15) taken after the 8/11 flow-flood event, mainly the plant debris and soils that had been strongly eroded and transported from the upstream banks of Nam Ko Yai channel with high sinuosity characteristic in flat and hilly valleys were further spread out and deposited in the area of decreased confinement to form an alluvial fan at the toe of mountain front according to their high buoyancy and low viscosity. The descriptions and evidences of previous flow-flood activities in the alluvial fan will be mentioned and discussed in the following chapter.

Figure 5-15 Oblique aerial photographs along Nam Ko Yai stream channel. The photograph, at location Z in Figure 5-11, illustrates the flow-flood track along plant debris and soils had been strongly eroded and transported from its banks before reaching the outlet of the Nam Ko Yai sub-catchment.
