2001 debris flow and debris flood in Nam Ko area, Phetchabun province, central Thailand

Abstract The factors of the debris flow and debris flood (debris flow-flood) occurrence on 11 August 2001 on the active Nam Ko alluvial fan in Phetchabun province, central Thailand, were studied. Evidences of past activity registered in the alluvial fan, and the debris flow-flood event were reconstructed. The disastrous debris flow-flood event was not the work of the unusual high amount of rainfalls alone, as previously theorized, but is a work of combined factors from the terrain characteristics with specific land covers to the time delay for accumulation of debris and sedi-

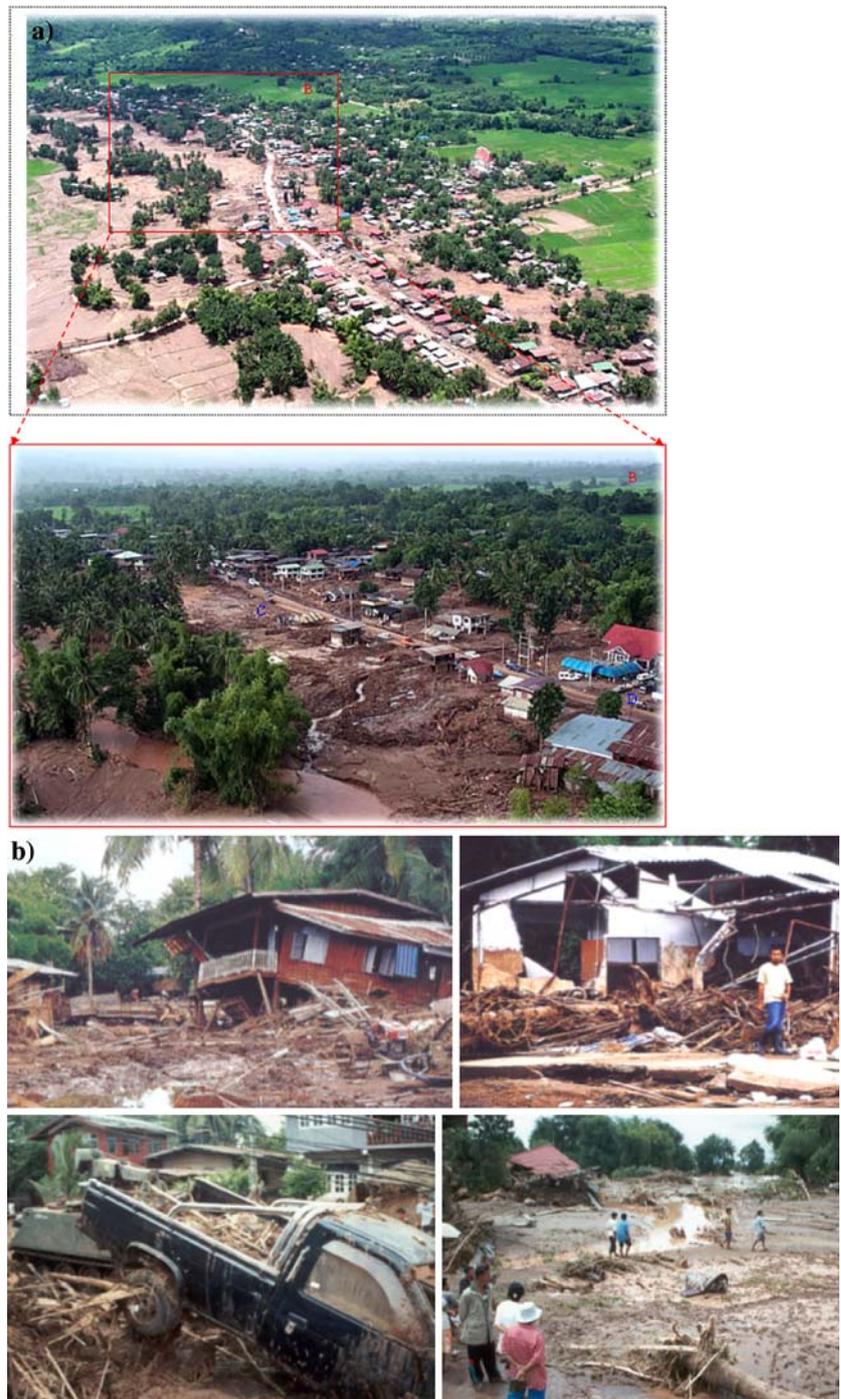
Fig. 1 **a** Two oblique aerial photographs perceptibly illustrating the characteristics and extension of a large volume of deposited sediments; and **b** four closed-up photographs illustrating the seriously battered structural damage of houses, orchard trees and other infrastructures in Nam Ko Yai village caused by the fast-moving debris flow-flood occurrence on 11 August 2001 (8/11)

The oblique aerial photographs of the severely damaged settlement areas (Fig. 1) illustrate characteristics and extent of a large volume of an active alluvial fan

deposit. The flood levels were established from mud traces on house walls and trees. The highest level of the debris flood, 190–200 cm above the ground level, was located in the most severely damaged zone at locations A and B (Fig. 17). The two locations faced the straight course of Nam Ko Yai stream before the channel changed direction abruptly further downstream. Here, the flood jumped over-bank to destroy houses and orchards and claim lives.

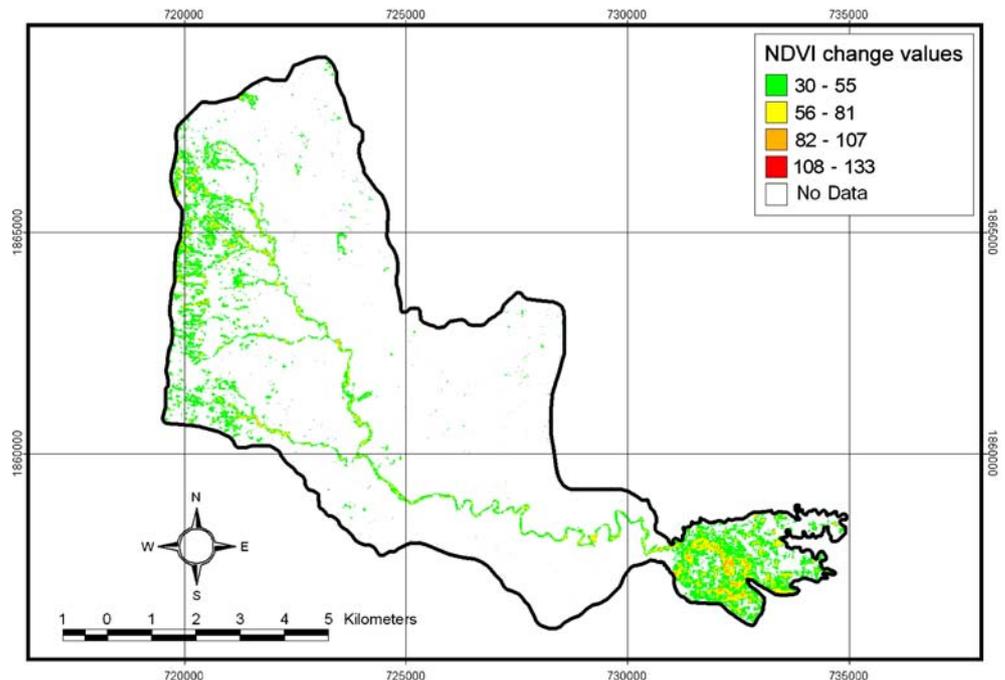
was used to establish a threshold of vegetated and un-vegetated pixels in the images for change detection at the scar-scouring and depositional locations (Fig. 4).

Fig. 4 The resulted significant change detection of NDVI showing scar-scouring and depositional locations in Nam Ko Yai sub-catchment and its alluvial fan that are caused from the 8/11 debris flow-flood occurrence

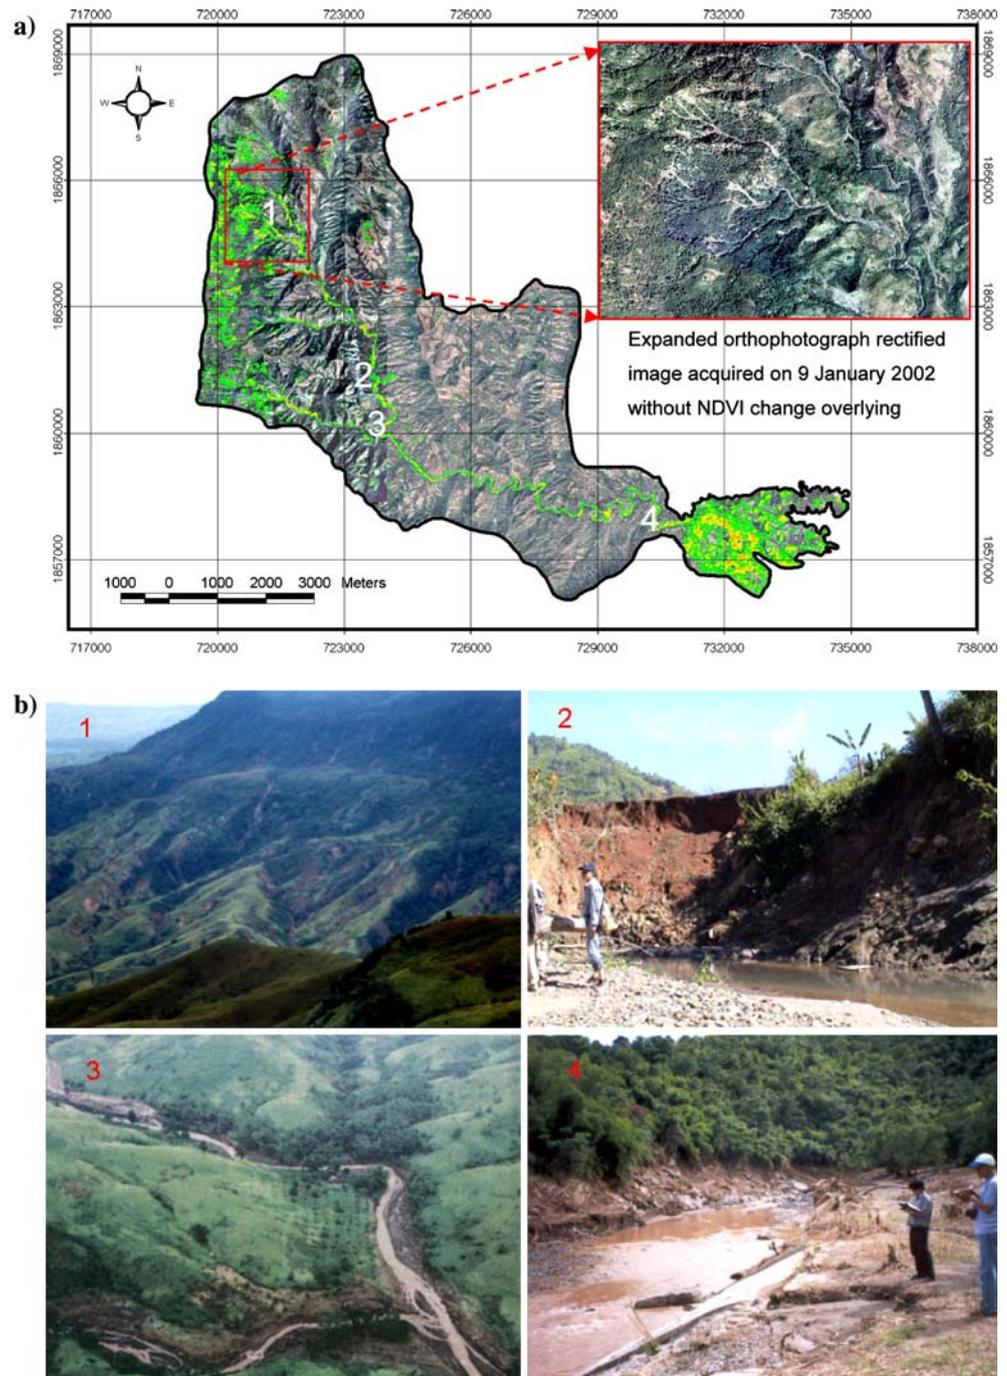
Fig. 5 a The significant change of NDVI (from Fig. 4) overlain on the orthophotograph rectified image acquired on 9 January 2002 (after the debris flow-flood occurrence); and **b** the photographs of four locations (number referred to the location in the map) taken a few days in Nam Ko Yai sub-catchment after the 8/11 event showing the ground truth evidences

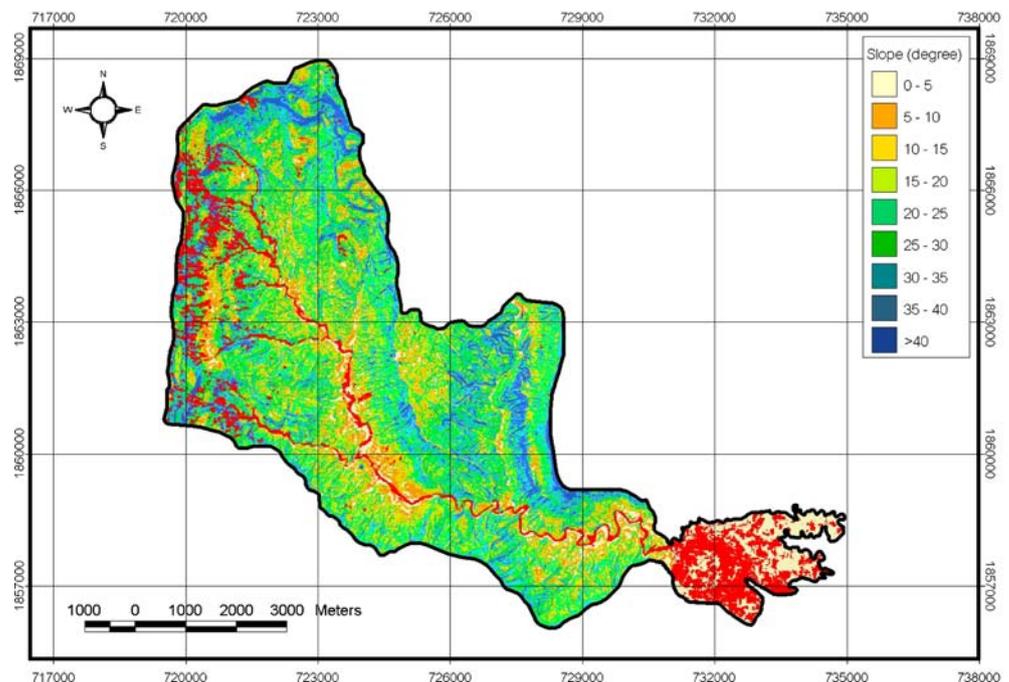
For slope configuration (Fig. 6), it was concluded that the steeper the slope, the greater the landslide probability was. For the slope inclination of 35–40° and

more than 40°, the ratios were 1.57 and 1.70, respectively, indicating a slightly high probability for the scar-scouring occurrence in both cases.

Fig. 6 Slope map overlain with scar-scouring and depositional locations (in red) in the study area

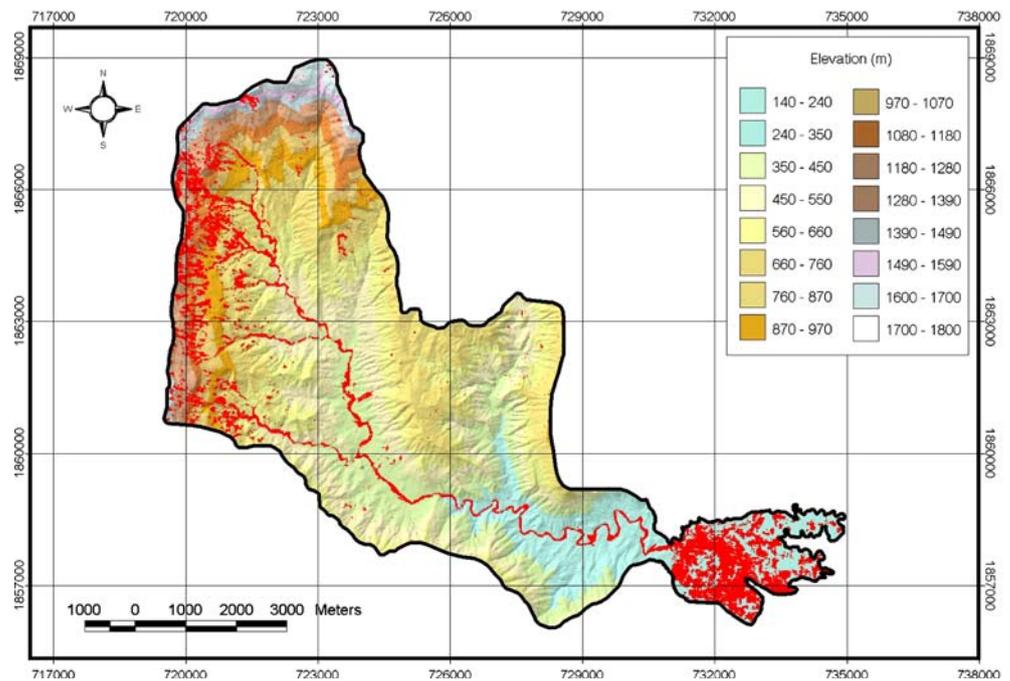
For elevation above mean sea level (Fig. 7), the higher elevation, the greater the scar-scouring probability. For elevations between 1,000 and 1,100; 1,100 and 1,200; 1,200 and 1,300; and 1,300 and 1,400 m, the ratios were 3.16, 3.41, 3.99 and 2.54, respectively, indicating a very high probability for scar-scouring. Similar elevation ranges were observed in the steep-cliff areas.

Fig. 7 Elevation map overlain with scar-scouring and depositional locations (in red) in the study area

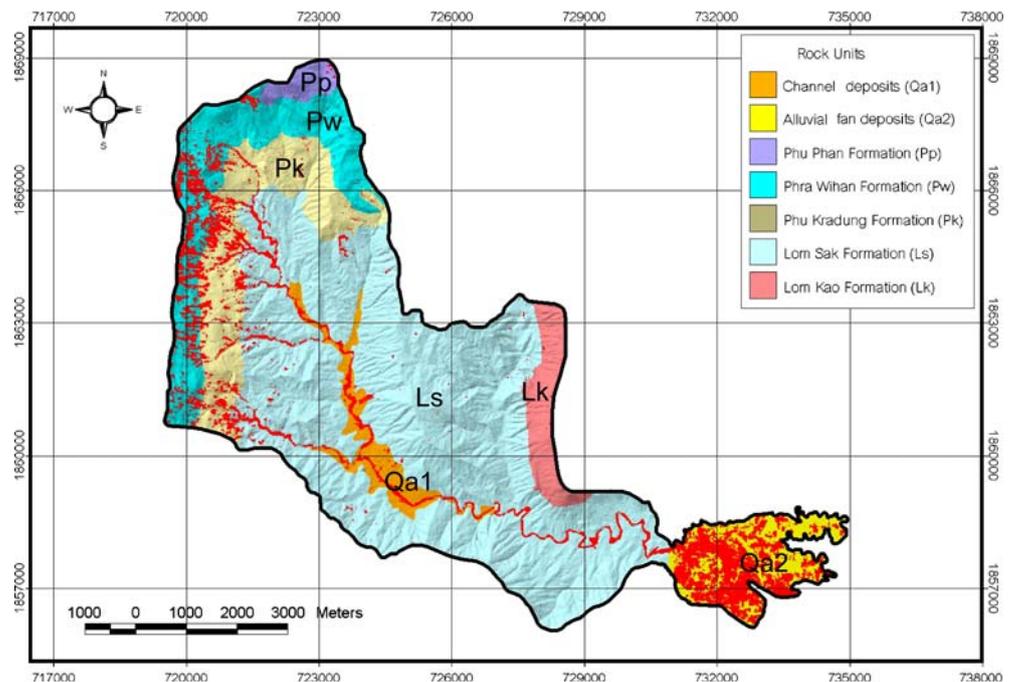
The frequencies of scar-scouring as related to the lithologic groups (Fig. 8) were determined for the different stratigraphic units. In the alluvial deposits (Qa1), Phra Wihan (Pw), Phu Kradung (Pk) and Lom Sak (Ls) Formations, the ratios were 3.188, 3.079, 2.302 and 2.713, respectively, indicating very high probabilities for scar-scouring occurrence in all units.

Fig. 8 Rock unit map overlain with scar-scouring and depositional locations (in red) in the study area

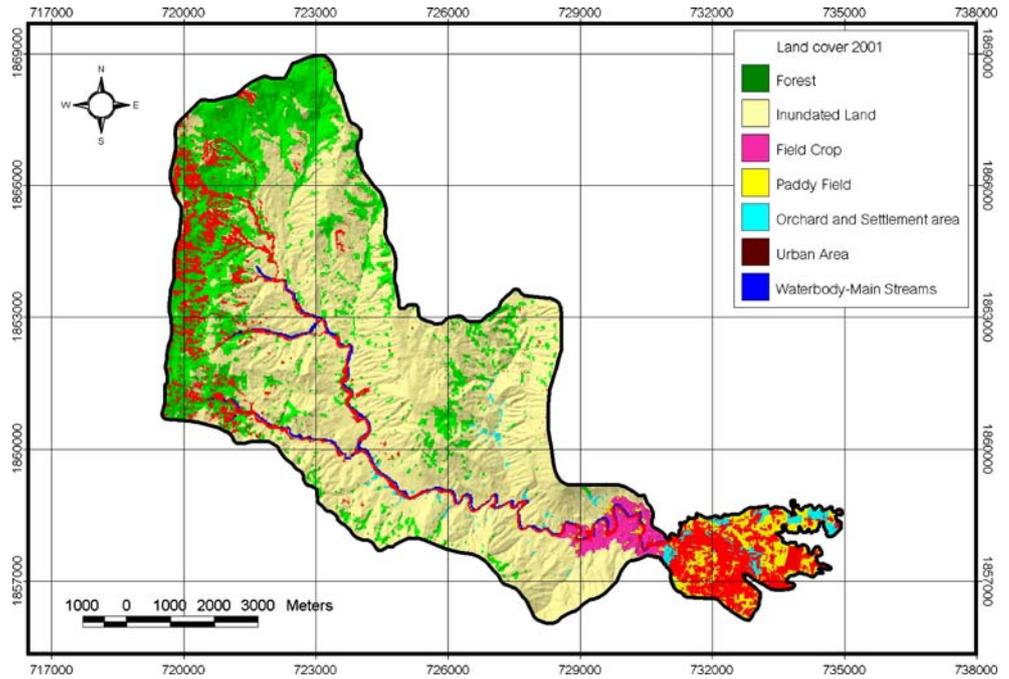
The relationship between the scar-scouring and different types of land cover (Fig. 9) was also determined. The study revealed a high probability value on the banks close to the stream course and in forest areas further away, but lower in the cultivated flat areas. This is con-

trary to a general belief that cultivated lands played a major role in this event. The explanation could be that the debris flow-flood occurred close to the main stream where there was high energy for erosion and transportation of sediments, and in the forested areas where water could be accumulated and retained to introduce more effective transport when the catastrophic event occurred.

Fig. 9 Land cover map overlain with scar-scouring and depositional locations (in red) in the study area

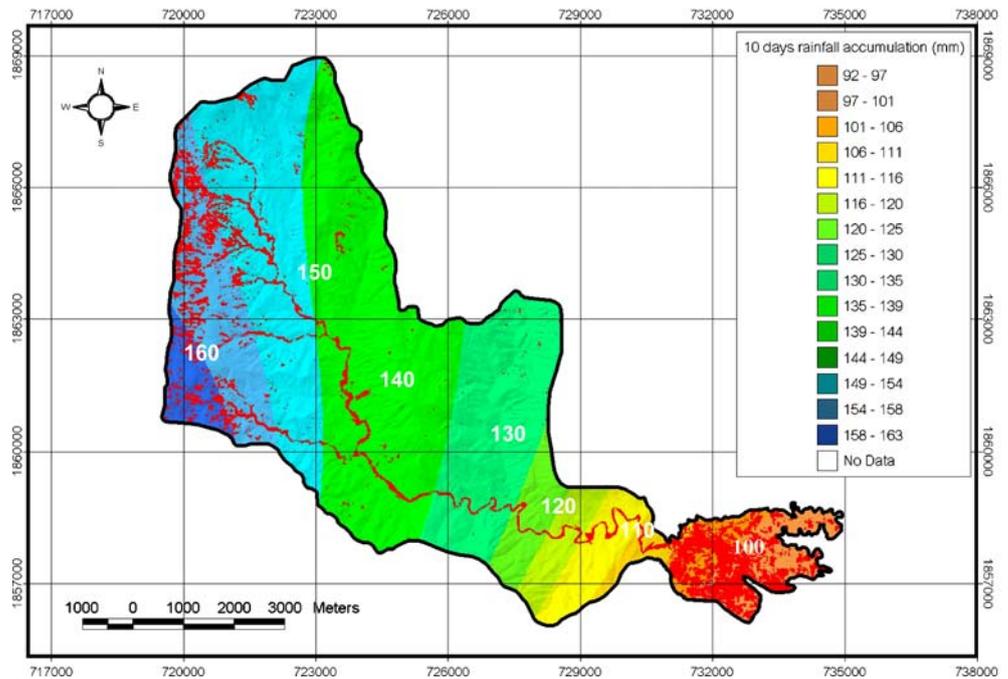
Fig. 11 Rainfall accumulation in the period of 1–10 August 2001 (before the 8/11 debris flow and debris flood occurrence) overlain with scar-scouring and depositional locations (in red) in the study area

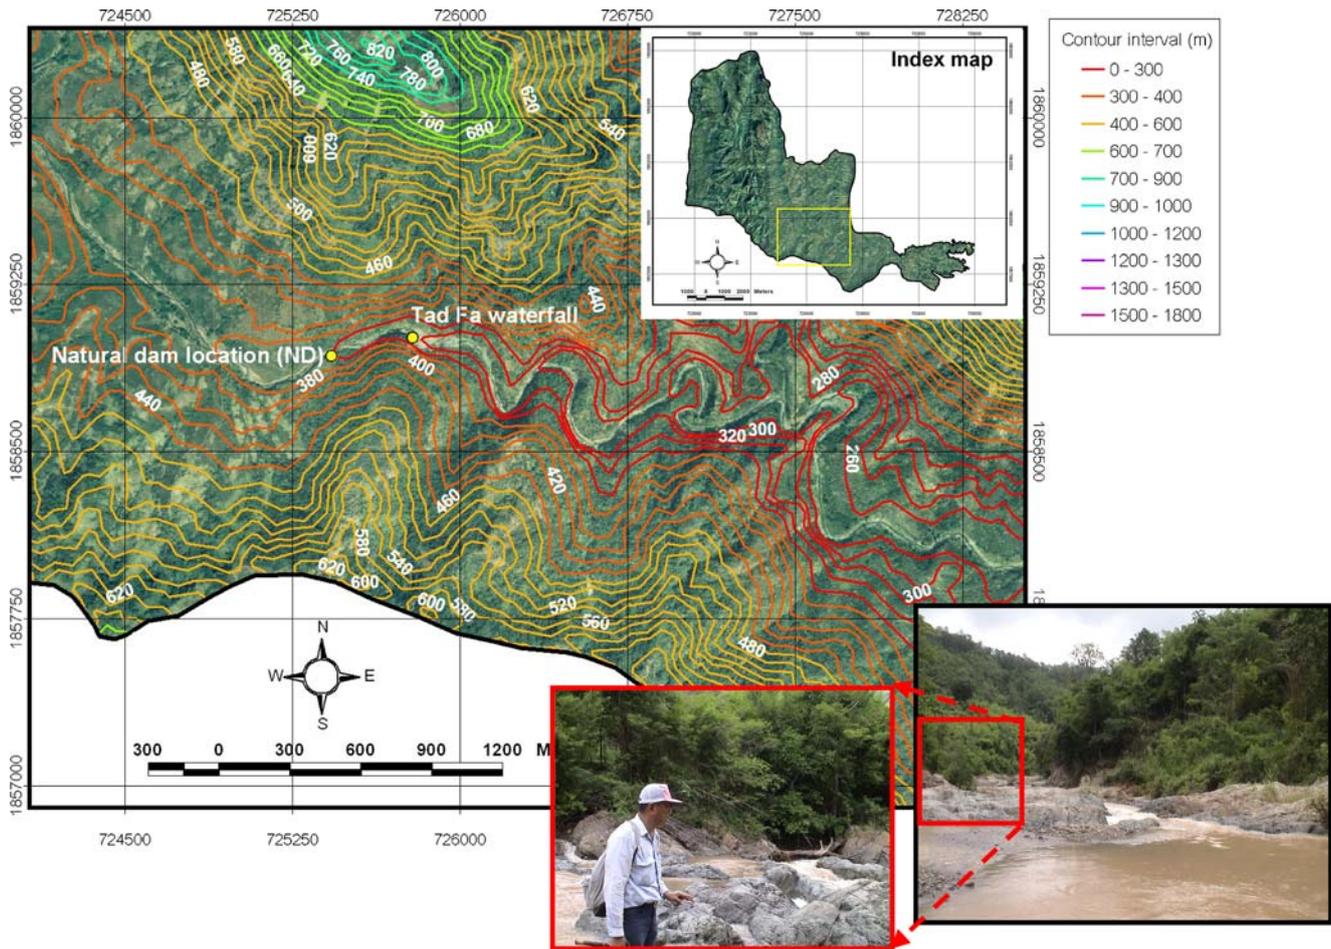
Fig. 13 The orthophotograph rectified image (1:25,000 scale, January 9, 2002 after the 8/11 event) overlain with the contour intervals (20 m) showing the specific configuration of Nam Ko Yai stream located in the lower central part of the study area proposed to be the natural dam location (ND) in front of the location of Tad Fa waterfall

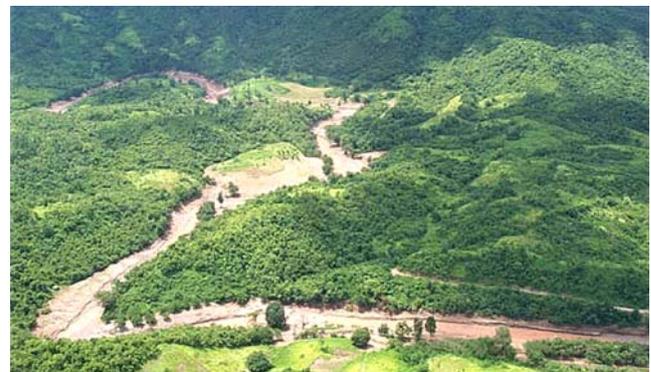
Fig. 14 The oblique aerial photograph (taken on 22 August 2001, 11 days after the event) along the channel of Nam Ko Yai stream with the high sinuosity characteristic illustrating the debris flow-flood track along plant debris and soils had been strongly eroded and transported from its banks before reaching the canyon mouth outlet of the stream

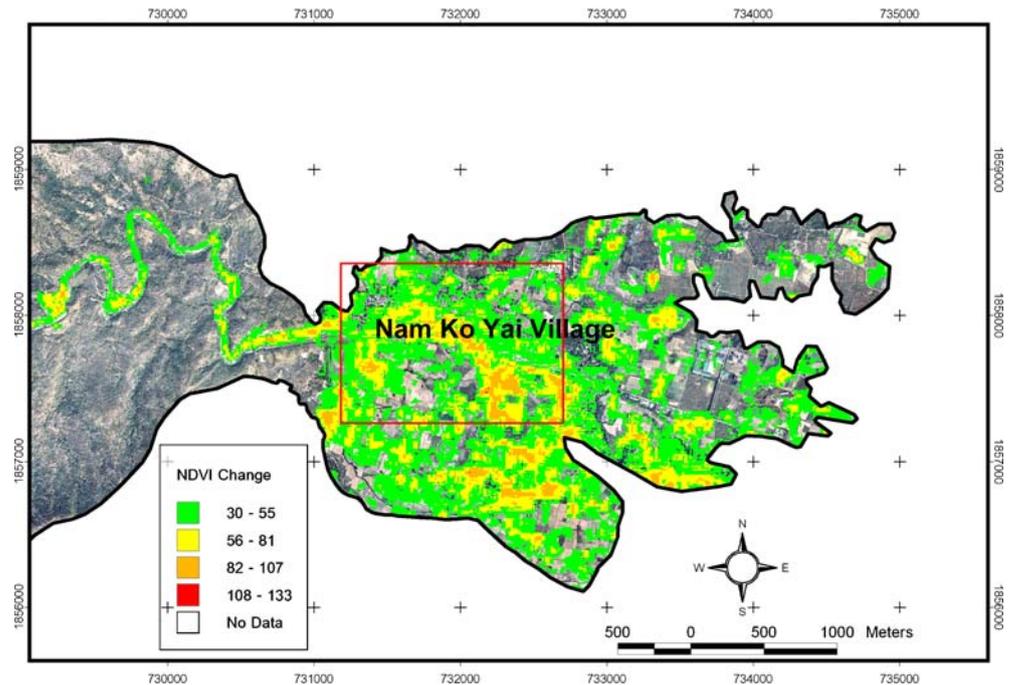
In the multi-spectral Landsat 7 ETM+ imageries analysis, evidences of the alluvial fan deposit from the 8/11 event were analyzed using NDVI value. NDVI value was also used to detect the depositional locations on the alluvial fan (Fig. 16). Oblique aerial photographs taken after the flood were used to characterize the extent of the deposit and validate analyzed result. The high value of NDVI change (56–107) in Fig. 16 generally conformed the areas of the most serious damage in Fig. 17.

Fig. 16 The detection change of NDVI in the depositional location of the alluvial fan (expanded from Fig. 4) overlain on the orthophotograph rectified image (1:25,000 scale) acquired on 9 January 2002. The *brown-colored zones* are new traces of fan deposit after 1996

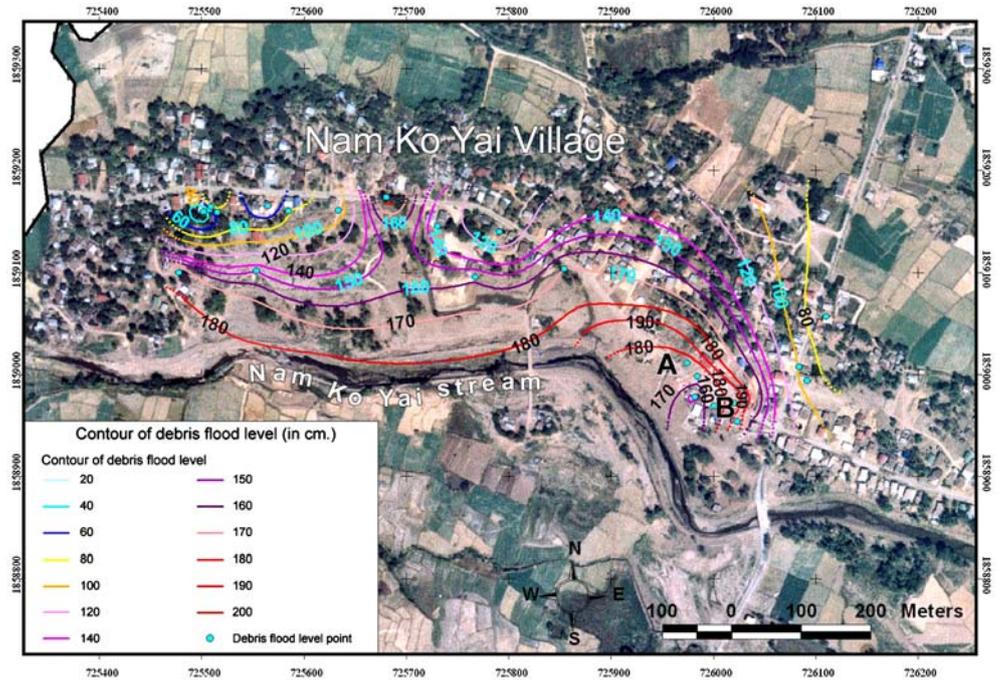
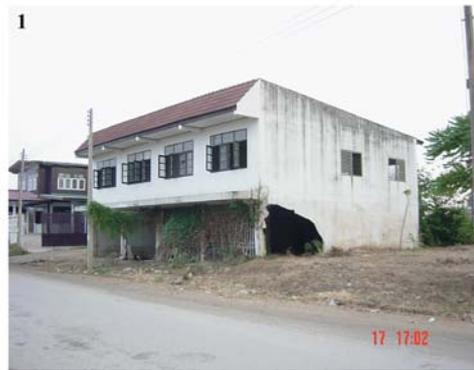
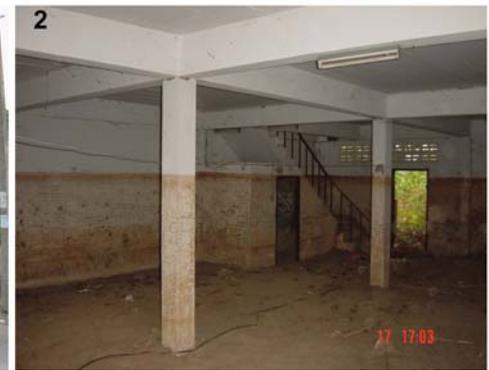
Fig. 17 The expanded ortho-photograph rectified image (1:25,000 scale) acquired on 9 January 2002 (red outline in Fig. 16) showing the contours of debris flood levels (in cm) above the ground surface (detected from the thin brown film left at house-walls and trees) in the strongly damaged area of Nam Ko Yai village caused by the 8/11 debris flow-flood

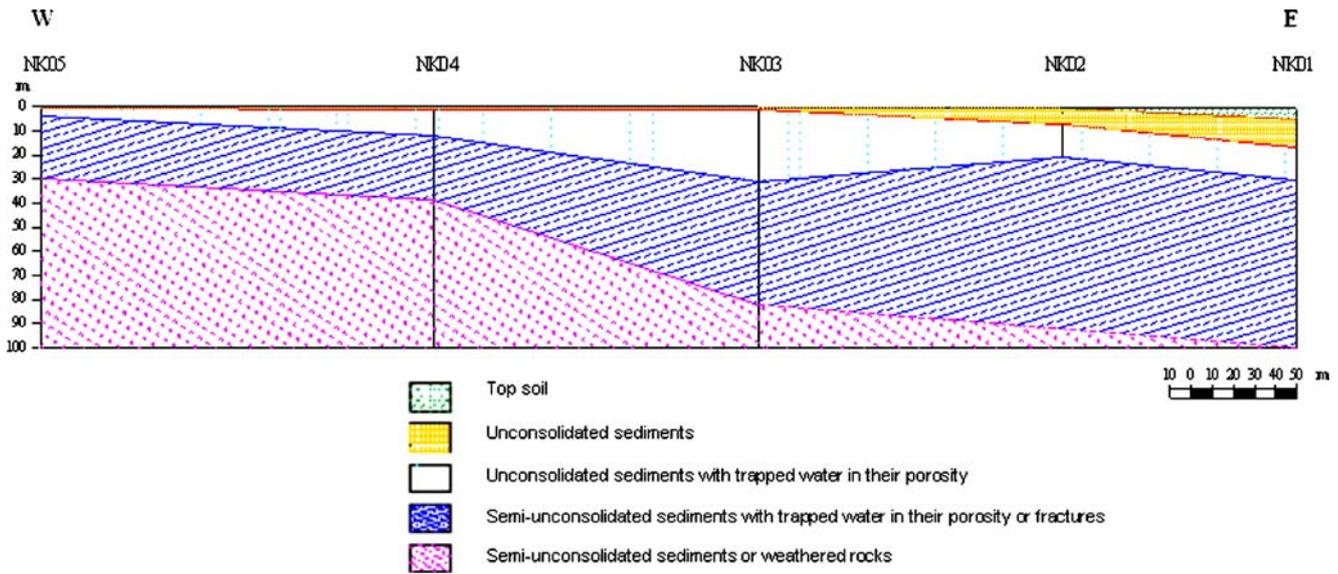
The results of the resistivity survey investigated along the lines NK 01–NK 05 (Fig. 18) to identify the local three-dimensional geology (thickness and depth of the older alluvial deposits), revealed four sedimentary units at a total depth of less than 100 m below the ground surface. The lowest unit was semi-unconsolidated sediments or weathered rocks of at least 70 m thick to the west with the bed top at a depth of about 30 m below ground surface (Fig. 18), and much thinner, less than 10 m to the east, with the bed top be noted at a depth of about 80 m below the ground surface. The overlying second unit was semi-unconsolidated sediments with trapped water in the bed openings. Thickness was 25–70 m and increased to the east. Its shallow horizon was 5 m below ground surface in the west to about 10–20 m to the east. These two lower units are never exposed near the site, but are at surface in the surrounding hills. The third unit was unconsolidated sediments with trapped water. Thickness was in the range of 5–30 m. The thickest part of this third unit was near the NK 03 line in the central part, where the depth to the top of the unit was from a few meters down to 15 m below the ground surface further to the east. The fourth and uppermost unit was of unconsolidated sediments with a thickness of a few meters in the west to 10 m in the east. The fourth unit was commonly exposed on the ground surface along all survey lines, except in the east where it was completely covered by recent topsoils.

Fig. 18 The cross-section of the resistivity survey interpreted from the five survey points (NK 01–NK 05 as shown in Fig. 19) that revealed four sedimentary units lying less than 100 m below ground surface

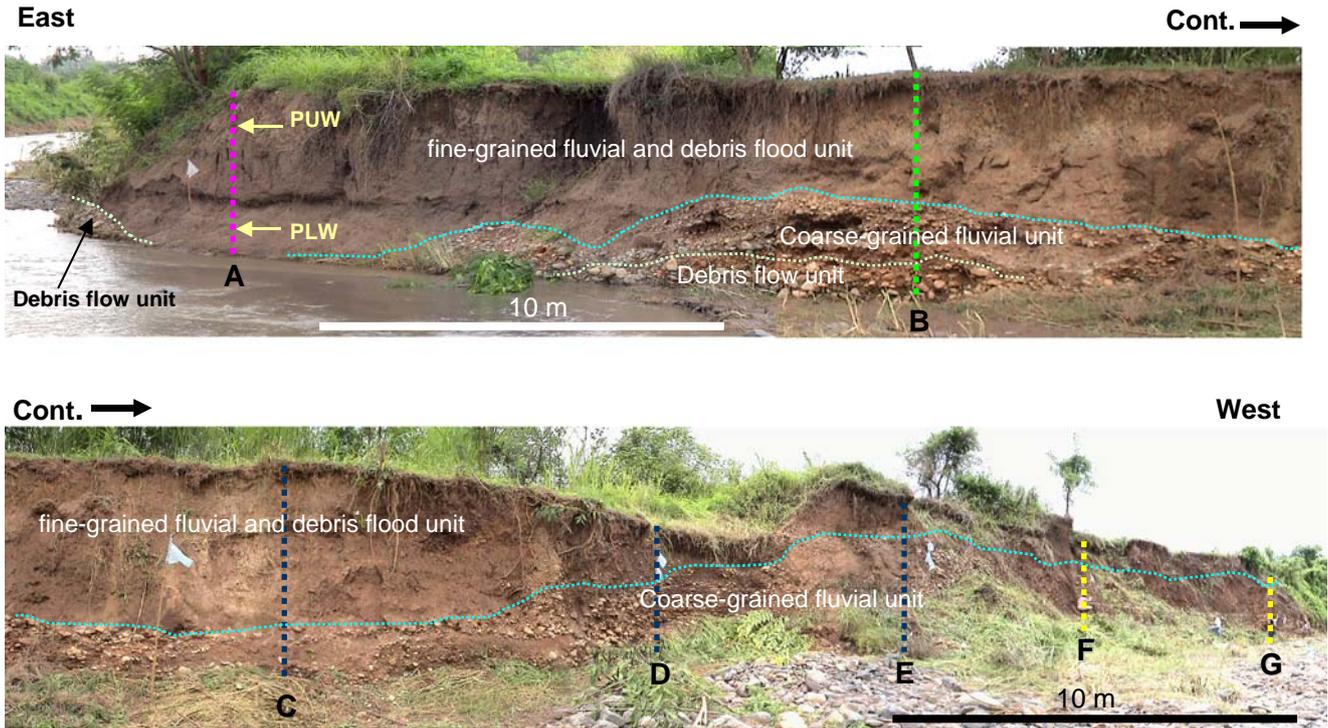
In the observed sections, the lowest sedimentary unit of the older alluvial fan deposits was a debris flow unit of floating texture, unsorted and unstratified material that was exposed in the stream-bed only in the eastern part. The coarse-grained fluvial unit of clast-supported texture and fining-upward graded bedding was transitionally deposited on top of the debris flow unit, especially in the middle part, and extended westward (upstream). This coarse-grained fluvial unit was the thickest in the western part and became thinner to the east. The uppermost part of this eroded-bank profile was a fine-grained fluvial and debris flood unit that was dominantly deposited to form a sharp contact on top of the coarse-grained fluvial unit. The uppermost unit is thicker to the east, especially in the eastern part. The representative and complete detailed sedimentary and stratigraphic characteristics in vertical succession are shown in Fig. 21, from bottom to top, the debris flow unit, the coarse-grained fluvial unit and the fine-grained fluvial and debris flood unit, respectively.

Fig. 20 The lateral and vertical stratigraphic characteristics of debris flow and debris flood deposits of older alluvial fan along the eroded bank of Nam Ko Yai stream with the locations of those seven measured stratigraphic profiles (A, B, C, D, E, F, G)

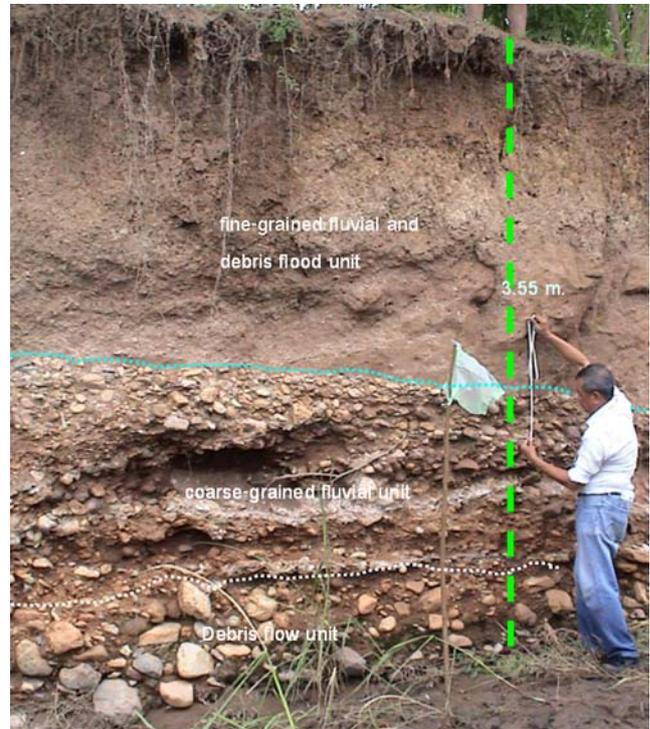
Fig. 21 The measured stratigraphic profile B showing the debris flow unit underlain by the coarse-grained fluvial unit with the transitional contact, and the uppermost fine-grained fluvial and debris flood unit overlying on top of the coarse-grained fluvial unit with a sharp contact

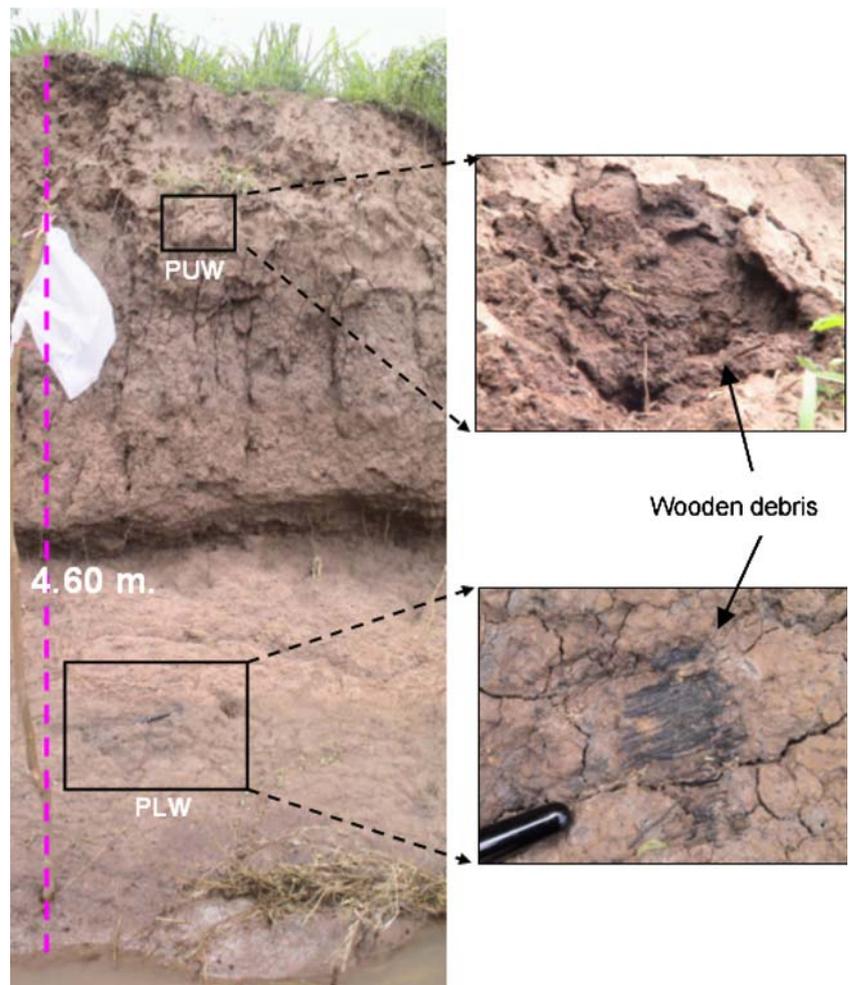
Significant evidences of the previous debris floods found in the eastern part of uppermost fine-grained fluvial and debris flood unit were two preserved wooden debris fragments, one at the lower part (location PLW) and the other at the upper part (location PUW) as shown in Fig. 22. These preserved wooden debris were dated by radiocarbon dating method to have the absolute ages of deposition between 2,618 \pm 35 years before present and post-1950, respectively. From these radioactive dating results, it is strongly confirmed that this is an active alluvial fan and that debris flow-flood process had occurred at least twice before the 8/11 disastrous event.

Fig. 22 The measured stratigraphic profile of the uppermost fine-grained fluvial and debris flood unit illustrating its general characteristics and two locations of preserved wooden debris at the *lower part* (location PLW) and *upper part* (location PUW)

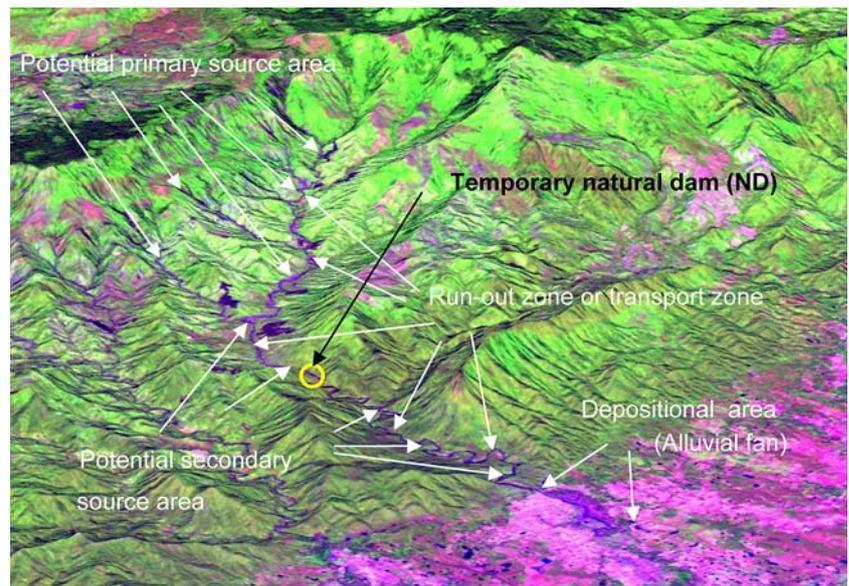
During these landslides and the flow-flood processes, a temporary natural dam might have built up somewhere in the causeway of this stream, most probably near Tad Fa waterfall. The temporary natural dam could have been formed when debris of plant remains, trees, soils and boulders both from several previous and the 8/11 events were locked at this specific location, forming a reservoir upstream. Then another powerful debris flow-flood followed to break this dam, perhaps with surges up to 10 m high to send water and debris flowing further down to destroy the village on the alluvial fan.

Fig. 23 Three-dimensional view of Nam Ko Yai sub-catchment and its alluvial fan modeled by overlaying the false color composite of Landsat 7 ETM+ (R=5, G=4, B=3) acquired on 21 November 2001 through the base-scale DEM showing the main features after the debris-flood occurrence with identified potential hazard zones of the potential primary and secondary source areas, the run-out zone or transport area, the proposed location of a temporary natural dam and the depositional area
