CHAPTER 6

EVIDENCES OF DEBRIS FLOW-FLOOD ACTIVITIES IN THE ALLUVIAL FAN

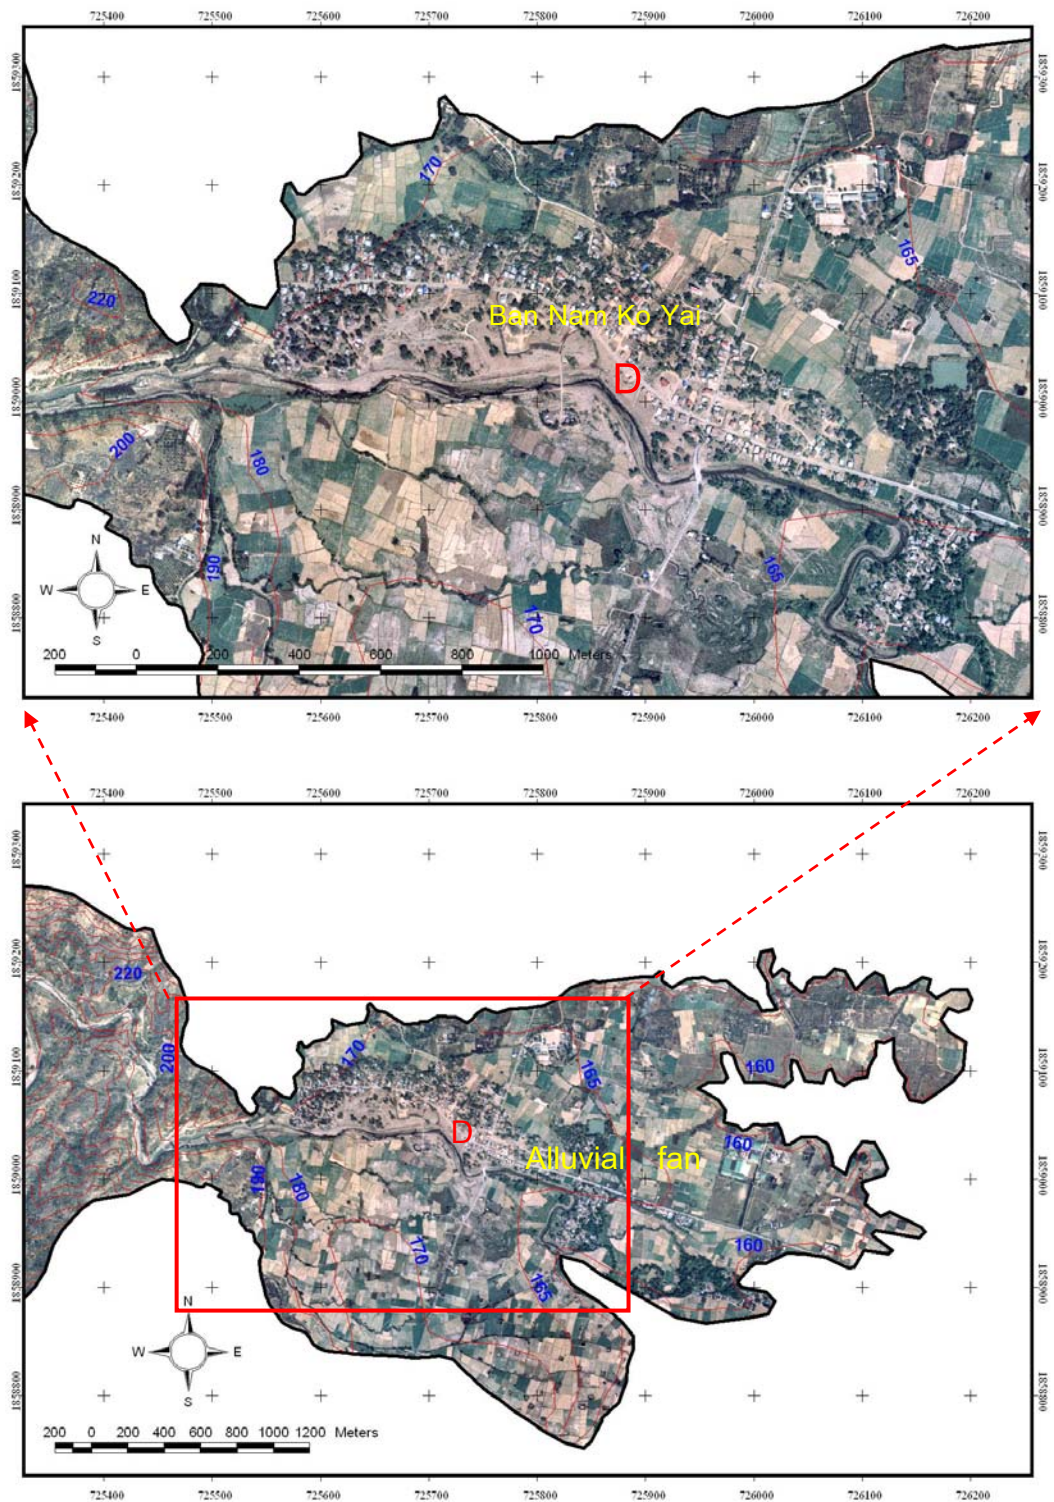
Figure 6-3 Orthophotograph (1:25,000 scale) acquired on 9th January 2002 (after the 8/11 flow-flood occurrence) showing the distinctive active alluvial fan deposit. The main area on the northern bank of Nam Ko Yai stream with populated settlement of Ban Nam Ko Yai (brown color zone surrounding the D location) was strongly damaged.

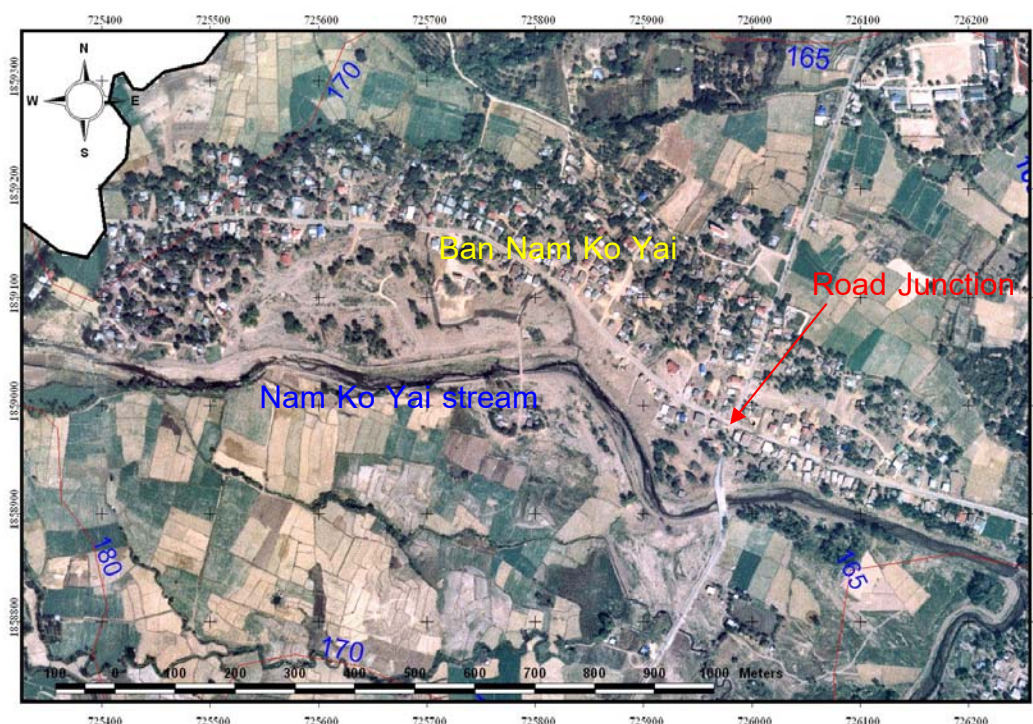
The expanded features of orthophotographs (1:25,000 scale) acquired on 9 January 2002 in Figures 6-4 and 6-5 clearly show the current traces and tracks of debris flood evidenced from the distinctively active alluvial fan deposits. The deposits mainly occurred on the northern bank of the alluvial fan area where the flood severely damaged houses and orchards once existing there as seen in the 1974 aerial photographs and 1996 orthophotographs (Figures 6-2 and 6-3).

Figure 6-4 Expanded features of orthophotograph (1:25,000 scale) acquired on 9th January 2002 (after the 8/11 flow-flood occurrence) showing the clear traces and tracks of flow-flood from the evidences of the distinctively active alluvial fan deposit (in brown color area) that mainly covered and severely damaged houses and orchards in the northern bank of Nam Ko Yai stream. (Note: the road-junction location in this figure will be used to refer to the same location in Figure 6-5)

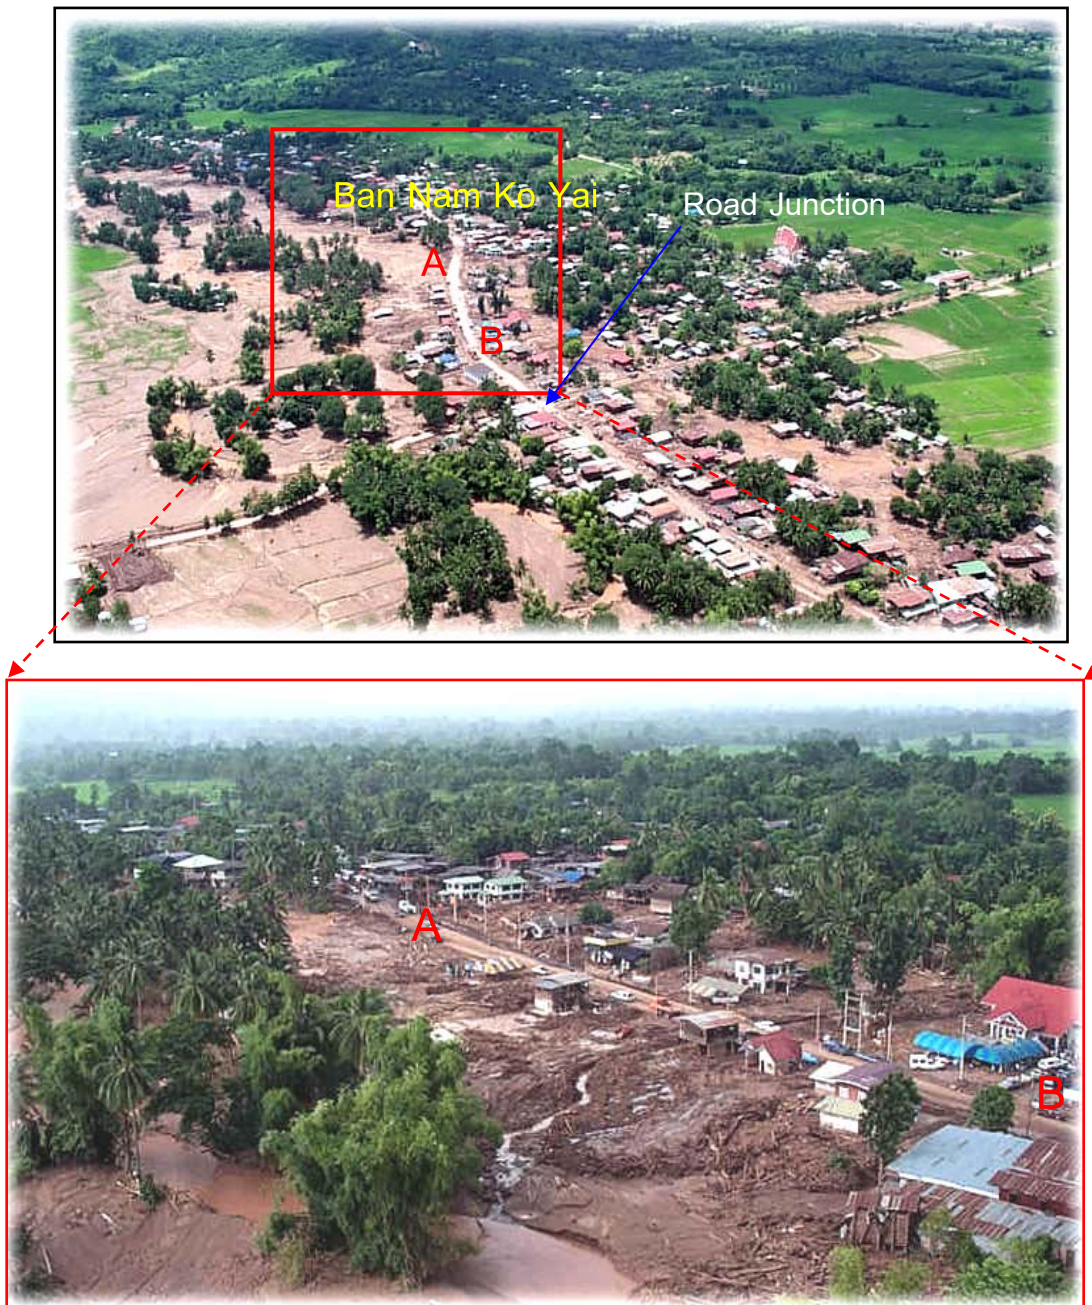
According to the oblique aerial photographs of the severely damaged settlement area (Figure 6-5), they illustrate characteristics and extent of a large volume of an active alluvial fan deposit. The ground visit was also conducted to investigate and record the flow-flood levels in this area. The flood levels were established from the mud traces on house walls and trees. It was found that the highest level of the flow-flood, 190-200 cm above ground surface, was located in the most severely damaged zone at locations A and B (Figure 6-8). It was also noted that these were the two locations facing the straight course of Nam Ko Yai stream before the channel changed its direction abruptly southerly further downstream. Here, the flood jumped over-bank to destroy houses and orchards and claim lives.

Figure 6-5 Two oblique aerial photographs perceptibly illustrating the characteristics and extension of a large volume of deposited sediments as evidences of 8/11 incidence.

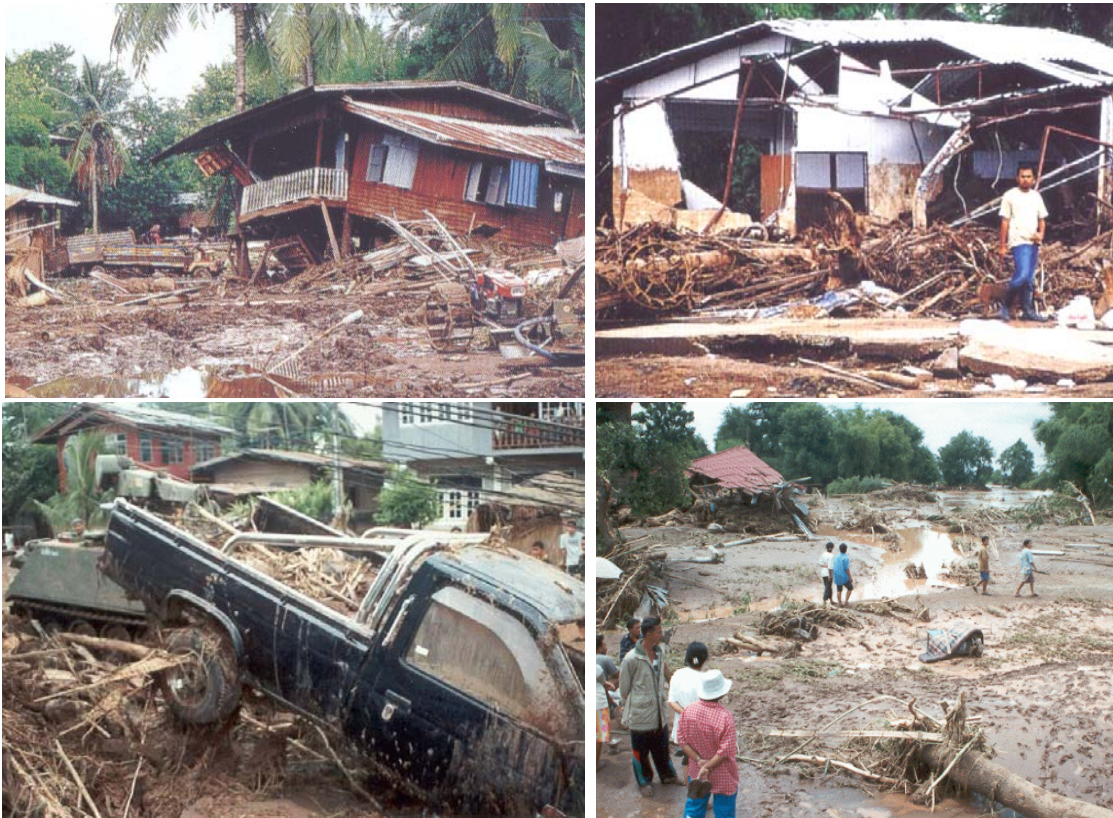
Figure 6-6 Four photographs showing some examples of seriously structural damage of houses and other infrastructures in Ban Nam Ko Yai (in the area between A and B in Figure 6-5) battered and caused by the fast-moving 8/11 flow-flood.

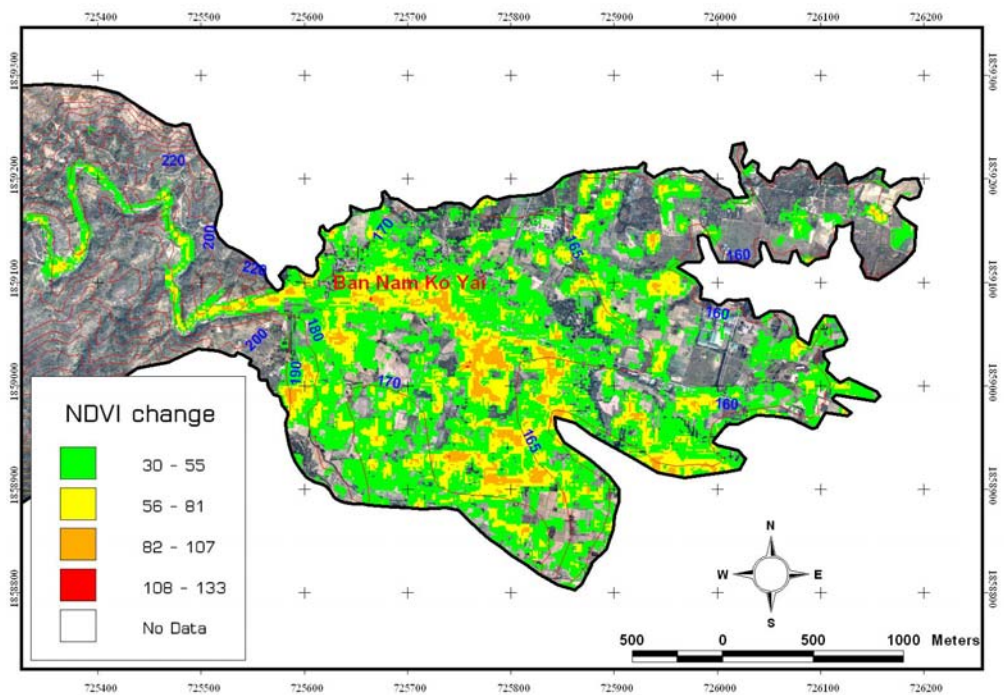
In the multi-spectral Landsat 7 ETM+ imageries analysis, evidence of the alluvial fan deposit from the 8/11 event were analyzed using NDVI value. NDVI value was also used to detect the depositional locations on the alluvial fan (Figure 6-7). Oblique aerial photographs (in Figure 6-5) of the depositional location in alluvial fan area taken after the event were used to characterize the extent of the deposit and validate analyzed result of NDVI value. It is remarked that the high value of NDVI change (56-107) in Figure 6-7 generally conformed the areas of the most serious damage in Figure 6-5. that covered an area of about 3.49 square kilometers from the total area of about 6.29 square kilometers of the alluvial fan. It is noted that the depositional locations from the 8/11 event cover more than 55 % of the total area of the alluvial fan.

Figure 6-7 Detection change of NDVI value in the depositional location of the alluvial fan (expanded from Figure 3-21) overlain on the orthophotograph (1:25,000 scale) acquired on 9th January 2002 (as shown in Figure 6-3).

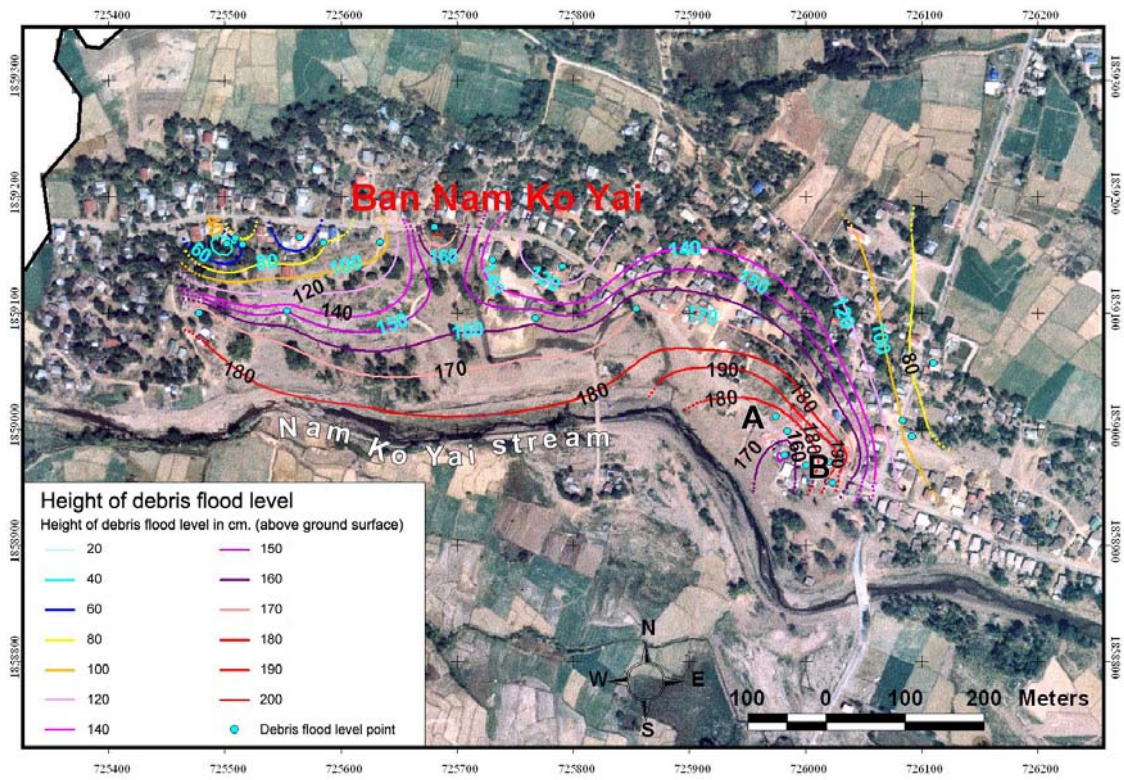
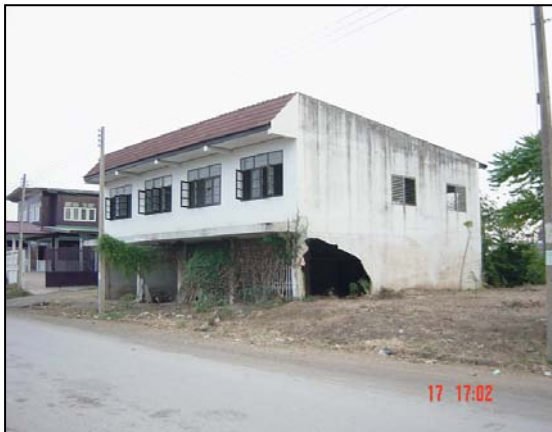
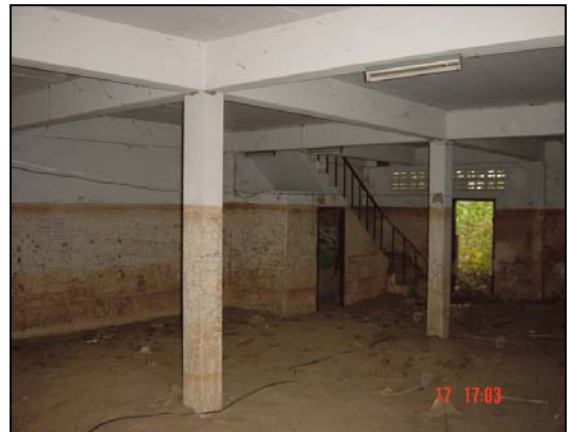
Figure 6-8 Height map of the flow-flood levels detected from the mud traces on the trees and house walls (as illustrating in the attached photographs below the map) in the severely damaged area of Ban Nam Ko Yai after the fast-moving 8/11 flow-flood

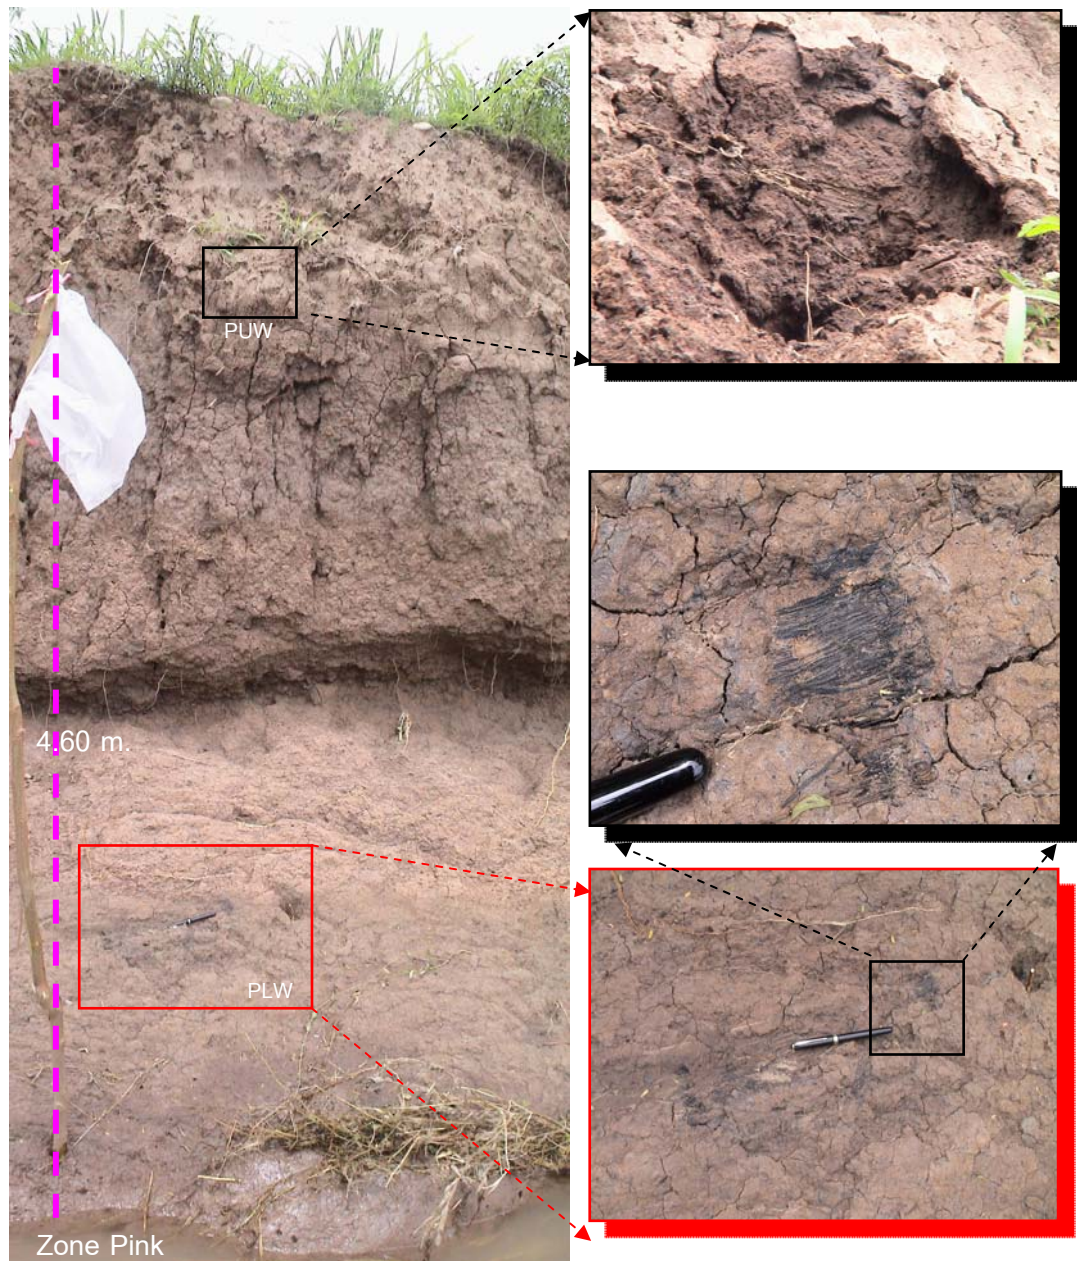
Significant evidences of the previous flows-floods found in the uppermost fine-grained fluvial and debris flood unit were two preserved wooden debris fragments, one at the lower part (location PLW) and the other at the upper part (location PUW) of the Pink section (Figures 6-16 and 6-17). It is noted that the PLW sample of the lower location was charcoal characteristic with fibrous texture whereas the sample of the upper location (PUW) was the pale brown wood with rather complete wooden texture (as shown in Figure 6-17). These preserved wooden debris were dated by radiocarbon dating method to have absolute ages of deposition between 2,618 \pm 35 before present and post-1950, respectively.

Figure 6-16 Photographs illustrating the general characteristics in the uppermost fine-grained fluvial and debris flood unit at the zone Pink (referred to Figures 6-9 and 6-11) and the preserved large wood debris at the lower part (PLW) and at the upper part (PUW) locations.

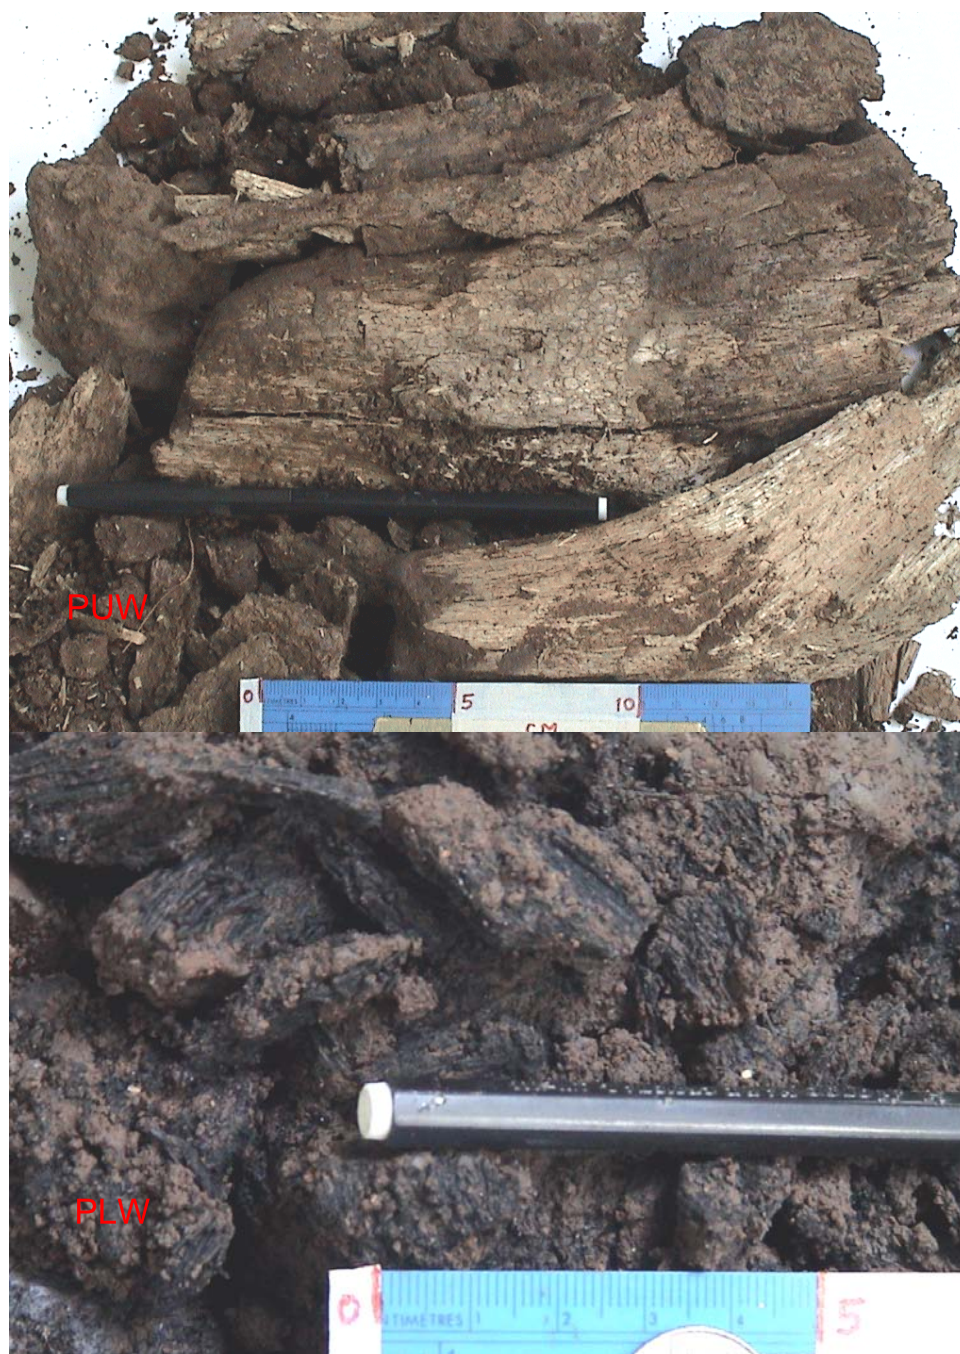
From these radioactive dating results, it is strongly confirmed that this is an active alluvial fan and the debris flow-flood processes had occurred at least twice before the recent 8/11 disastrous event.

Figure 6-17 Closed-up photographs of the collected wood debris samples from the preserved locations at PLW and PUW (as shown in Figure 6-16) illustrating their general characteristics of charcoal characteristic with fibrous texture and pale brown wood with rather complete wooden texture, respectively.
