APPENDICES

2001 debris flow and debris flood in Nam Ko area, Phetchabun province, central Thailand

Abstract The factors of the debris flow and debris flood (debris flow-flood) occurrence on 11 August 2001 on the active Nam Ko alluvial fan in Phetchabun province, central Thailand were studied. Evidences of past activity registered in the alluvial fan, and the debris flow-flood event were reconstructed. The disastrous debris flow-flood event was not the work of the unusual high amount of rainfalls alone, as previously theorized, but is a work of combined factors from the terrain characteristics with specific land covers to the time-delay for accumulation of debris and sediments. This combination of factors could lead to a debris flow-flood after a high amount of precipitation. The process could also be worse if a landslide formed a natural dam, then the dam was destroyed under the weight of impounded water. After such a disastrous event, it would take time for more plant debris and sediments in the sub-catchment area to accumulate before the next debris flow-flood.

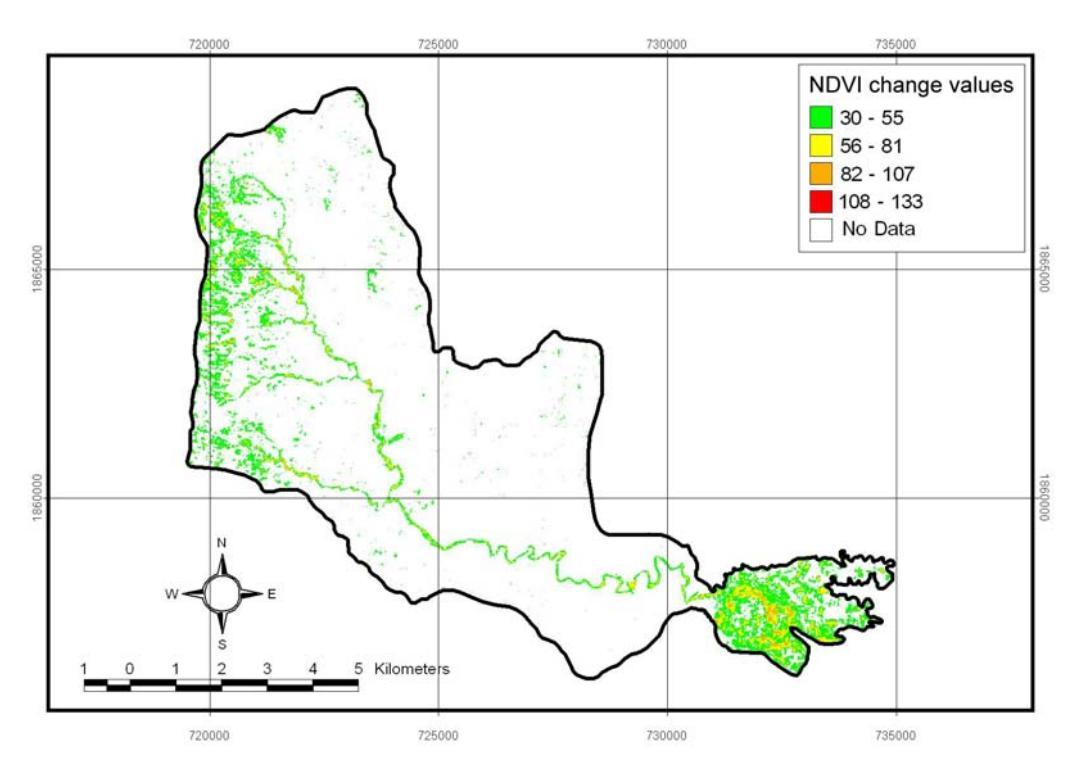
Fig. 4 The resulted significant change detection of NDVI showing scar-scouring and depositional locations in Nam Ko Yai sub-catchment and its alluvial fan that are caused from the 8/11debris flow-flood occurrence

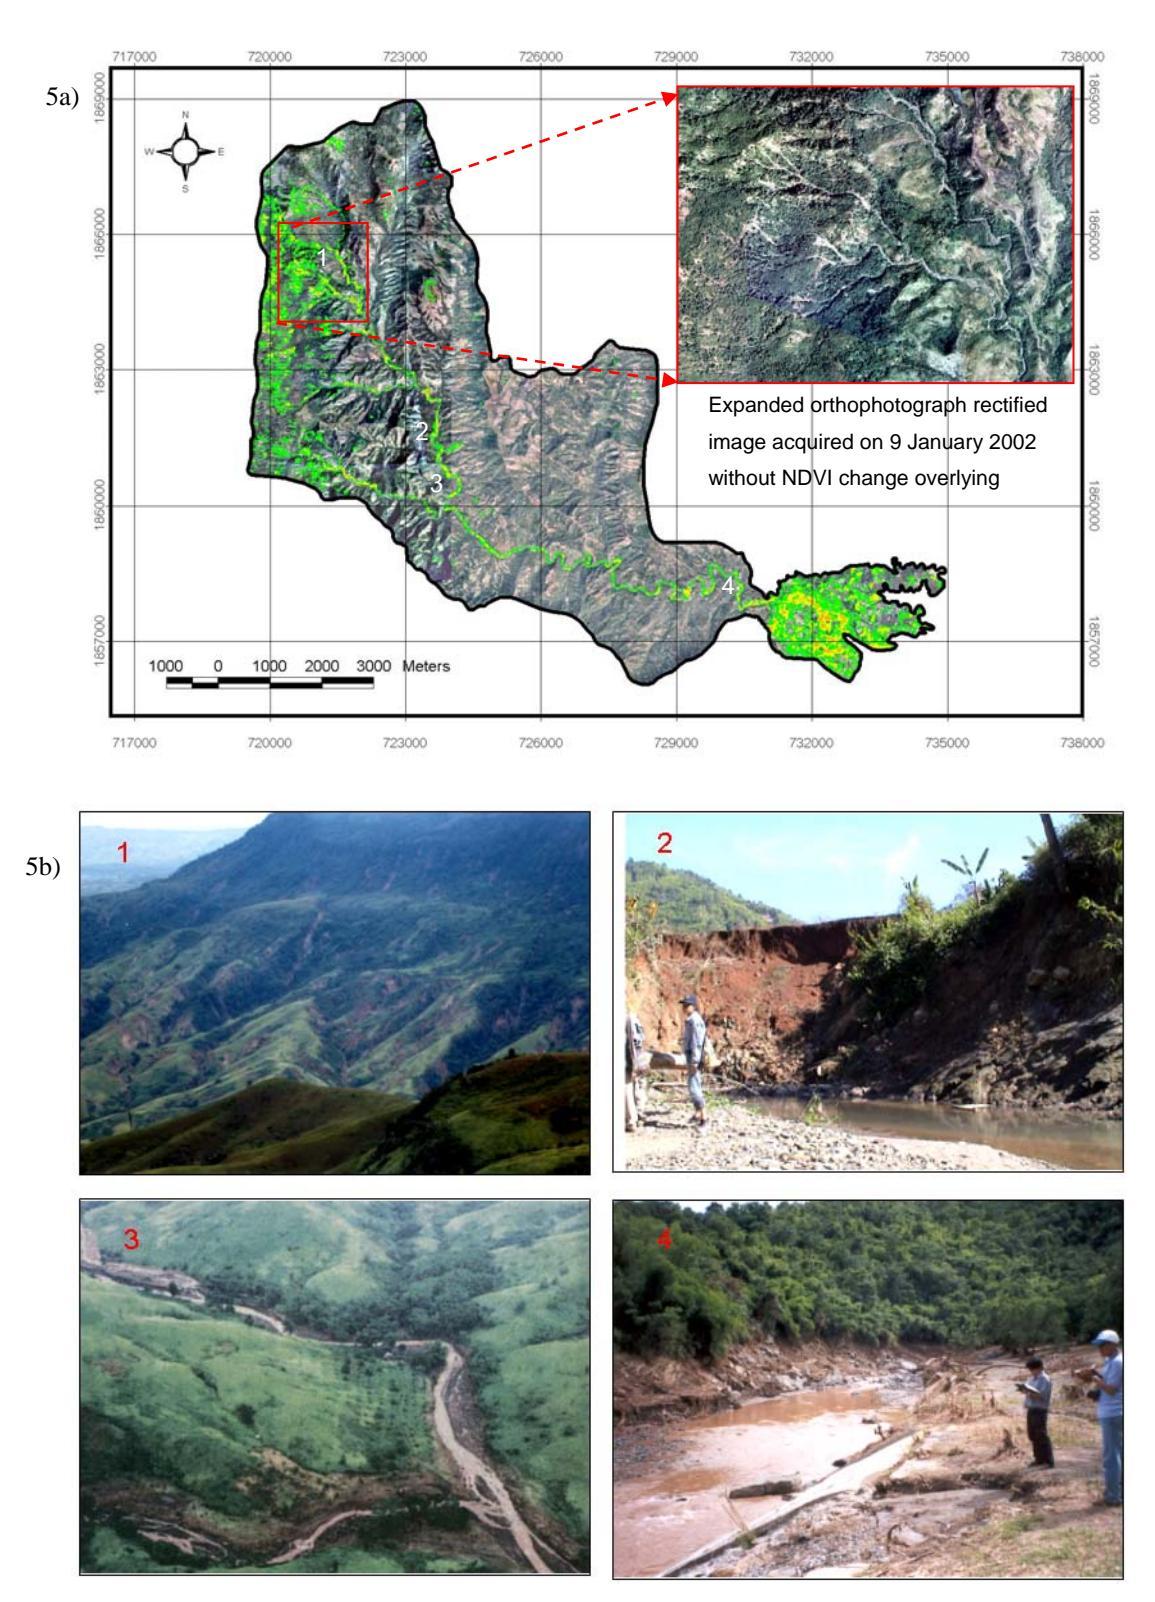
Fig. 5 5a) The significant change of NDVI (from Fig. 4) overlain on the orthophotograph rectified image acquired on 9 January 2002 (after the debris flow-flood occurrence); and 5b) the photographs of four locations (number referred to the location in the map) taken a few days in Nam Ko Yai sub-catchment after the 8/11 event showing the ground truth evidences

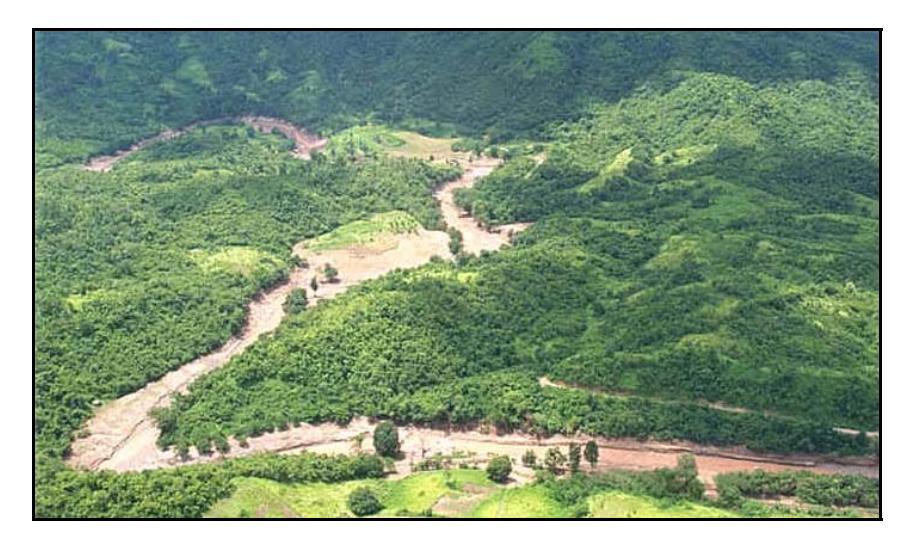
From field investigations and rectified orthophotograph interpretation at a point along the course of Nam Ko Yai stream in the middle of the study area, the stream here issues from a flat open land to a very narrow V-shape channel with a sudden change of elevation at Tad Fa waterfall (Fig. 13). It could be hypothesized that this specific location is suitable for an accumulation of sediments composed of plant debris, soils, and rock boulders to form a natural dam. A field check revealed fallen trees and vegetation traces. This probably indicated that the temporary natural dam was broken, sending the debris and water to flood further downstream, eroding the channel along the way, and finally dropping its load on the alluvial fan at the canyon mouth. The evidences of 8/11 event could be observed where Nam Ko Yai stream had a steep V-shape cross-section. The traces of the erosional feature in the outer curving-bank were common. Some huge logs or intertwined bamboo clumps were left in the channel. Newly deposited large boulders were found in the channel where the gradient of stream bed changes from steep to flat. Eroded soil banks were also common.

Fig. 14 The oblique aerial photograph (taken on 22 August 2001, 11 days after the event) along the channel of Nam Ko Yai stream with the high sinuosity characteristic illustrating the debris flow-flood track along plant debris and soils had been strongly eroded and transported from its banks before reaching the canyon mouth outlet of the stream

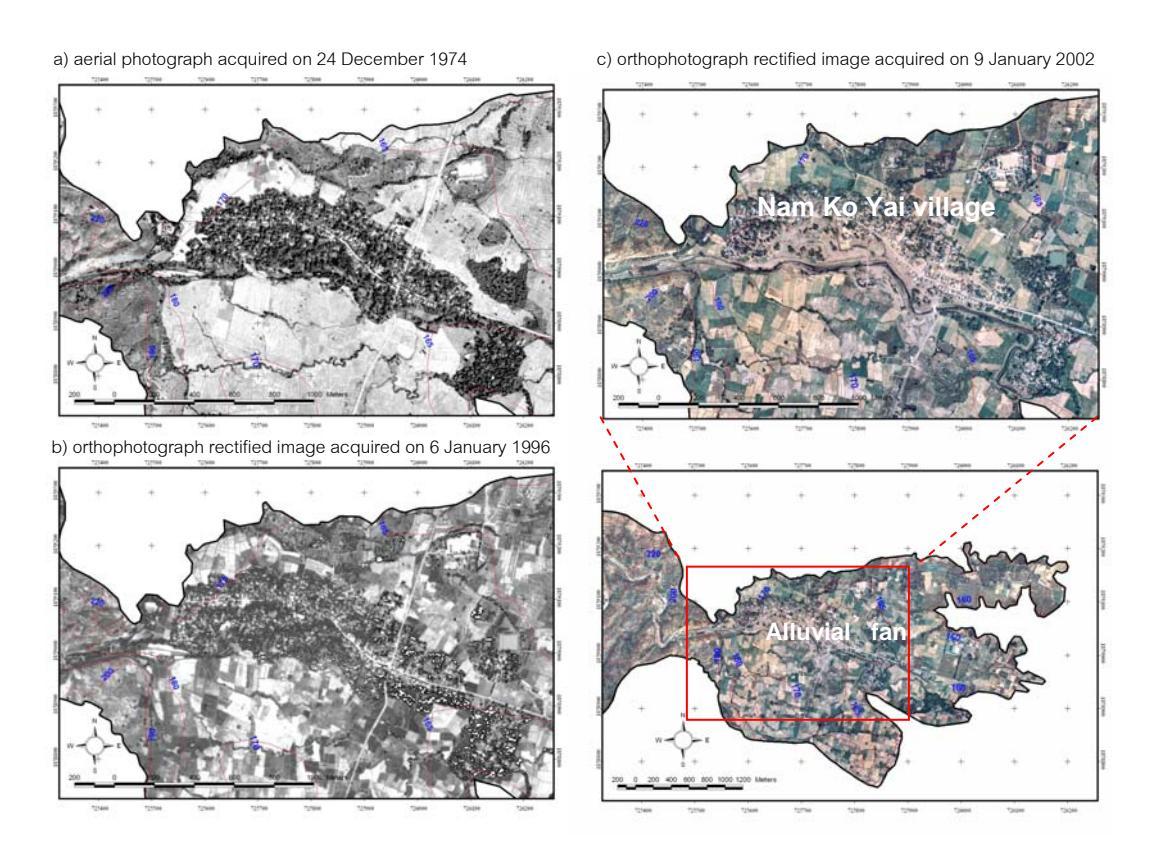
The expanded features of rectified orthophotographs (1:25,000 scale) taken on 9 January 2002 in Figures 15 and 16 clearly show current traces and tracks of debris flood evidenced from the distinct and active alluvial fan deposit. The deposits mainly occurred on the northern bank of the alluvial fan area where the flood severely damaged houses and orchards dominantly seen in the 1974 aerial photograph and 1996 rectified orthophotograph.

Fig. 15 The multi-temporal low-altitude images of aerial photograph and orthophotograph (with contour intervals in red line) acquired on three different periods: a) 24 December 1974, b) 6 January 1996, and c) 9 January 2002 showing the distinct identification of the topographic apex of Nam Ko Yai stream in the alluvial fan that was slightly modified from 1974 until 1996. Pronounced and still active changes are evident following the 8/11debris flow-flood

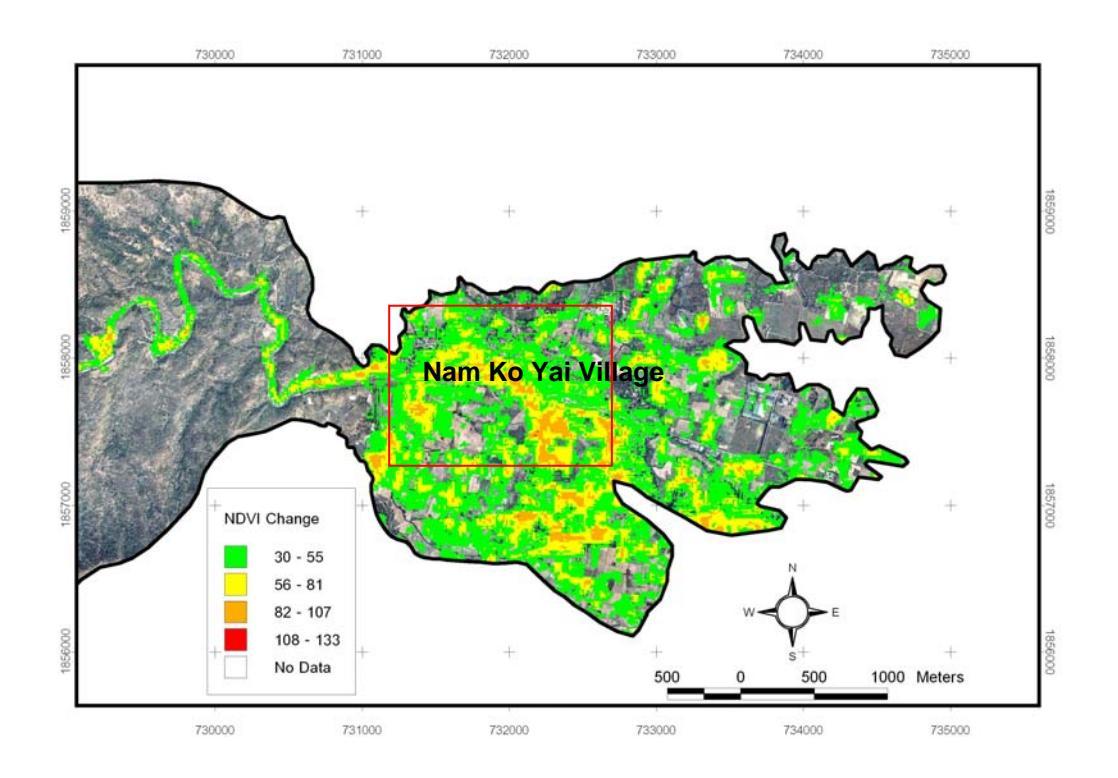
Fig. 16 The detection change of NDVI in the depositional location of the alluvial fan (expanded from Fig. 4) overlain on the orthophotograph rectified image (1:25,000 scale) acquired on 9 January 2002. The brown-colored zones are new traces of fan deposit after 1996

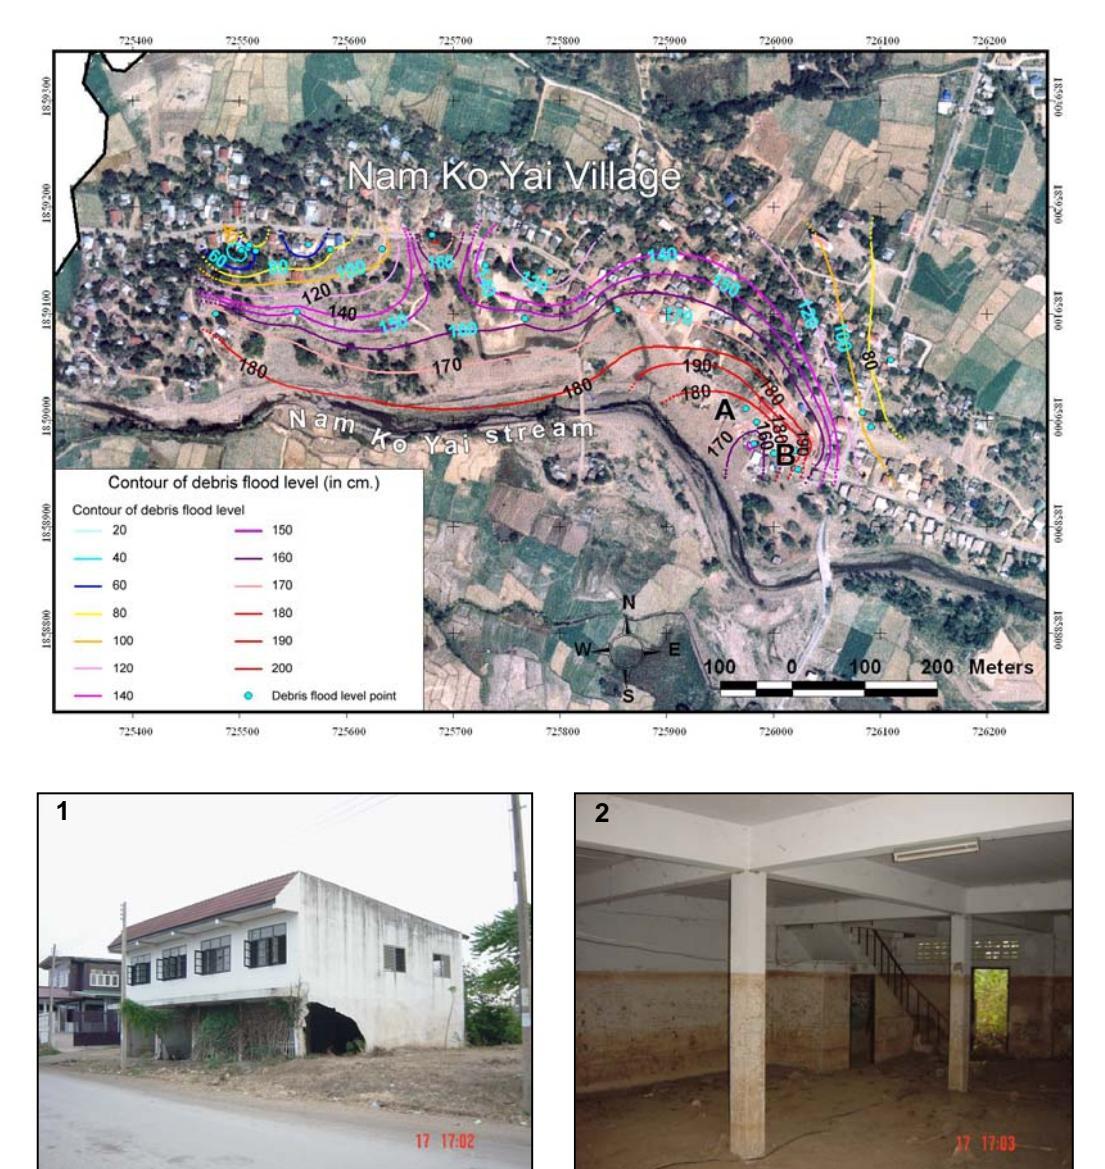
In the multi-spectral Landsat 7 ETM+ imageries analysis, evidences of the alluvial fan deposit from the 8/11 event were analyzed using NDVI value. NDVI value was also used to detect the depositional locations on the alluvial fan (Fig. 16). Oblique aerial photographs taken after the flood were used to characterize the extent of the deposit and validate analyzed result. The high value of NDVI change (56-107) in Figure 16 generally conformed the areas of the most serious damage in Figure 17.

Fig. 17 The expanded orthophotograph rectified image (1:25,000 scale) acquired on 9 January 2002 (red outline in Fig. 16) showing the contours of debris flood levels (in cm) above the ground surface (detected from the thin brown film left at house-walls and trees) in the strongly damaged area of Nam Ko Yai village caused by the 8/11 debris flow-flood

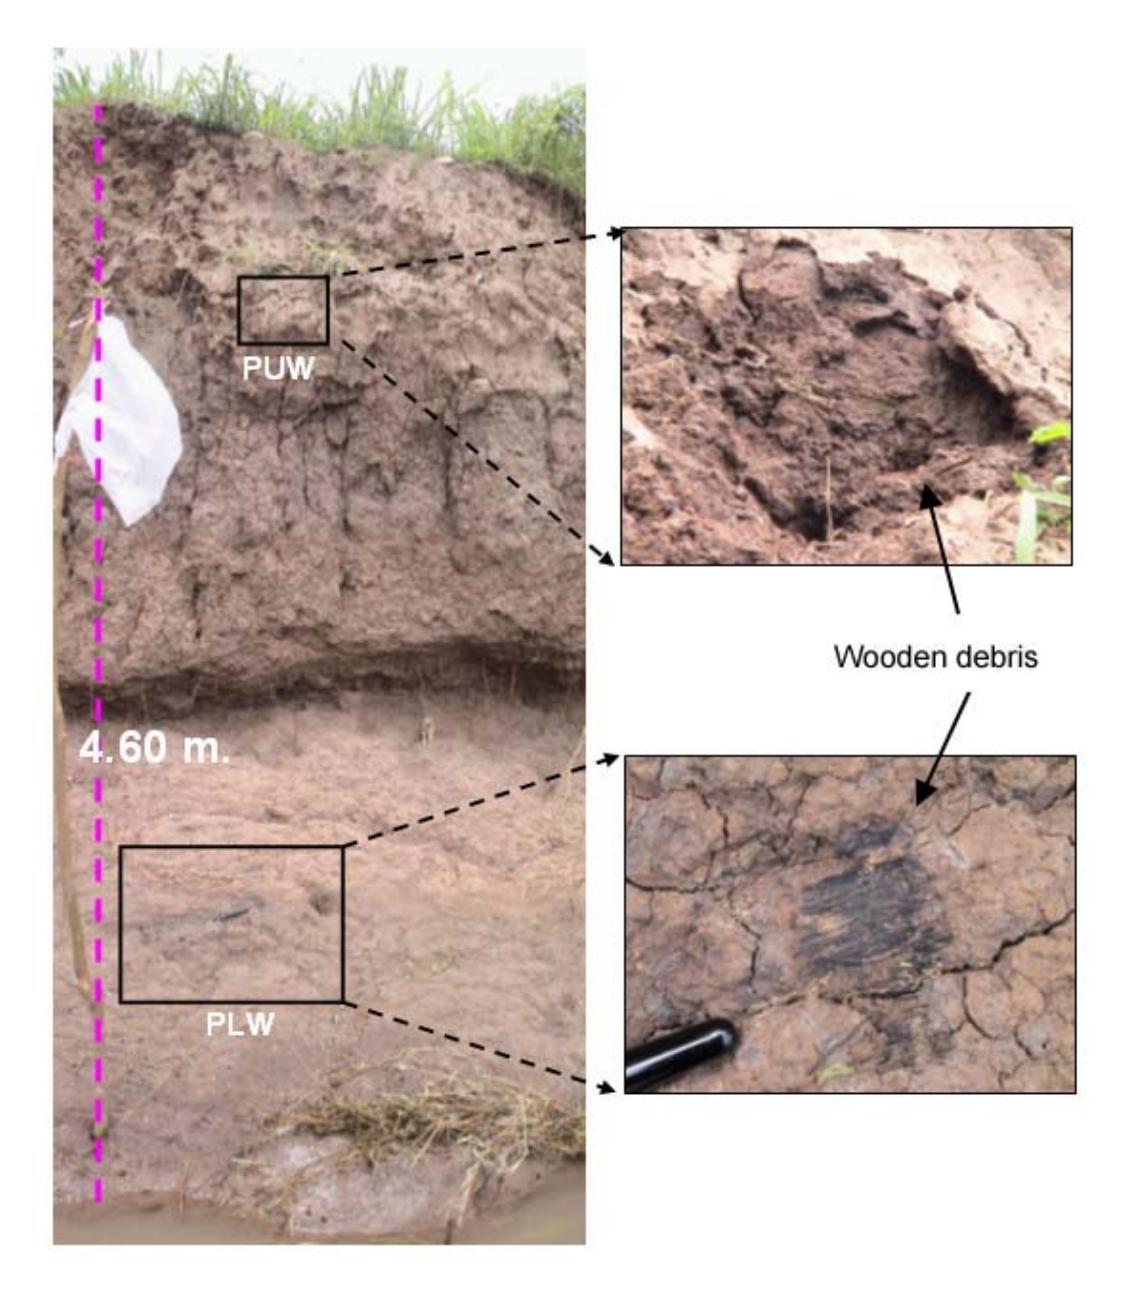
Significant evidences of the previous debris floods found in the eastern part of uppermost fine-grained fluvial and debris flood unit were two preserved wooden debris fragments, one at the lower part (location PLW) and the other at the upper part (location PUW) as shown in Figure 22. These preserved wooden debris were dated by radiocarbon dating method to have the absolute ages of deposition between 2,618 +/-35 years before present and post-1950, respectively. From these radioactive dating results, it is strongly confirmed that this is an active alluvial fan and that debris flow-flood process had occurred at least twice before the 8/11disastrous event.

Fig. 22 The measured stratigraphic profile of the uppermost fine-grained fluvial and debris flood unit illustrating its general characteristics and two locations of preserved wooden debris at the lower part (location PLW) and upper part (location PUW)

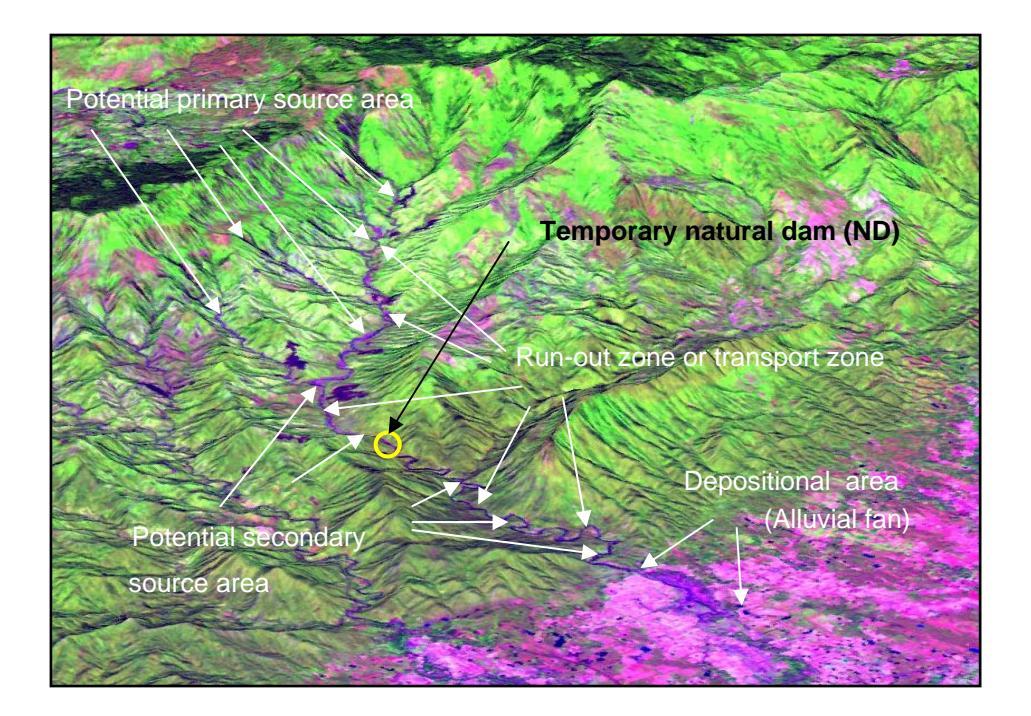
During these landslides and the flow- flood processes, a temporary natural dam might have built up somewhere in the causeway of this stream, most probably near Tad Fa waterfall. The temporary natural dam could have been formed when debris of plant remains, trees, soils and boulders both from several previous and the 8/11 events were locked at this specific location, forming a reservoir upstream. Then another powerful debris flow-flood followed to break this dam, perhaps with surges up to 10 m high to send water and debris flowing further down to destroy the village on the alluvial fan.

Fig. 23 Three-dimensional view of Nam Ko Yai sub-catchment and its alluvial fan modeled by overlying the false color composite of Landsat 7 ETM+ (R=5, G=4, B=3) acquired on 21November 2001 through the base-scale DEM showing the main features after the debris-flood occurrence with identified potential hazard zones of the potential primary and secondary source areas, the run-out zone or transport area, the proposed location of a temporary natural dam, and the depositional area

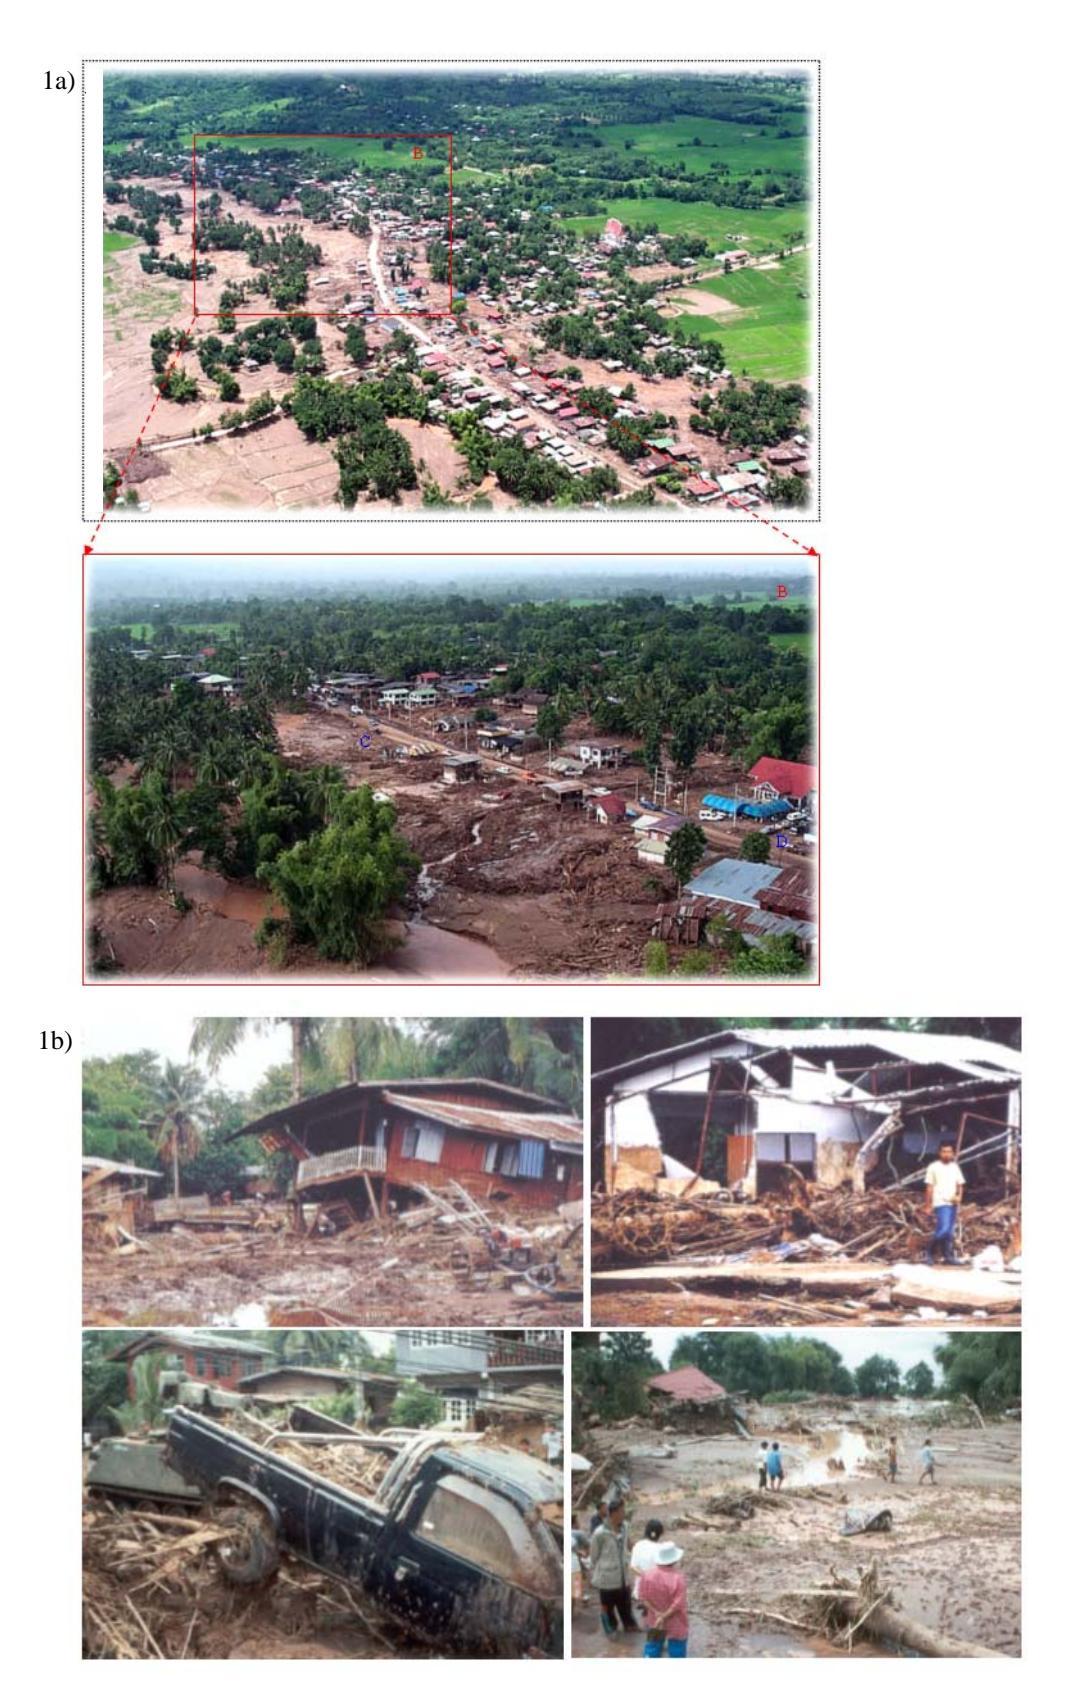
The oblique aerial photographs of the severely damaged settlement areas (Fig. 1) illustrate characteristics and extent of a large volume of an active alluvial fan deposit. The flood levels were established from mud traces on house walls and trees. The highest level of the debris flood, 190-200 cm above the ground level, was located in the most severely damaged zone at locations A and B (Fig.17). The two locations faced the straight course of Nam Ko Yai stream before the channel changed direction abruptly further downstream. Here, the flood jumped over-bank to destroy houses and orchards and claim lives.

Fig. 1 1a) Two oblique aerial photographs perceivably illustrating the characteristics and extension of a large volume of deposited sediments; and 1b) four closed-up photographs illustrating the seriously battered structural damage of houses, orchard trees and other infrastructures in Nam Ko Yai village caused by the fast-moving debris flow-flood occurrence on 11 August 2001 (8/11)
