การประเมินศักยภาพของตะกอนไหลถล่มและน้ำปนตะกอนป่า ในปี 2544
บริเวณพื้นที่น้ำก้อ อำเภอหล่มสัก จังหวัดเพชรบูรณ์ ภาคกลางของประเทศไทย

EVALUATION OF POTENTIAL FOR 2001 DEBRIS FLOW AND DEBRIS FLOOD
IN THE VICINITY OF NAM KO AREA, AMPHOE LOM SAK,
CHANGWAT PHETCHABUN, CENTRAL THAILAND

A Dissertation Submitted in Partial Fulfillment of the Requirements
for the Degree of Doctor of Philosophy Program in Geology

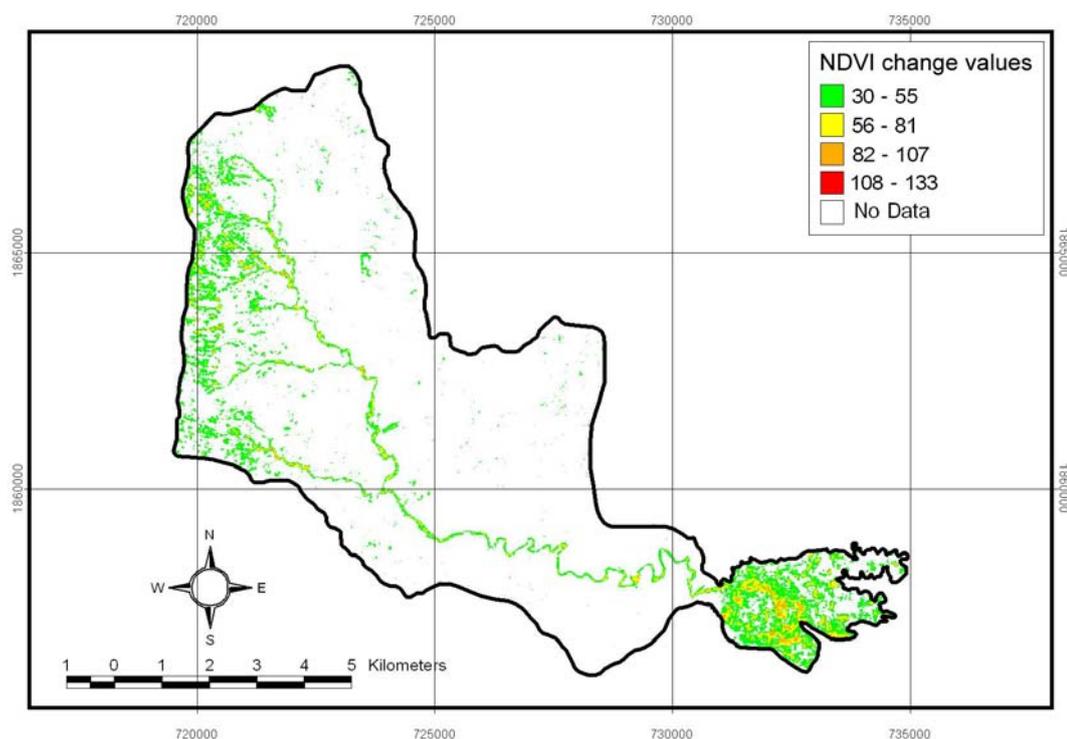
Figure 3-21 Resulted significant change detection of NDVI that used to detect the scar-scouring and depositional locations in the study area that are caused from the 8/11 flow-flood occurrence.

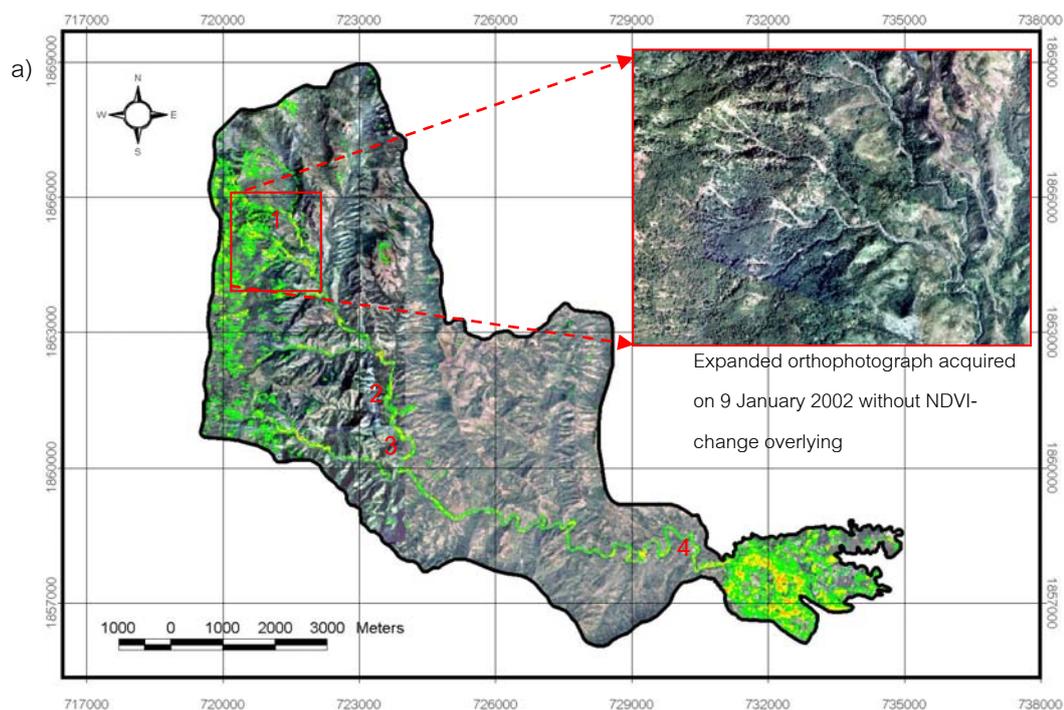
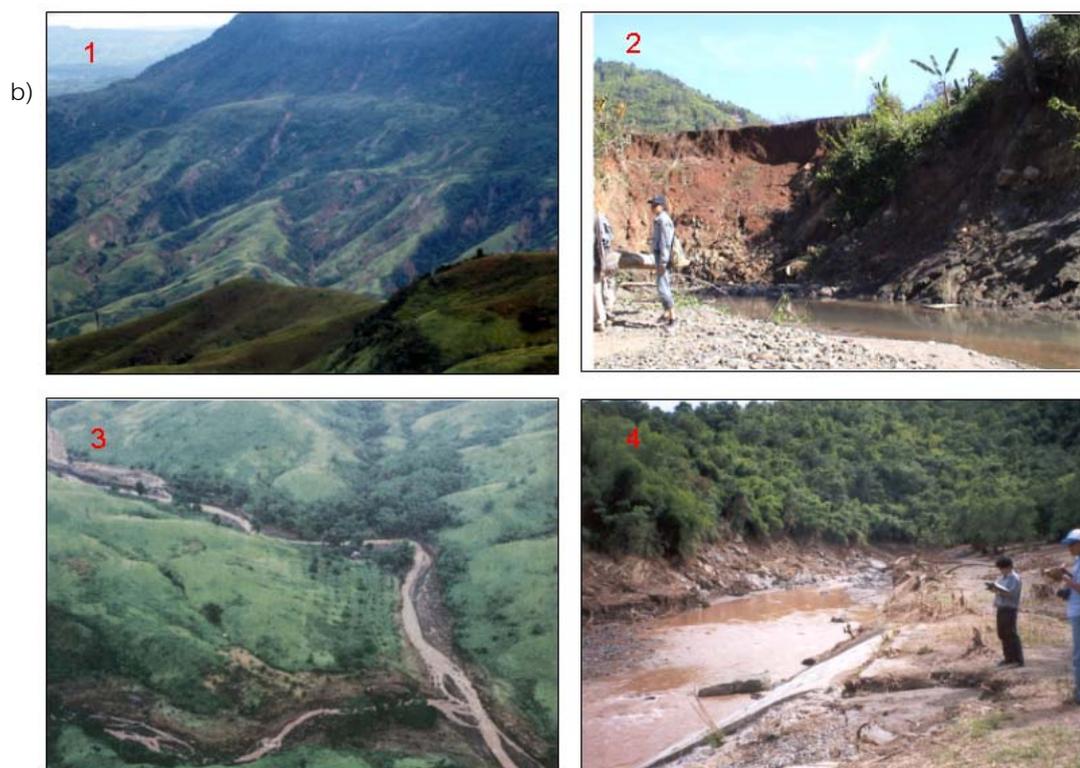
Figure 3-22 a) Significant change of NDVI (referred to Figure 3-21) overlain on the orthophotograph image acquired on 9th January 2002 (after 8/11); and b) photographs of four locations (number referred to the location in the map) taken a few days after the 8/11 event showing the ground truth evidences.

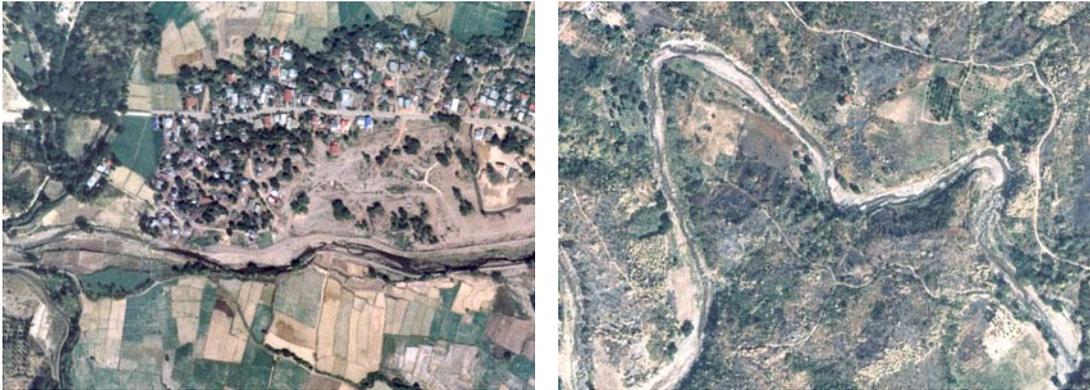
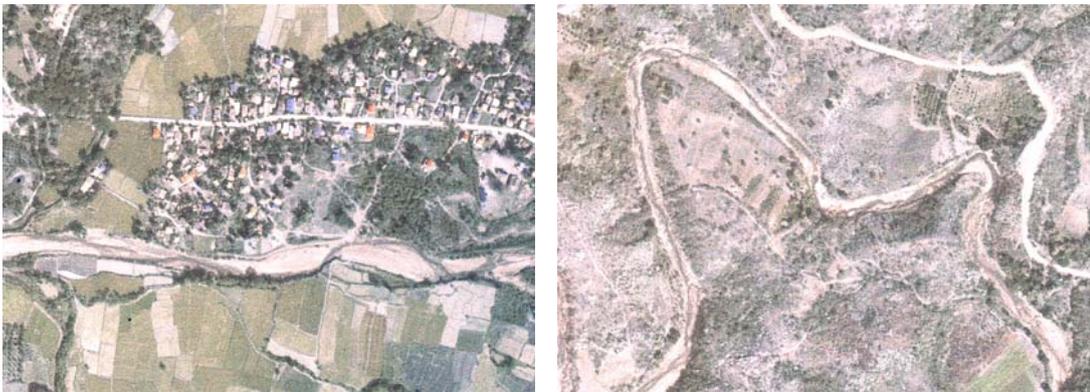
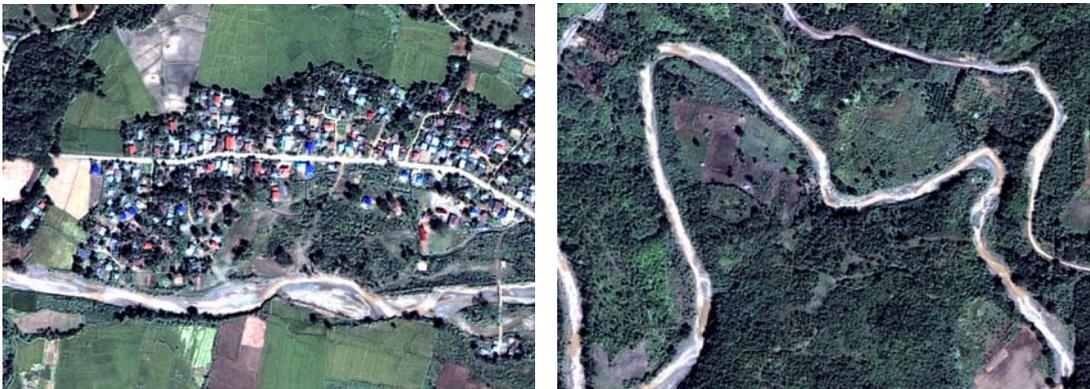
a) Orthophotographs acquired on 9th January 2002

b) Orthophotographs acquired on 29th March 2002

c) IKONOS imagery acquired on 31st October 2002

Figure 3-23 Examples of high resolution remote sensing imageries (acquired after the 8/11 event) used for classifying accuracy and validating NDVI results that related to detect the scar-scouring and depositional locations in the study area.

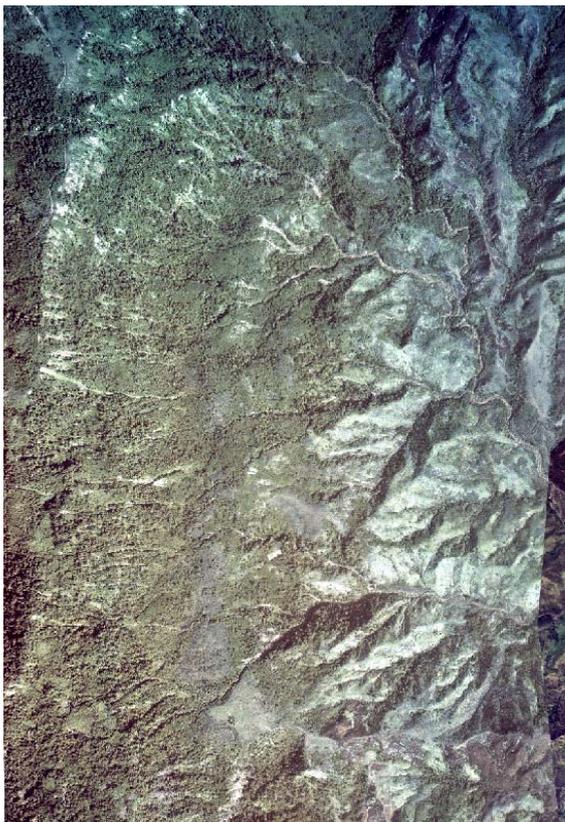
Orthophotograph acquired on 14th January 2003
(1:20,000 scale) in training area of Figure 3-24

This step applied the confusion matrix method to determine the accuracy of scar-scouring delineation from training area of Landsat imagery acquired on 21st November 2001 in Nam Ko Yai sub-catchment (Figure 3-24). The confusion matrix was used to compare the evaluating classification of scar-scouring locations interpreted from NDVI change (Figure 3-25) and ground truth data of scar-scouring delineation manually digitized from 1:20,000 orthophotograph acquired on January 14, 2003 (Figure 3-26). These two set data of the scar-scouring boundaries were used for calculating the accuracy assessment in 10 meter-resolution.

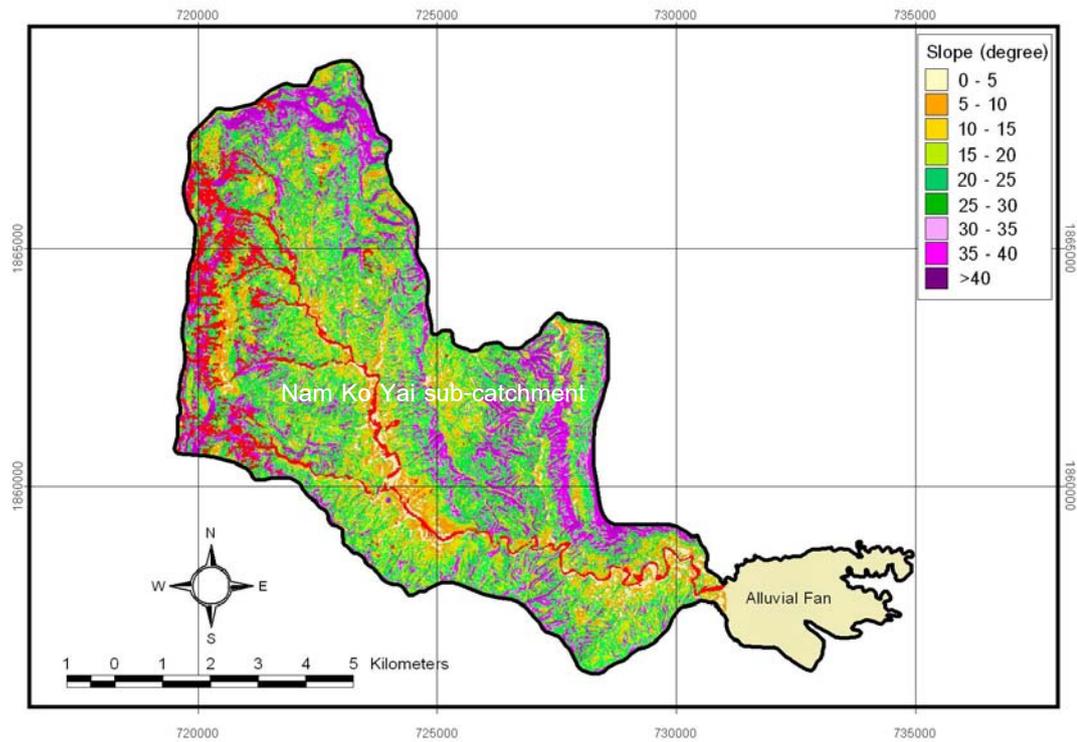
Figure 4-1 Slope map overlain with scars-scouring locations (grouped in red color) in Nam Ko Yai sub-catchment.

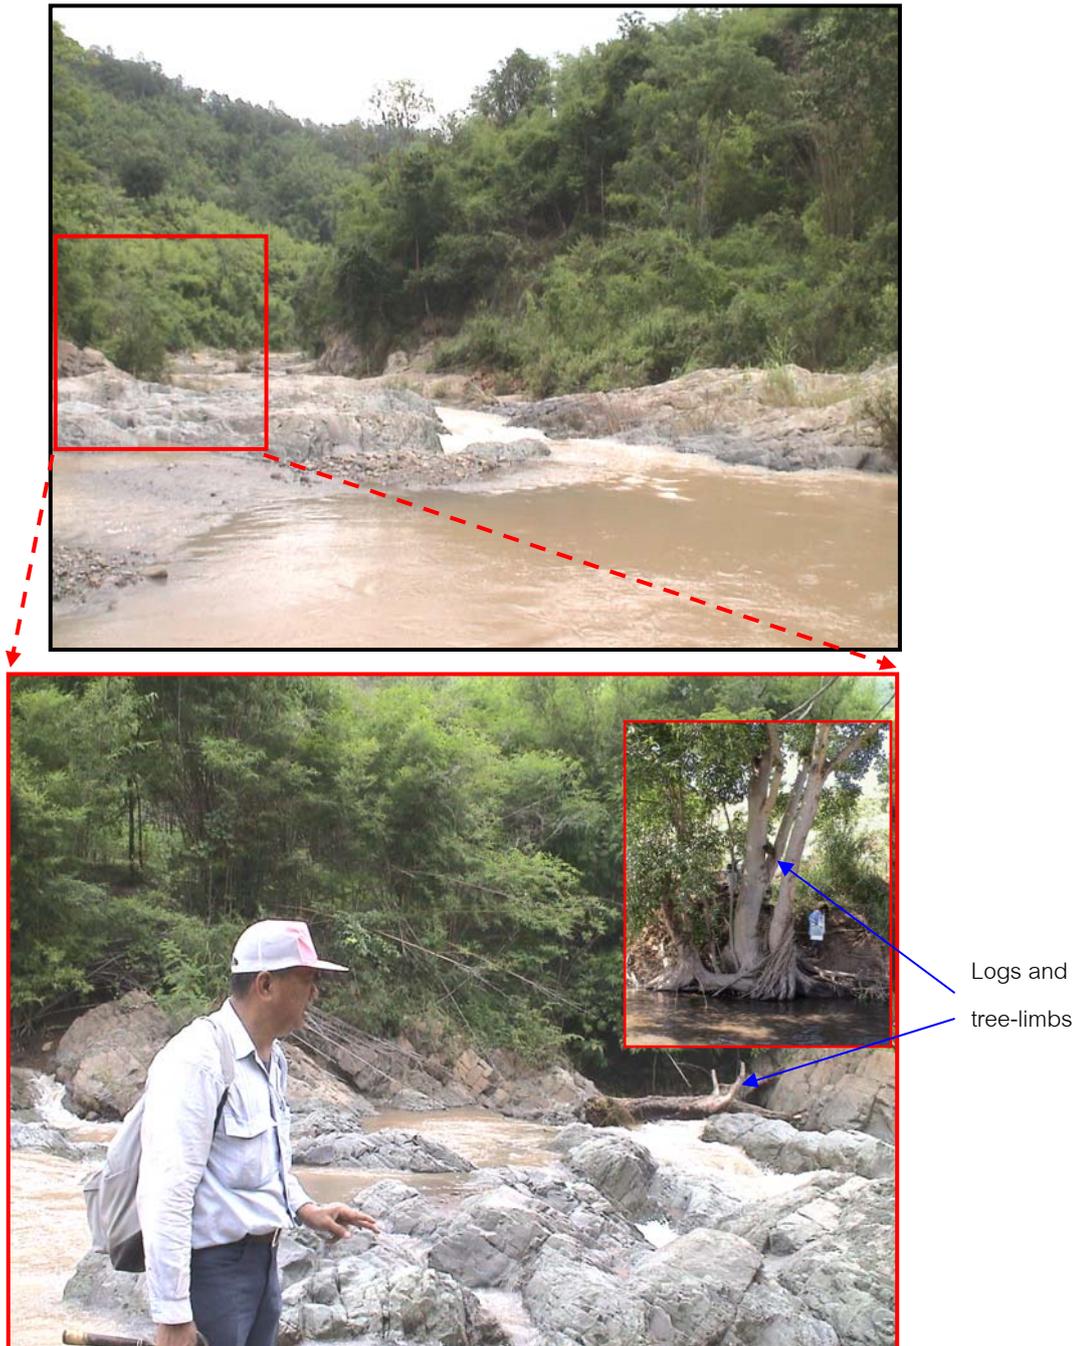
Figure 5-4 Photographs (looking eastward direction) illustrating the configuration of Nam Ko Yai stream channel at location ND (referred to Figure 5-3) that is suitable for accumulated sediments for blockage a torrent stream and formed a natural temporary landslide dam. Note: The evidence of transported timbers was still found not only in the channel as a large one but also left as a smaller one at the higher level of the tree-branches (as shown in the inserted photograph that taken at the upstream of Nam Ko Yai stream, 2.5 km. far away from this point).

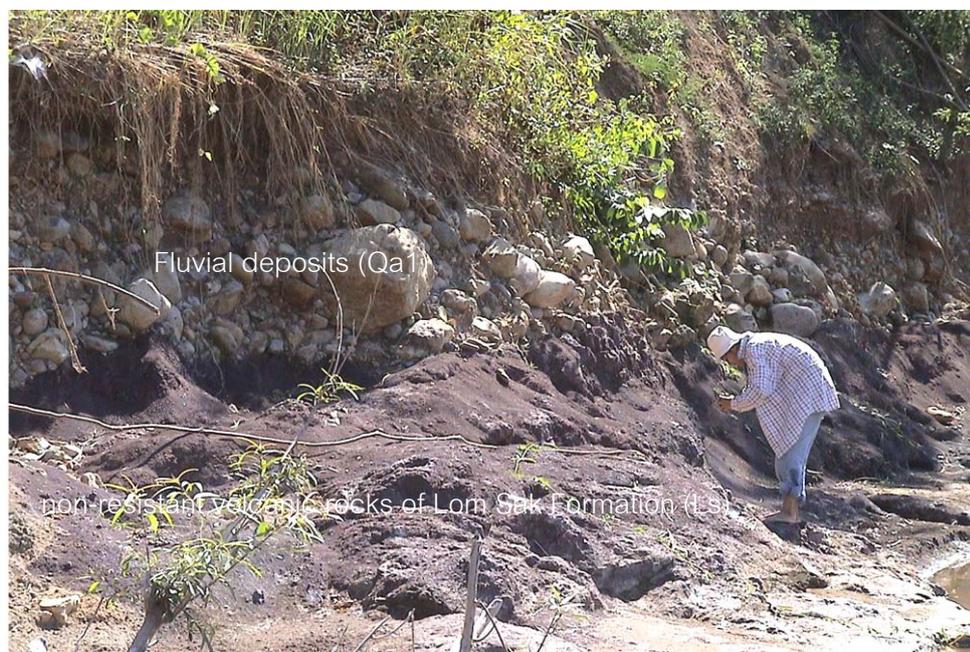
Figure 5-9 Photograph showing the soft and non-resistant volcanic rocks of Lom Sak Formation in the upstream from the suspected natural temporary dam location.

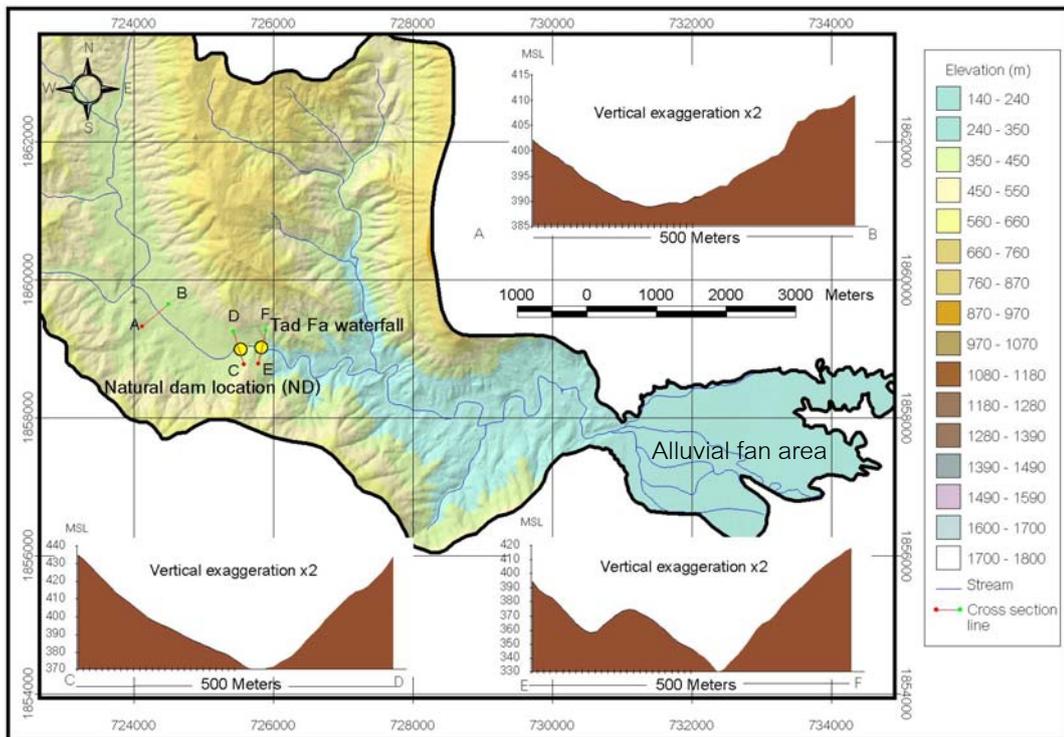
Figure 5-10 Three cross-sections (line A-B, C-D and E-F) across Nam Ko Yai stream channel and its valley at the upstream area, the suspected natural landslide dam location, and Tad Fa waterfall, respectively.

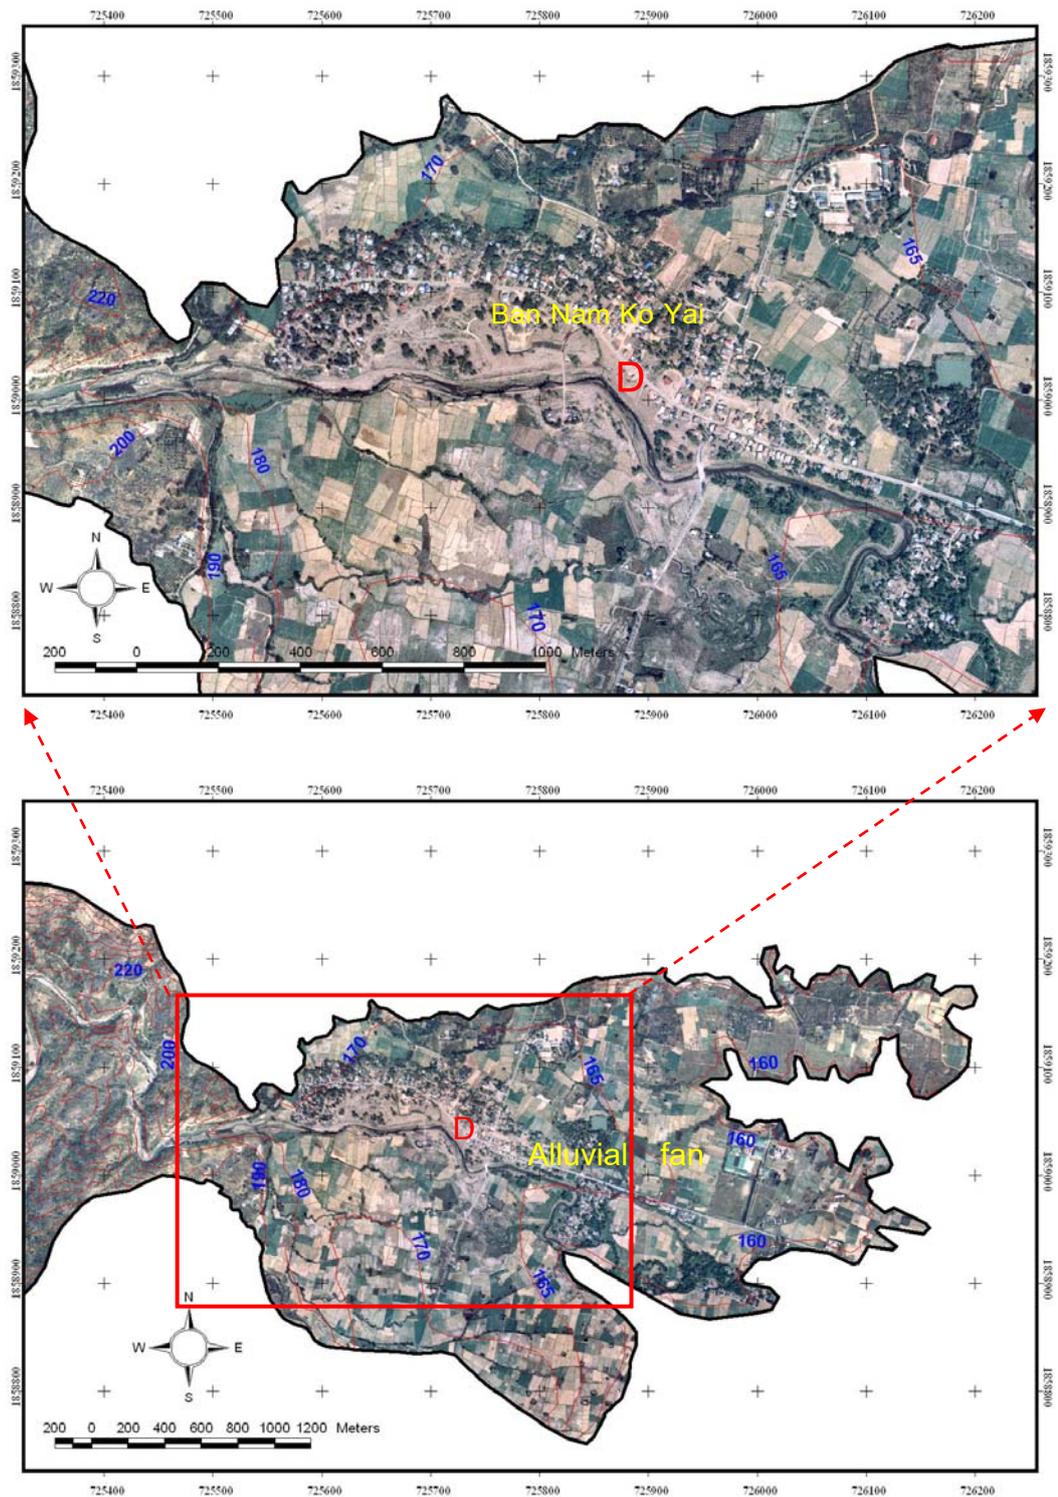
Figure 6-3 Orthophotograph (1:25,000 scale) acquired on 9th January 2002 (after the 8/11 flow-flood occurrence) showing the distinctive active alluvial fan deposit. The main area on the northern bank of Nam Ko Yai stream with populated settlement of Ban Nam Ko Yai (brown color zone surrounding the D location) was strongly damaged.

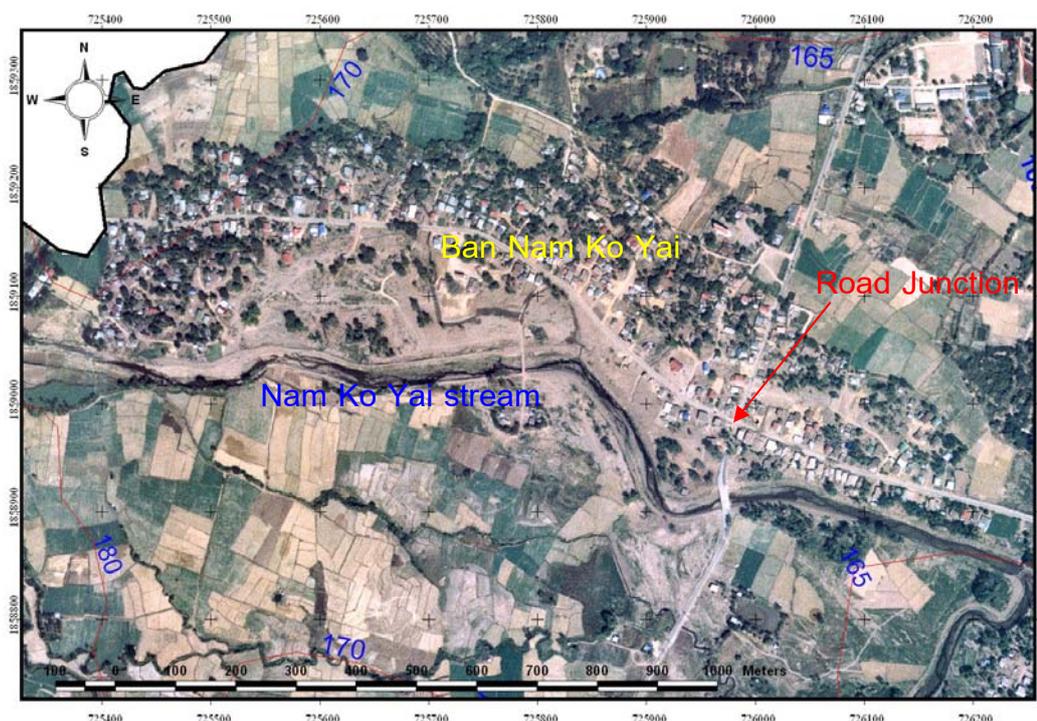
Figure 6-4 Expanded features of orthophotograph (1:25,000 scale) acquired on 9th January 2002 (after the 8/11 flow-flood occurrence) showing the clear traces and tracks of flow-flood from the evidences of the distinctively active alluvial fan deposit (in brown color area) that mainly covered and severely damaged houses and orchards in the northern bank of Nam Ko Yai stream. (Note: the road-junction location in this figure will be used to refer to the same location in Figure 6-5)

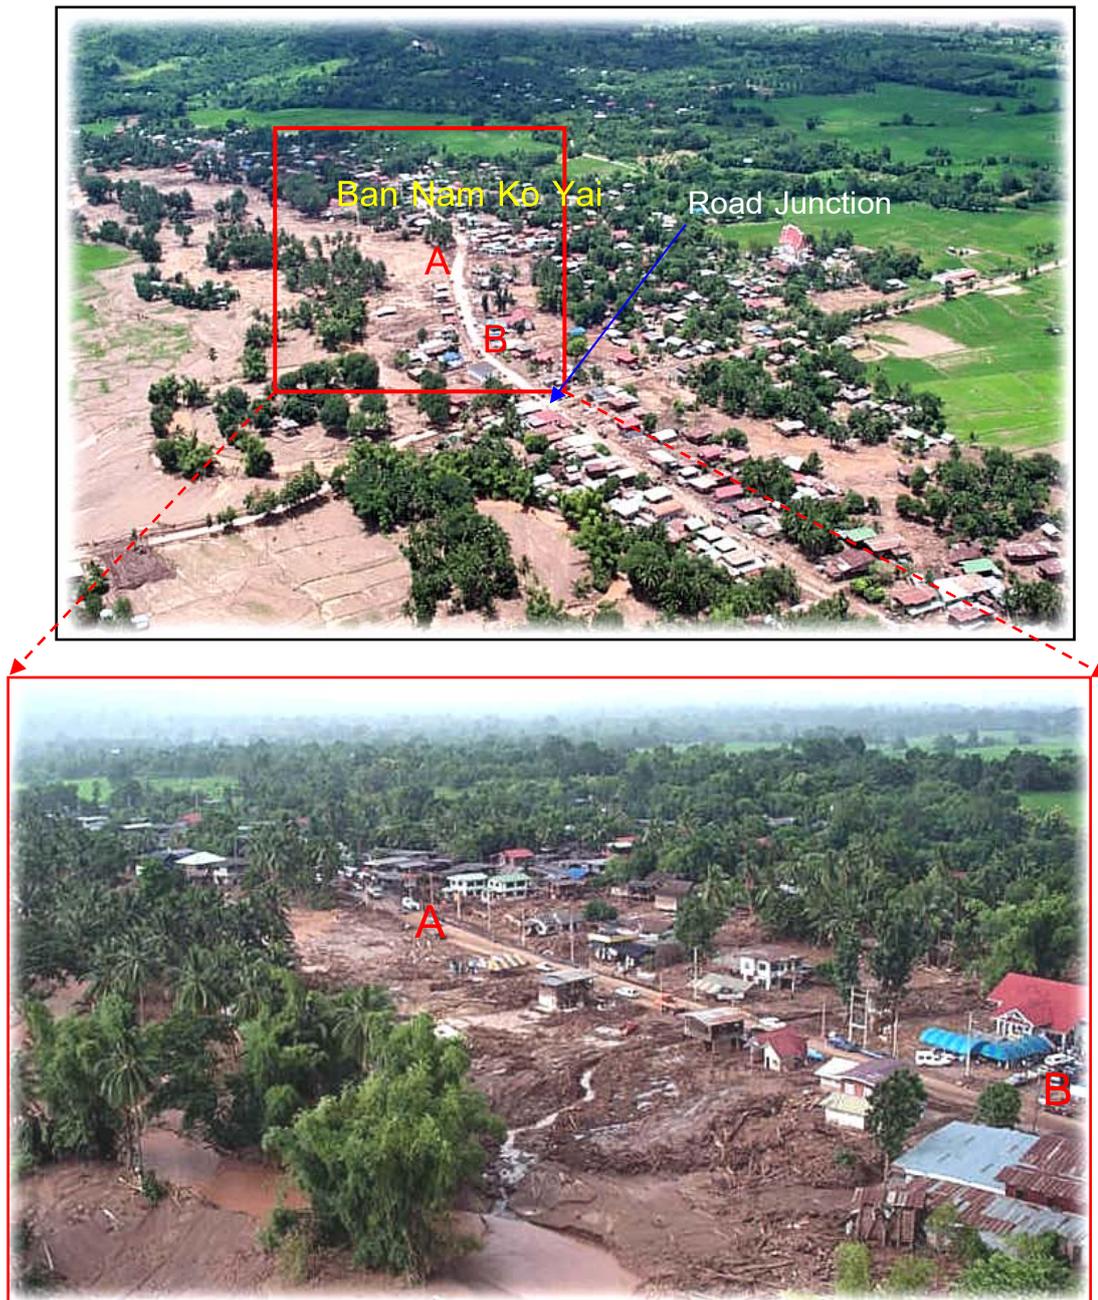
Figure 6-5 Two oblique aerial photographs perceptibly illustrating the characteristics and extension of a large volume of deposited sediments as evidences of 8/11 incidence.

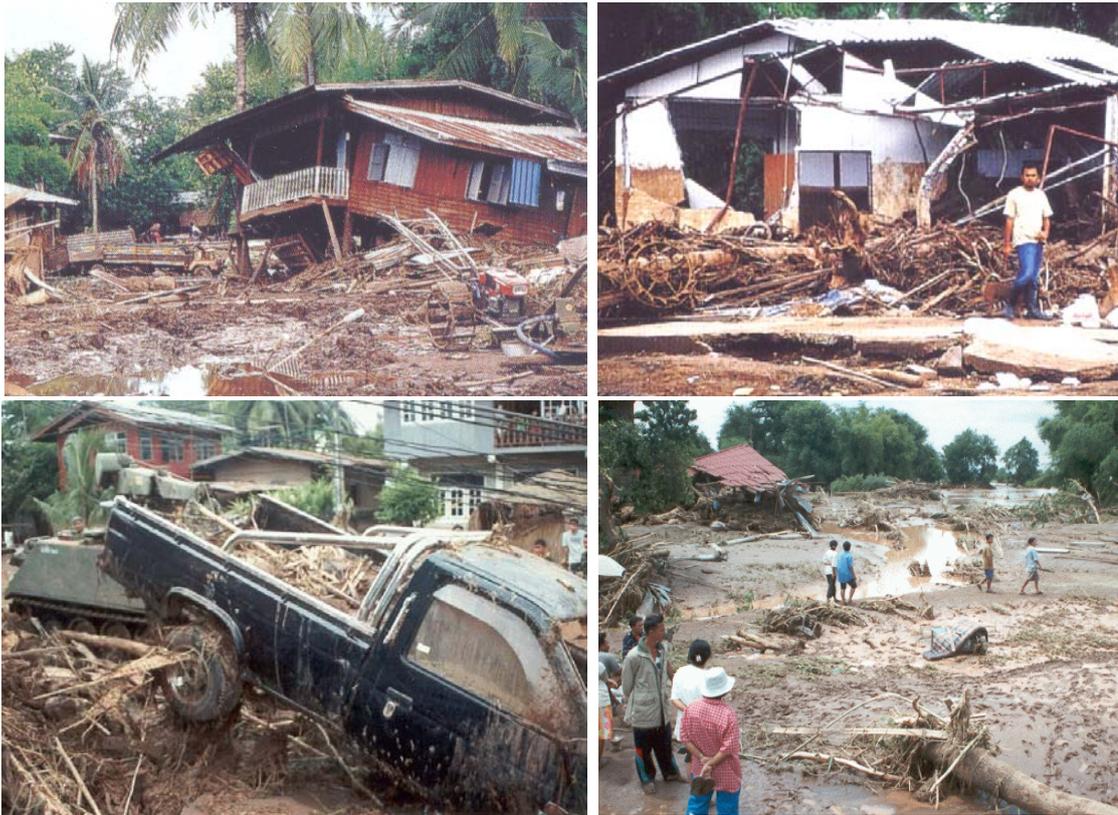
Figure 6-6 Four photographs showing some examples of seriously structural damage of houses and other infrastructures in Ban Nam Ko Yai (in the area between A and B in Figure 6-5) battered and caused by the fast-moving 8/11 flow-flood.

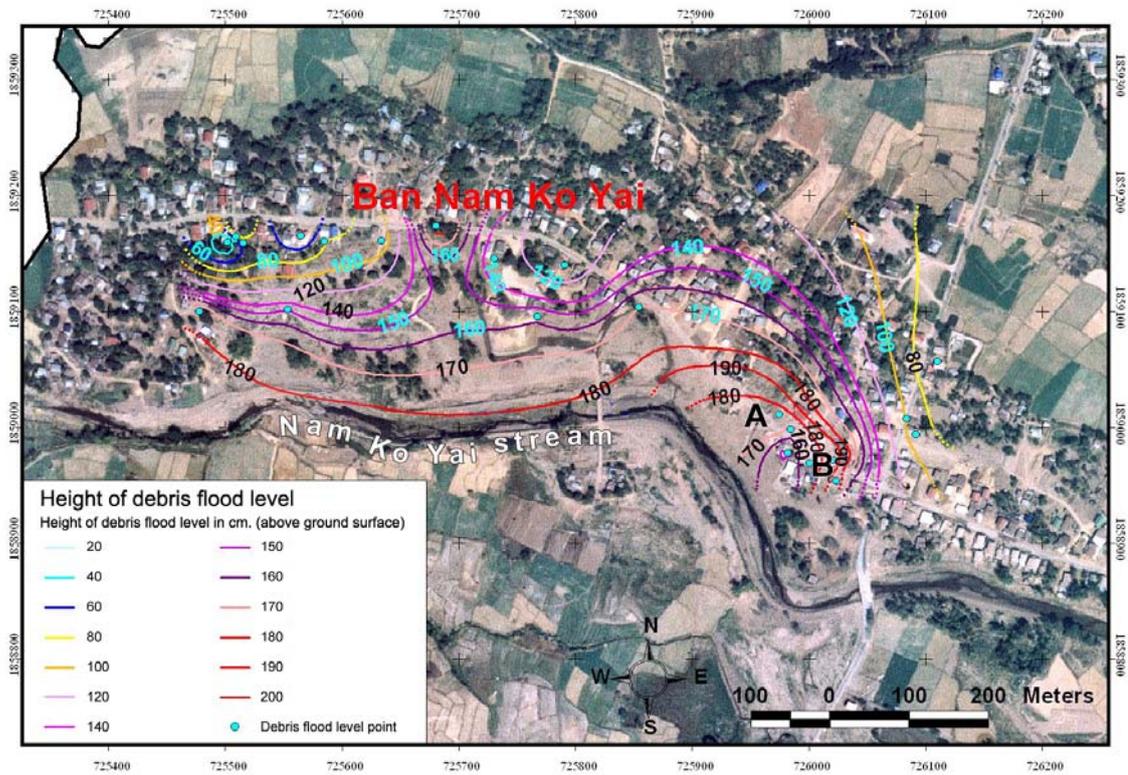
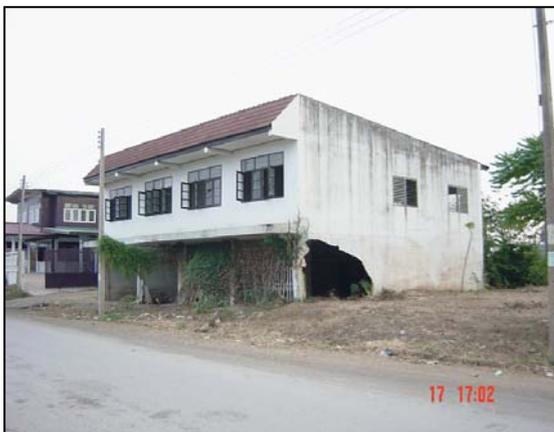
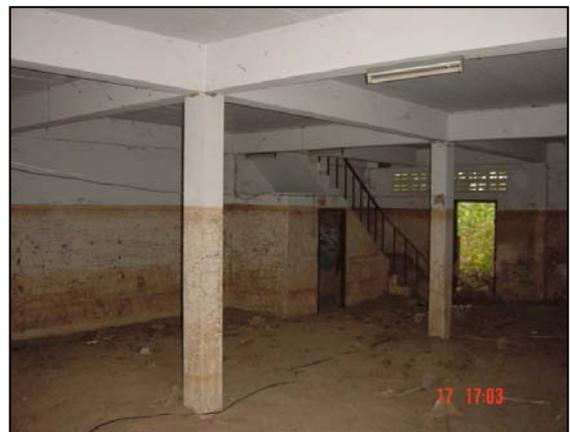
Figure 6-8 Height map of the flow-flood levels detected from the mud traces on the trees and house walls (as illustrating in the attached photographs below the map) in the severely damaged area of Ban Nam Ko Yai after the fast-moving 8/11 flow-flood

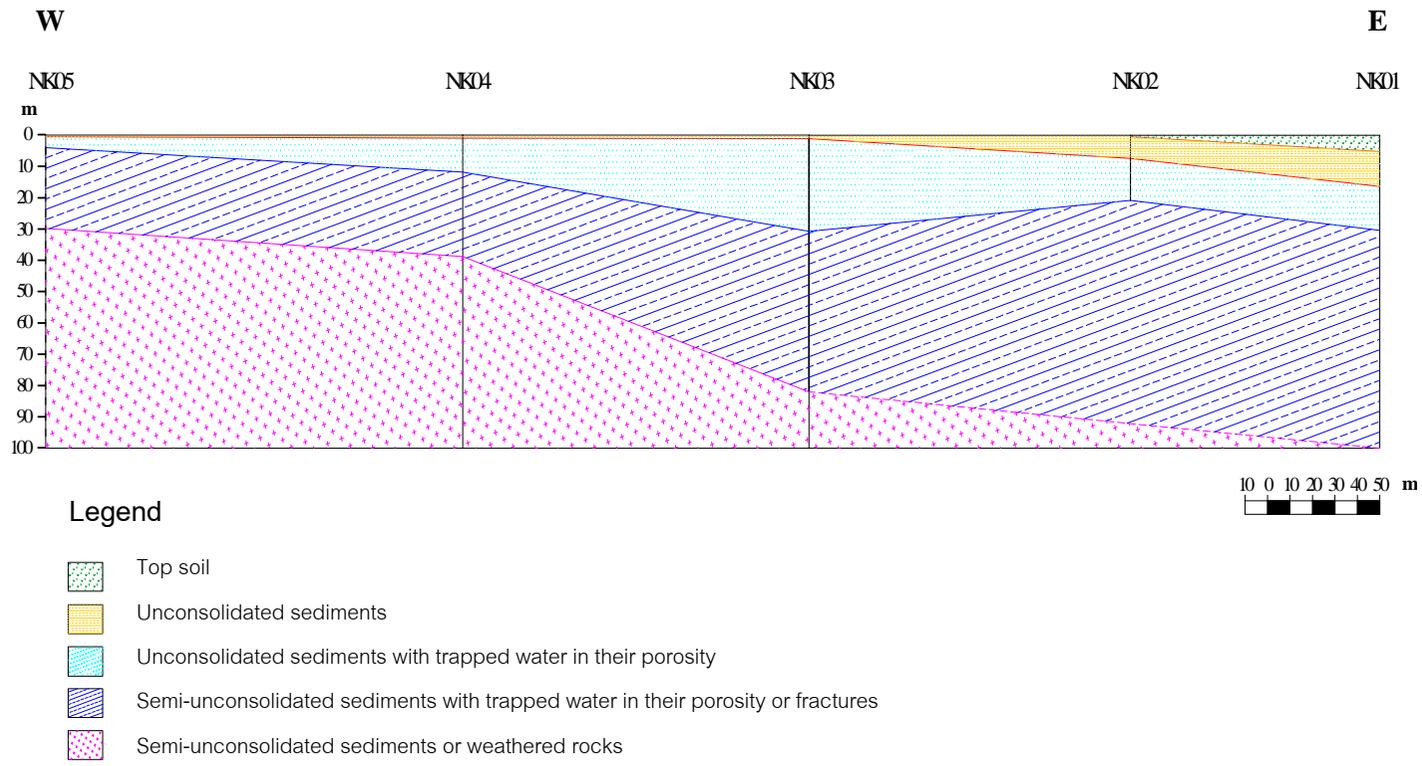
Figure 6-10 Cross-section of the resistivity survey interpreted from the five survey points (NK 01 – NK 05 as shown in Figure 5-9) that revealed four sedimentary units lying less than 100 m below ground surface.

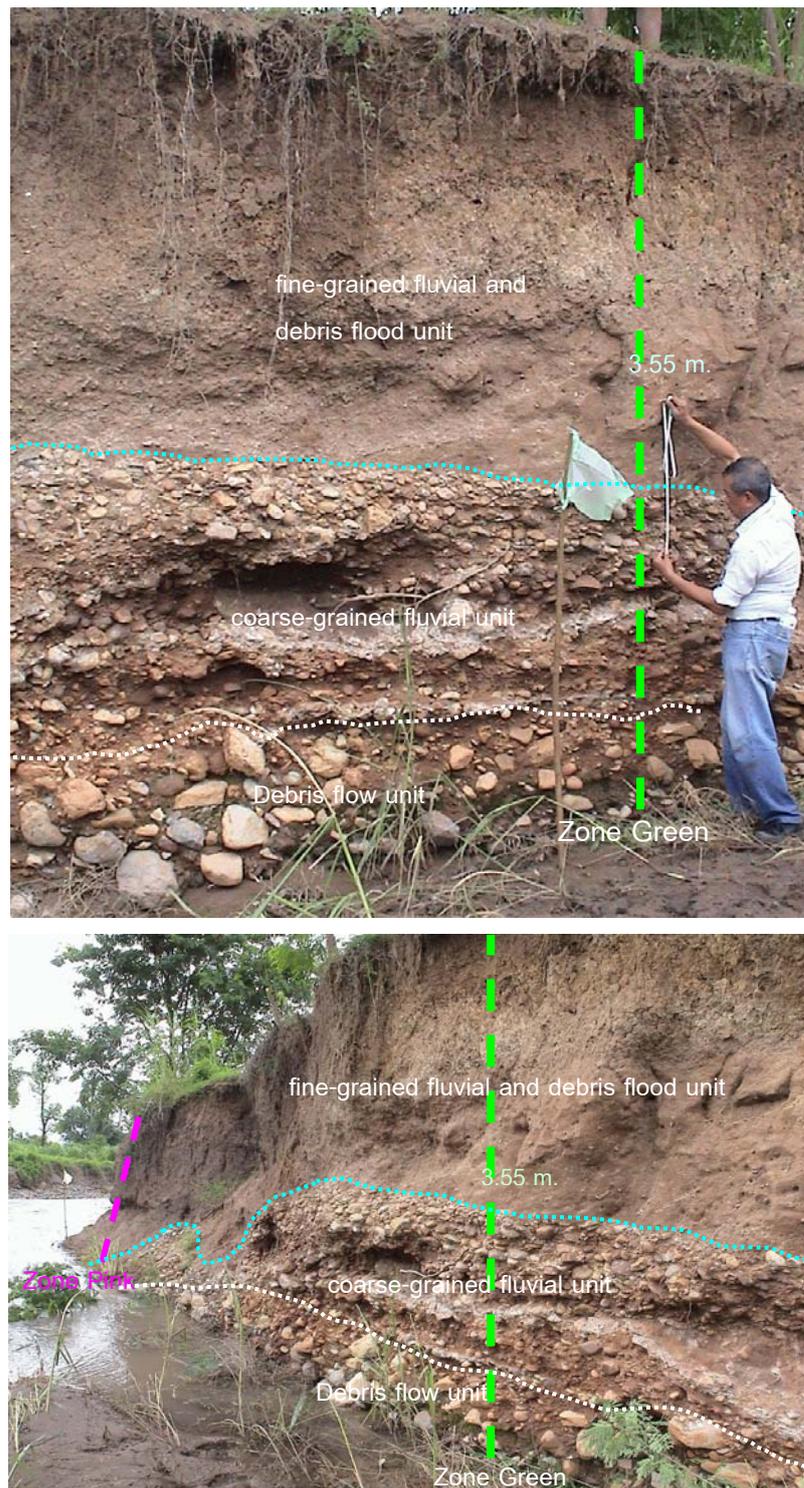
Figure 6-13 Photographs illustrating detailed sedimentary and stratigraphic characteristics in vertical and lateral succession of three sedimentary units (debris flow unit, coarse-grained fluvial unit, and fine-grained fluvial and debris flow unit) of the previous alluvial fan deposits at the zone Green.

(Note: location of the zone Green referred to Figures 6-9 and 6-11)

In the observed stream-bank profiles, the lowest sedimentary unit of the previous alluvial fan deposits was a debris flow unit of floating texture, unsorted, and un-stratified material that was exposed in the stream-bed only in the lowest part of the zone Green (Figure 6-13). The coarse-grained fluvial unit of clast-supported texture and fining-upward graded bedding was transitionally deposited on top of the debris flow unit, especially in the middle part of the zone Green, and extended westward (upstream) beyond the zone Yellow2 (Figure 6-14). This coarse-grained fluvial unit was the thickest in the western part and became thinner to the east.

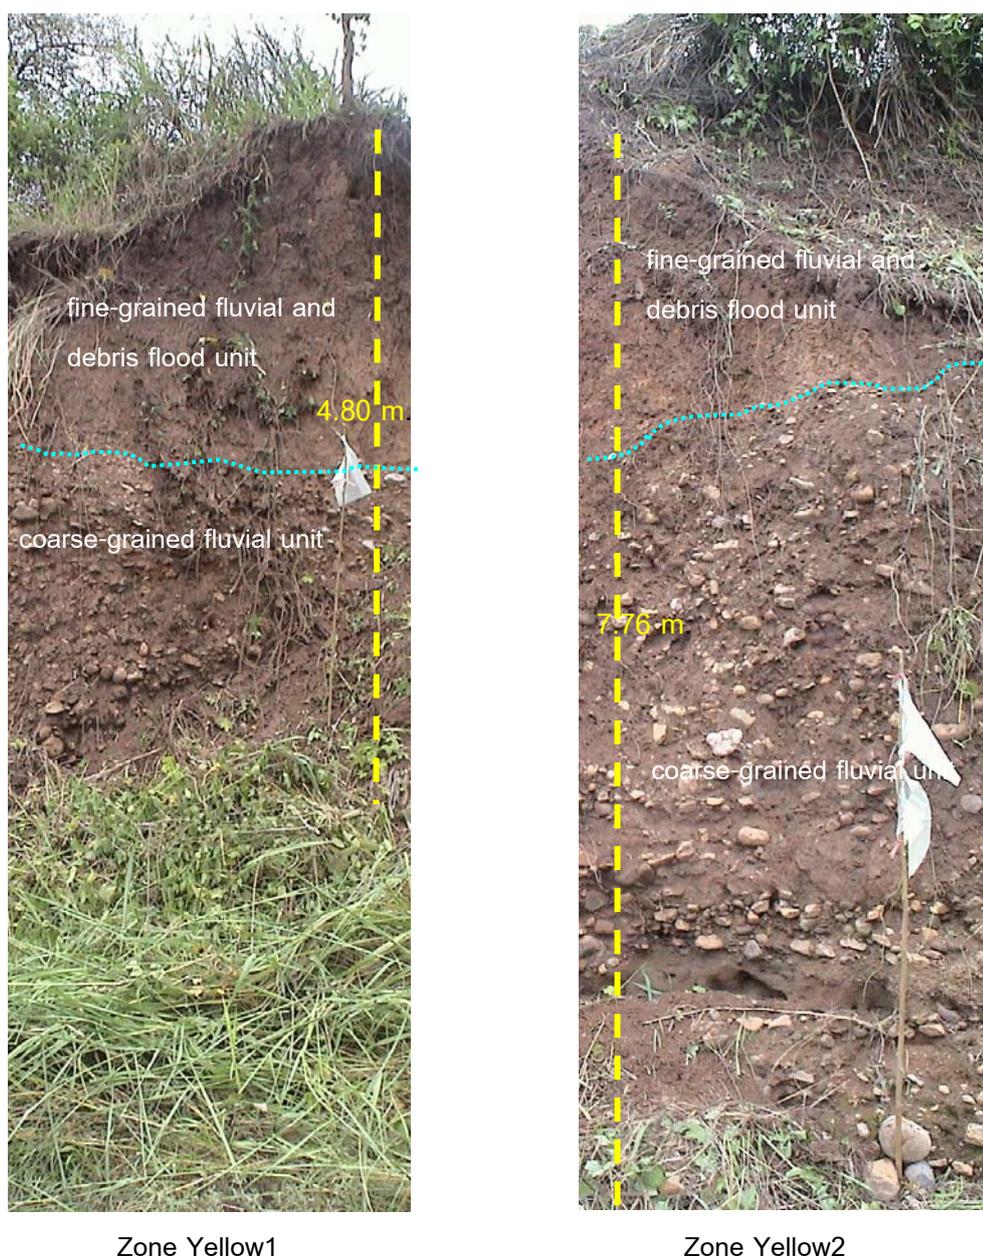
Figure 6-14 Photographs illustrating detailed sedimentary and stratigraphic characteristics in vertical succession of two sedimentary units (coarse-grained fluvial unit, and fine-grained fluvial and debris flow unit) of the previous alluvial fan deposits at the zones Yellow1 and Yellow2.

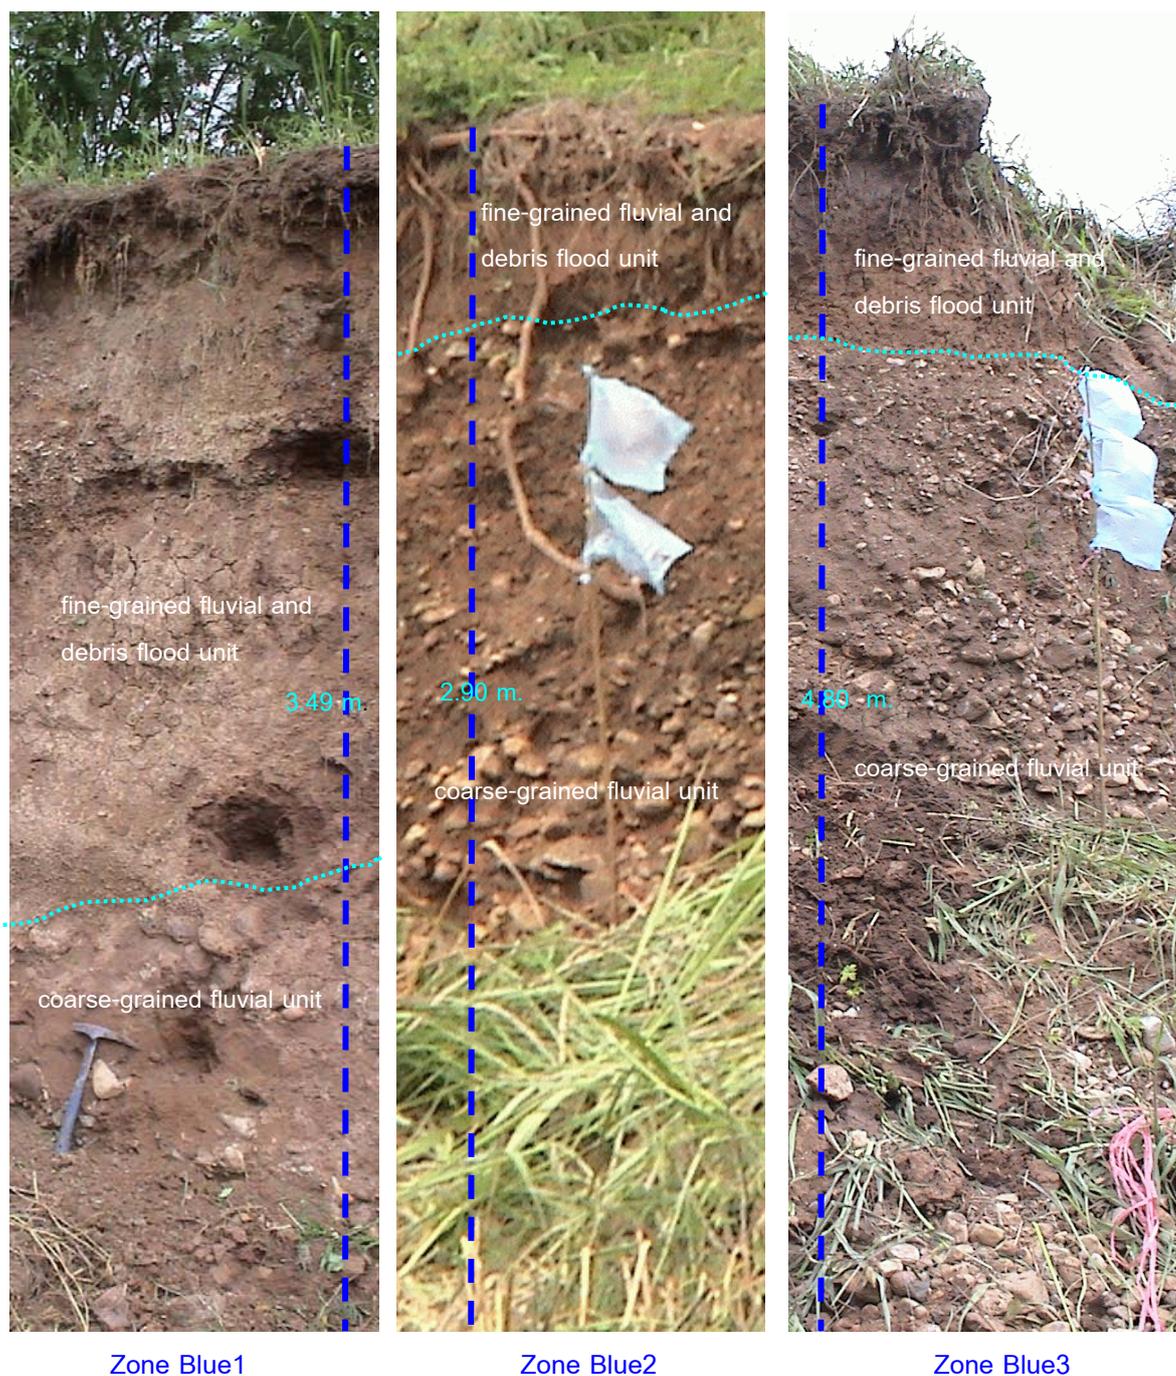
Figure 6-15 Photographs illustrating detailed sedimentary and stratigraphic characteristics in vertical succession of the fine-grained fluvial and debris flood unit that overlay with the sharp contact manner on top of the coarse-grained fluvial unit at the zones Blue1, Blue2 and Blue3.

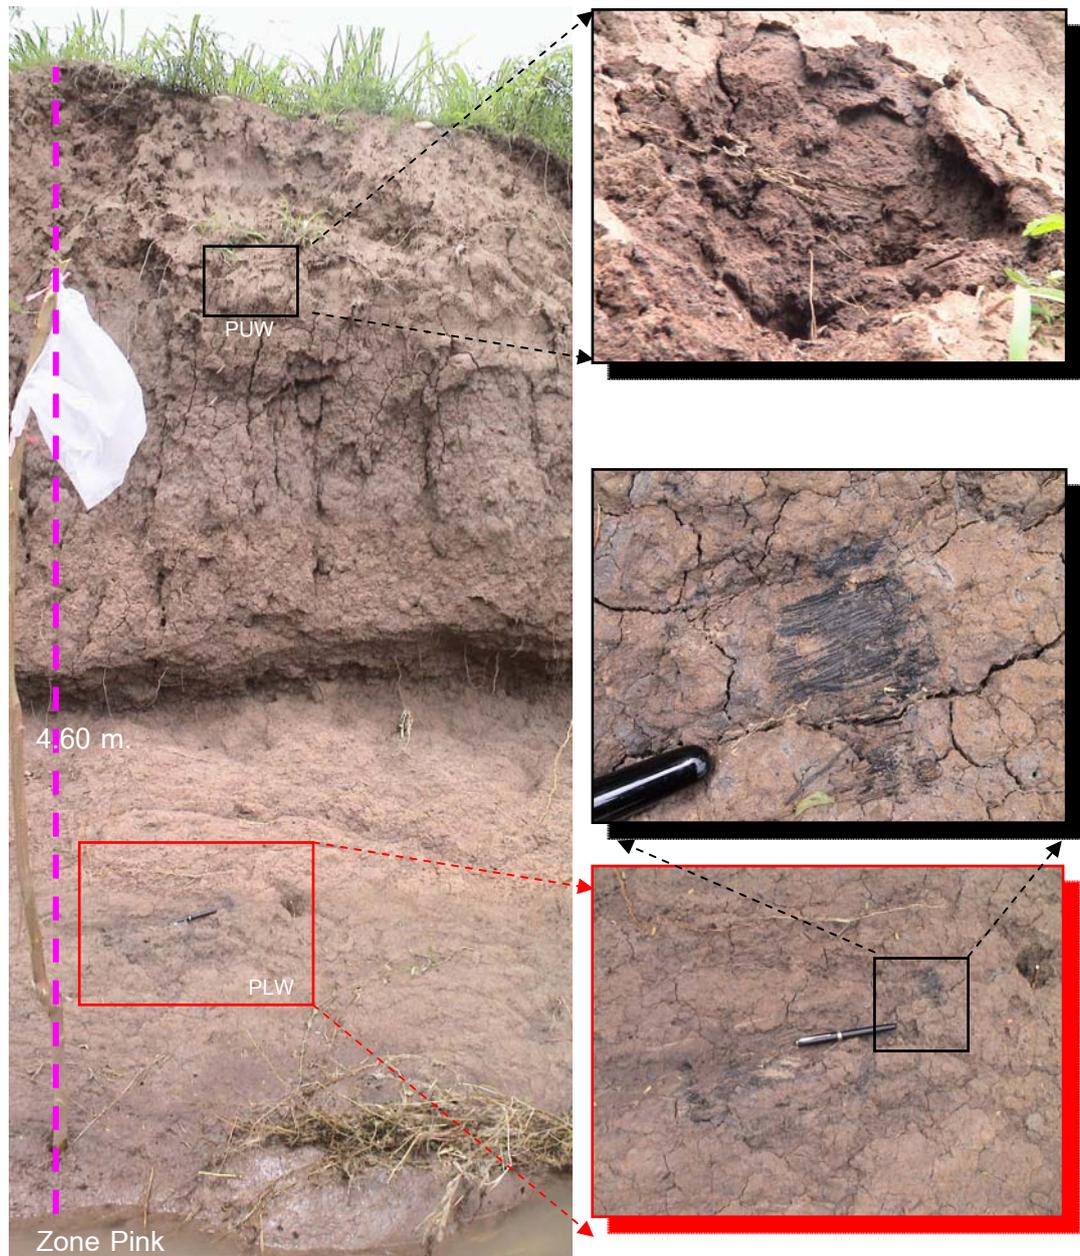
Figure 6-16 Photographs illustrating the general characteristics in the uppermost fine-grained fluvial and debris flood unit at the zone Pink (referred to Figures 6-9 and 6-11) and the preserved large wood debris at the lower part (PLW) and at the upper part (PUW) locations.
