การประเมินศักยภาพของตะกอนไหลถล่มและน้ำปนตะกอนป่า ในปี 2544
บริเวณพื้นที่น้ำก้อ อำเภอหล่มสัก จังหวัดเพชรบูรณ์ ภาคกลางของประเทศไทย

EVALUATION OF POTENTIAL FOR 2001 DEBRIS FLOW AND DEBRIS FLOOD
IN THE VICINITY OF NAM KO AREA, AMPHOE LOM SAK,
CHANGWAT PHETCHABUN, CENTRAL THAILAND

A Dissertation Submitted in Partial Fulfillment of the Requirements
for the Degree of Doctor of Philosophy Program in Geology

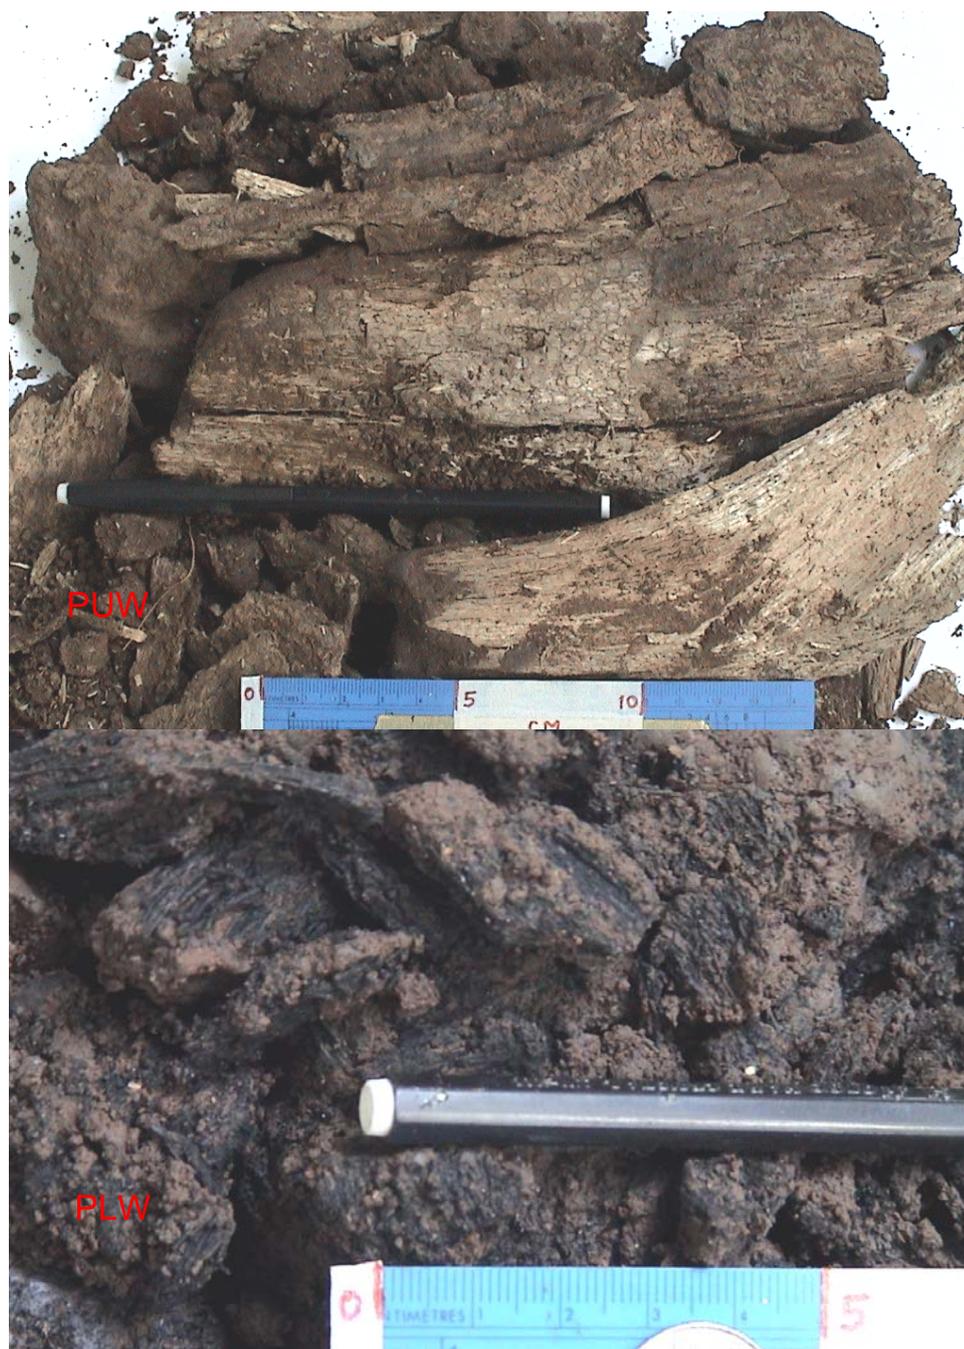
Figure 6-17 Closed-up photographs of the collected wood debris samples from the preserved locations at PLW and PUW (as shown in Figure 6-16) illustrating their general characteristics of charcoal characteristic with fibrous texture and pale brown wood with rather complete wooden texture, respectively.

Significant evidences of the previous flows-floods found in the uppermost fine-grained fluvial and debris flood unit were two preserved wooden debris fragments, one at the lower part (location PLW) and the other at the upper part (location PUW) of the Pink section (Figures 6-16 and 6-17). It is noted that the PLW sample of the lower location was charcoal characteristic with fibrous texture whereas the sample of the upper location (PUW) was the pale brown wood with rather complete wooden texture (as shown in Figure 6-17). These preserved wooden debris were dated by radiocarbon dating method to have absolute ages of deposition between 2,618 \pm 35 before present and post-1950, respectively.

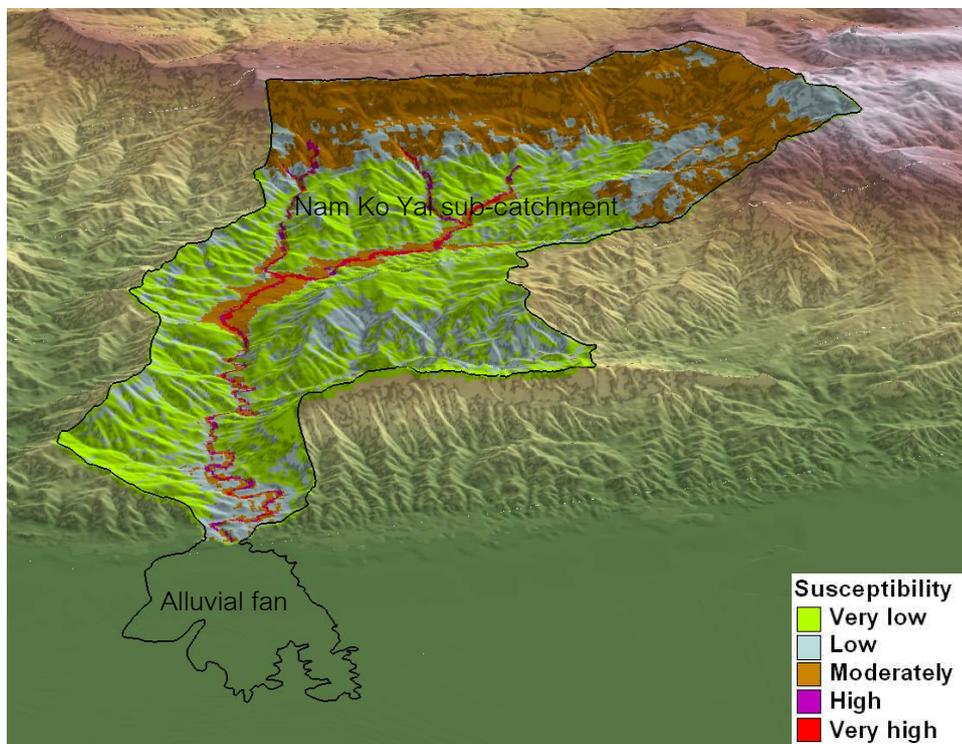
Figure 7-2 Three-dimensional drupe of five classes susceptibility of very high, high, moderate, low, and very low, through a 1:20,000 base-scale DEM in Nam Ko Yai sub-catchment. Very high to very low susceptibility was noted here.

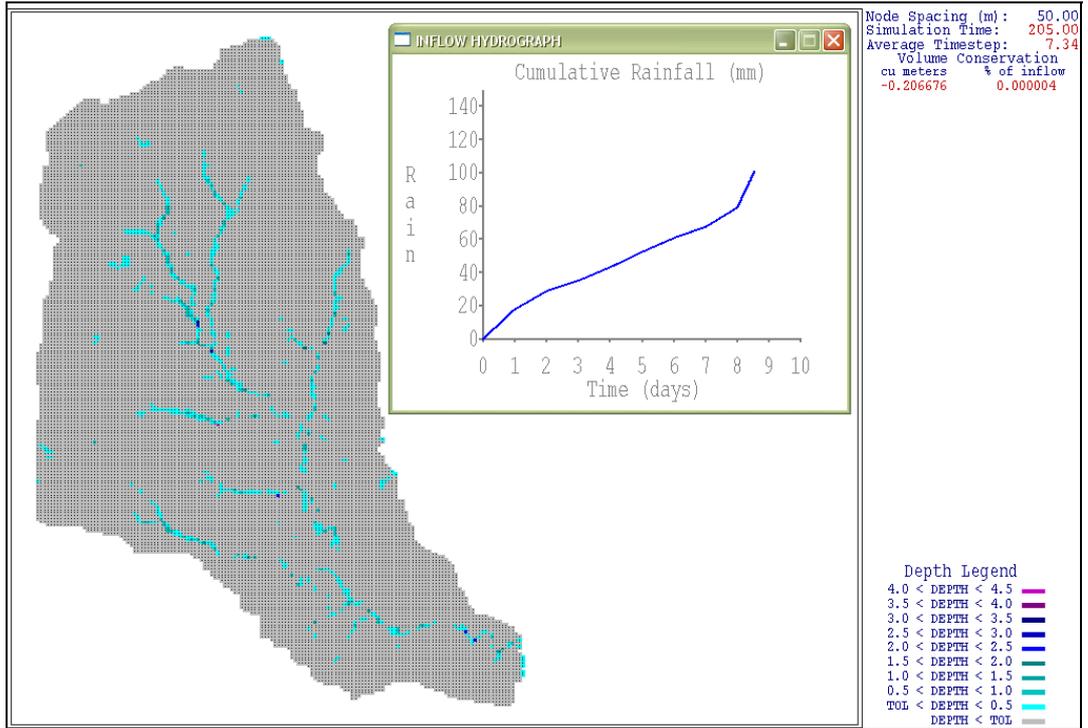
Figure 7-5 FLO-2D simulation results of the channel flow conditions of water height from the condition without dam while the rainfall accumulation was more than 100 mm at 8 p.m. on 9th August 2001 (about 31 hours before the 8/11 event).

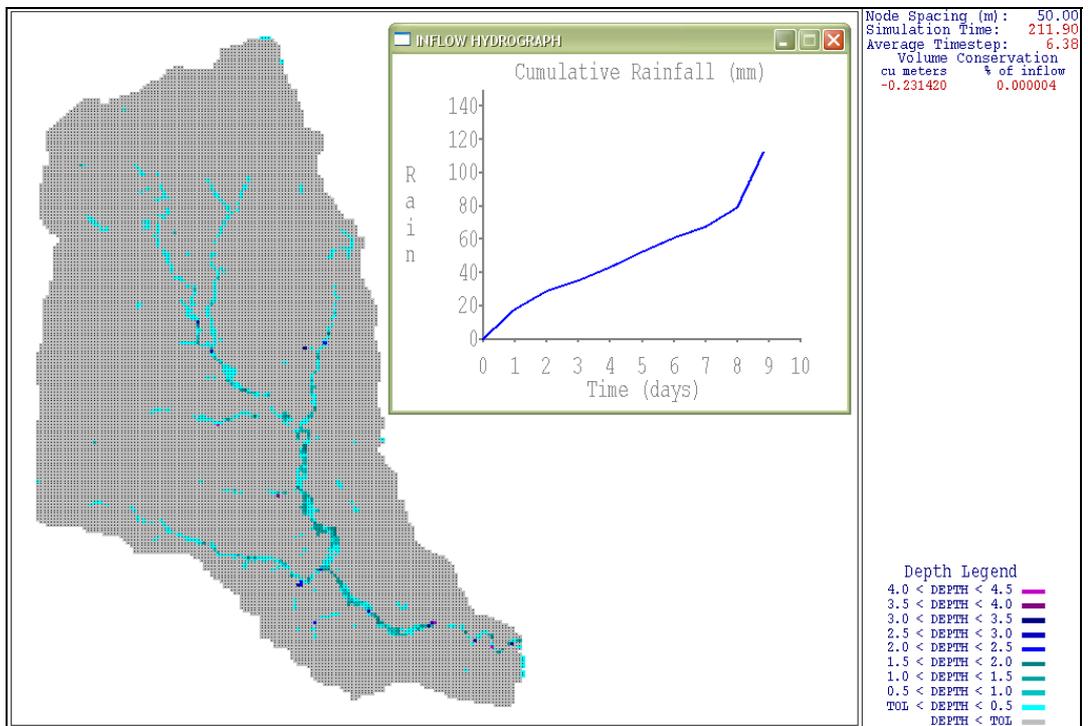
Figure 7-6 FLO-2D simulation results of the channel flow conditions of water height from the condition without dam while the rainfall accumulation was 120 mm at 3 a.m. on 10th August 2001 (about 24 hours before the 8/11 event).

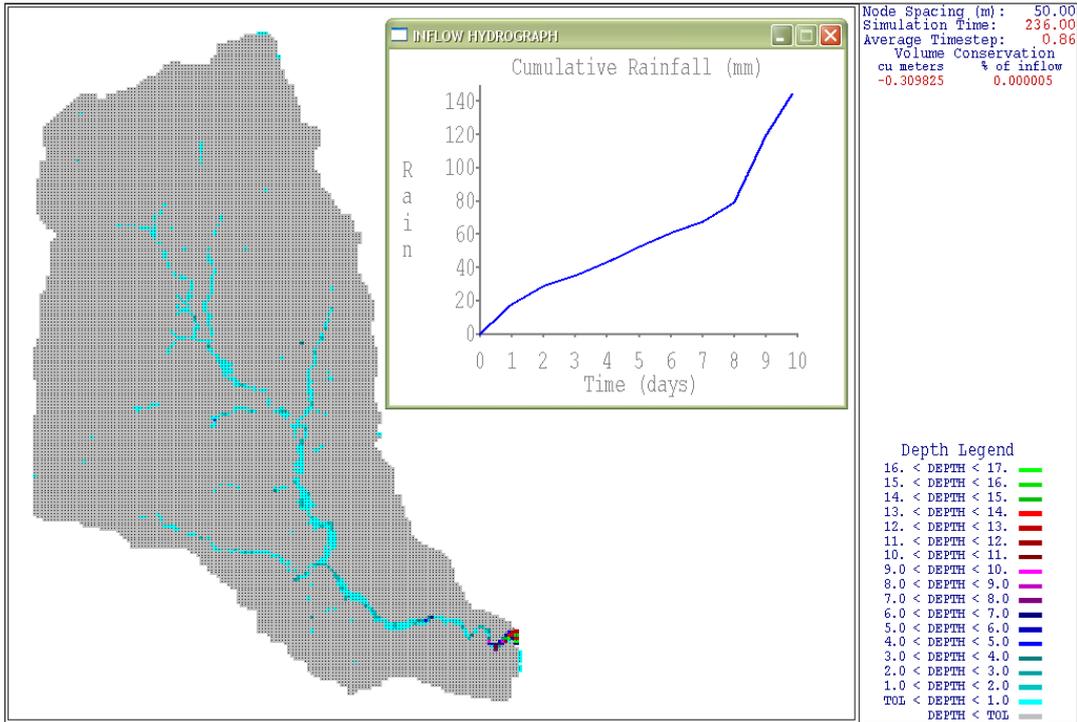
Figure 7-7 FLO-2D simulation results of the channel flow conditions of water height from the condition without dam while the rainfall accumulation was more than 140 mm at 3 a.m. on 11th August 2001 (0.5 hour before the 8/11 event).

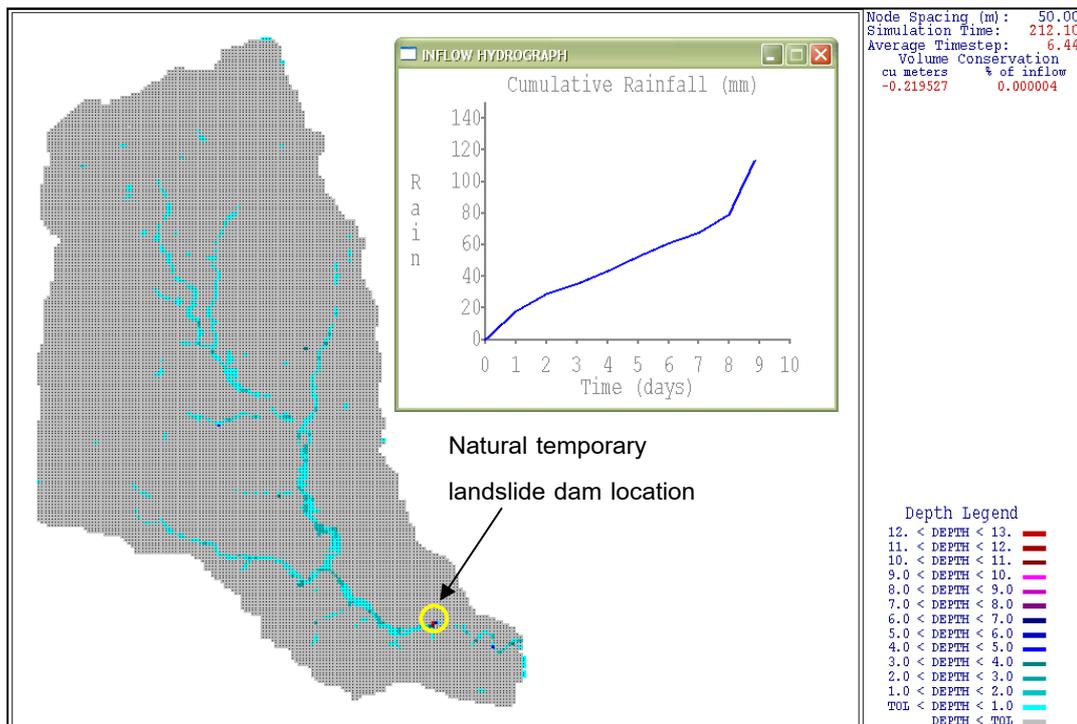
Figure 7-8 FLO-2D simulation results of the channel flow conditions of water height from the condition with dam while the rainfall accumulation was 120 mm at 3 a.m. on 10th August 2001 (about 24 hours before the 8/11 event).

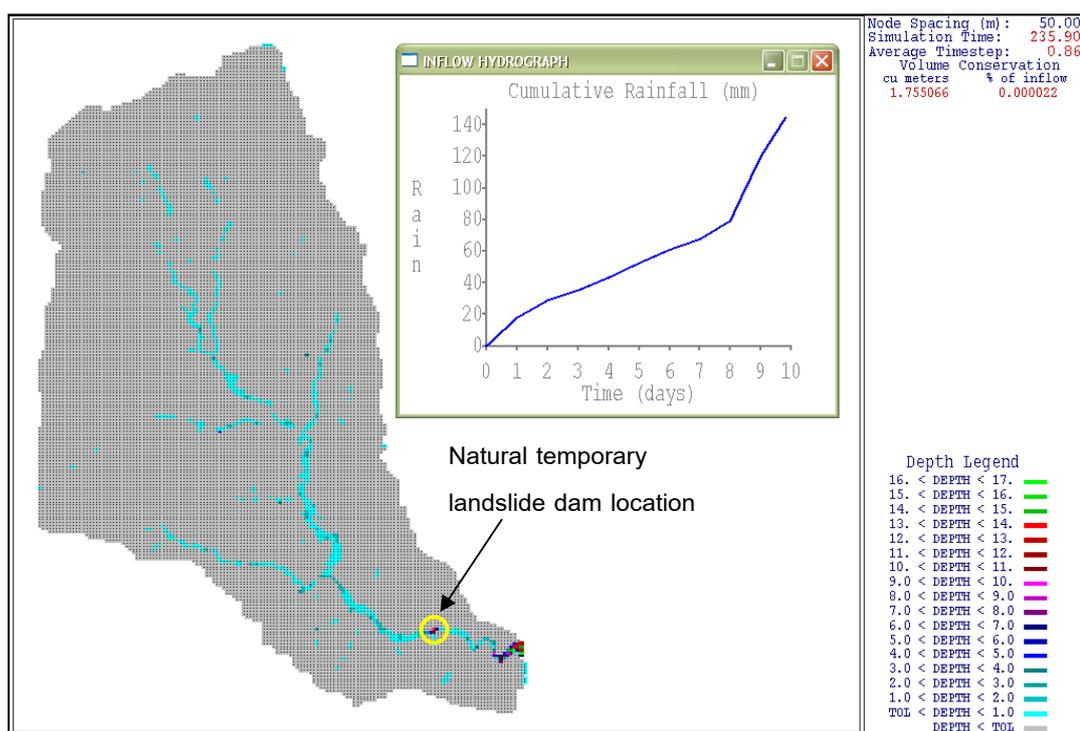
Figure 7-9 FLO-2D simulation results of the channel flow conditions of water height from the condition with dam while the rainfall accumulation was more than 140 mm at 3 a.m. on 11th August 2001 (0.5 hour before the 8/11 event).

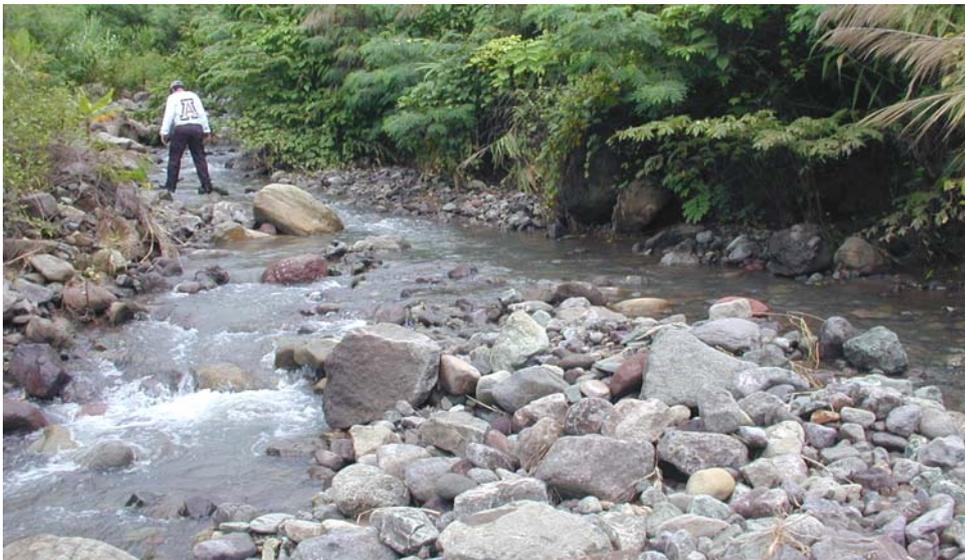
Appendix B-1 Field location along a stream (location B-2 as shown in Figure 5-1) from where rock specimens were collected for point load testing

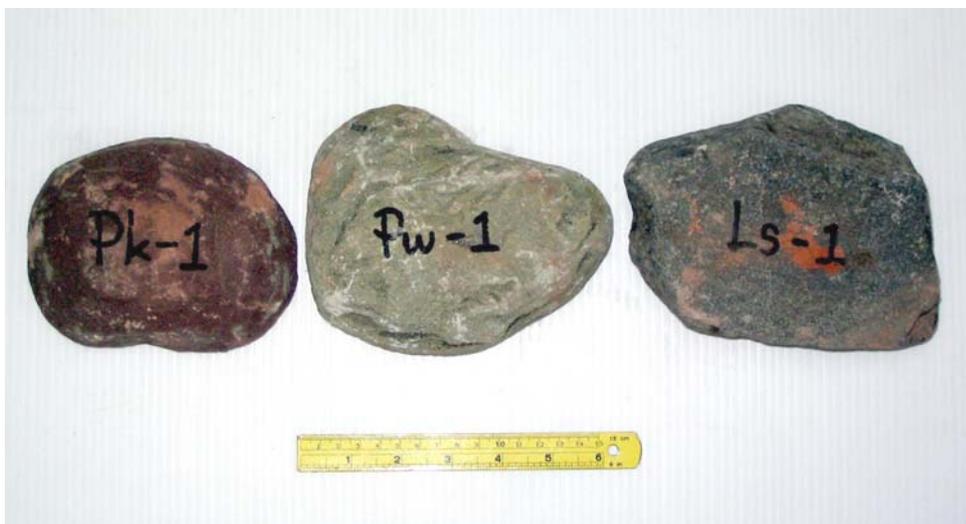
Appendix B-2 The representative three rock-sample types of Phra Wihan sandstone/siltstone (lithologic unit Pw), Phu Kradung sandstone (lithologic unit Pk), and Lom Sak volcanic complex (lithologic unit Ls) respectively, that used in the point load testing

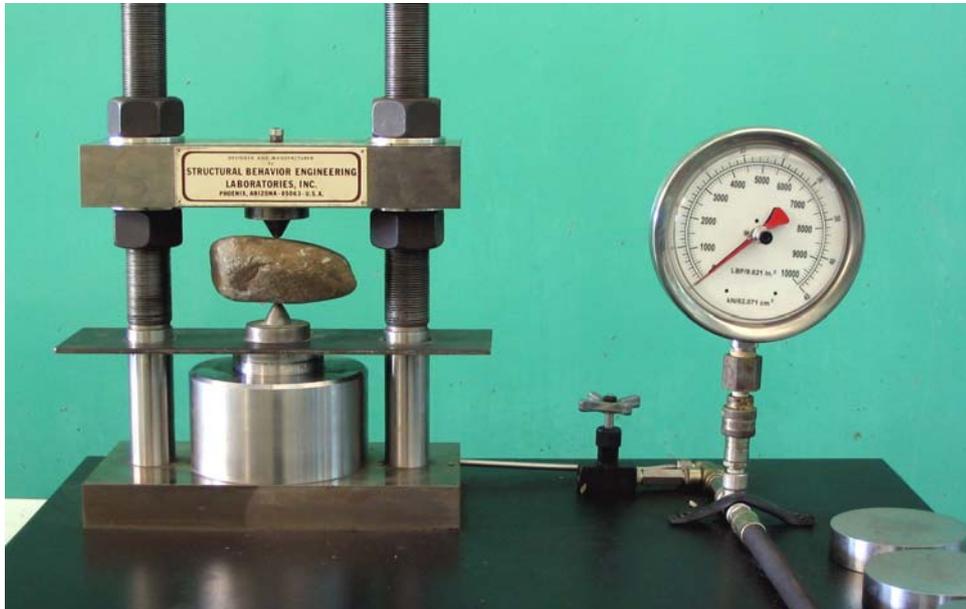
Appendix B-4 Demonstration of a rock specimen forced by head-press until it is broken

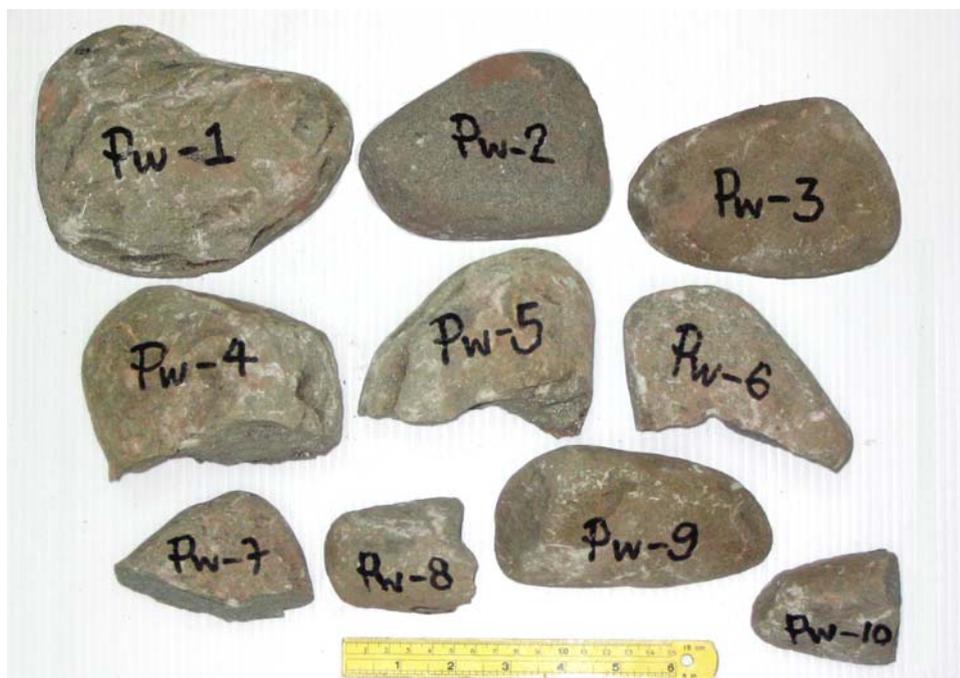
Appendix B-5 Characteristics of ten rock specimens of Phra Wihan sandstone/siltstone (lithologic unit Pw) before point load testing

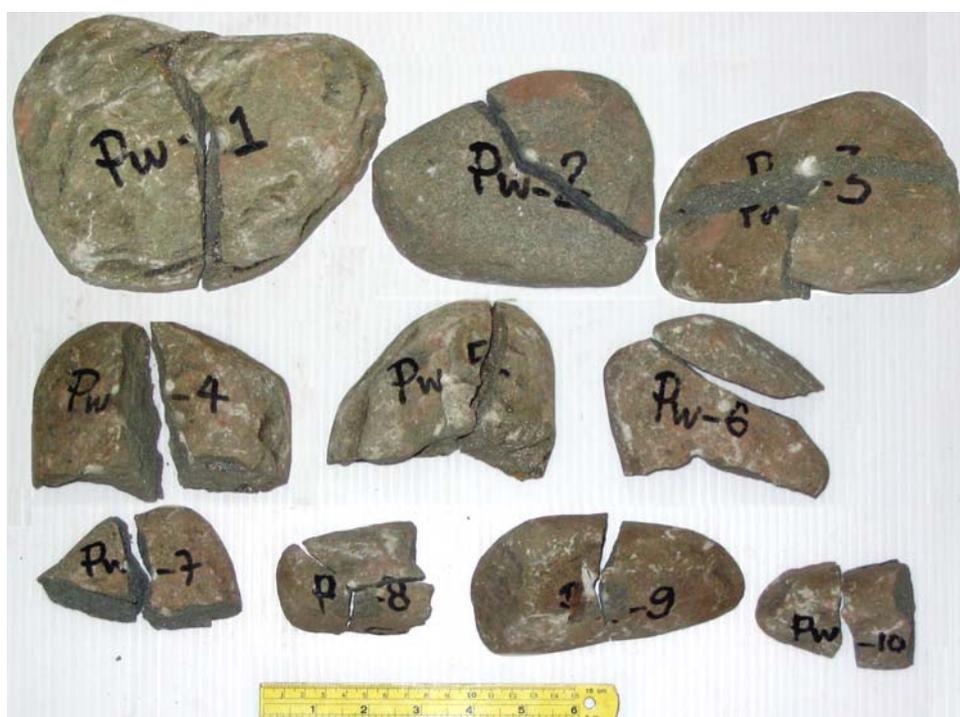
Appendix B-6 Characteristics of ten rock specimens of Phra Wihan sandstone/siltstone (lithologic unit Pw) after point load testing

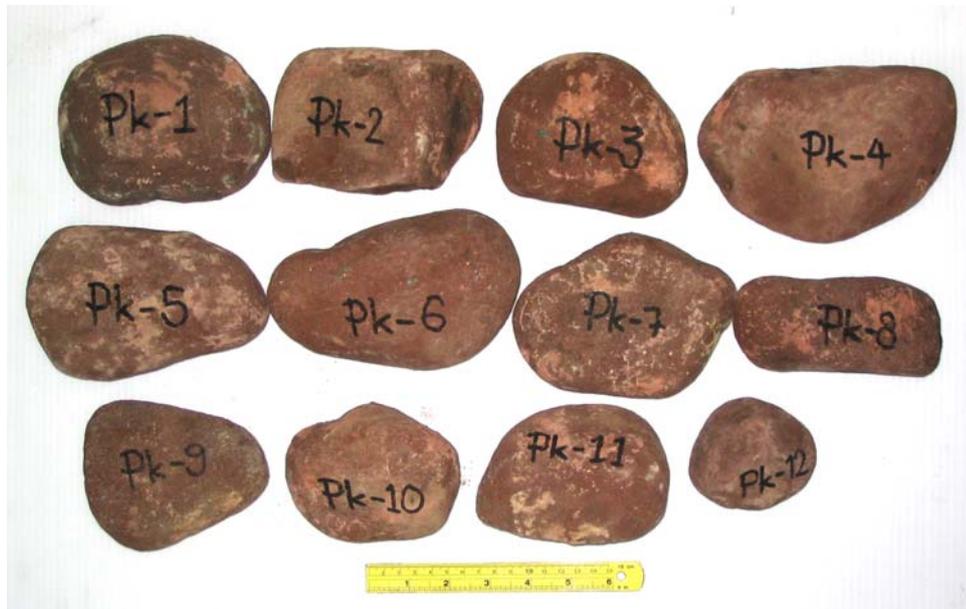
Appendix B-7 Characteristics of twelve rock specimens of Phu Kradung sandstone/siltstone (lithologic unit Pk) before point load testing

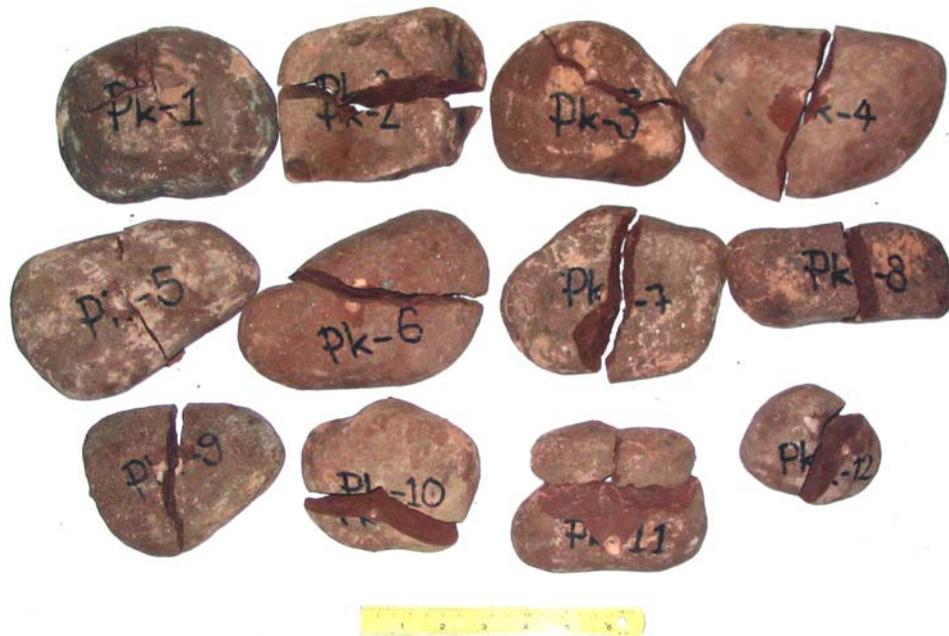
Appendix B-8 Characteristics of twelve rock specimens of Phu Kradung sandstone/siltstone (lithologic unit Pk) after point load testing

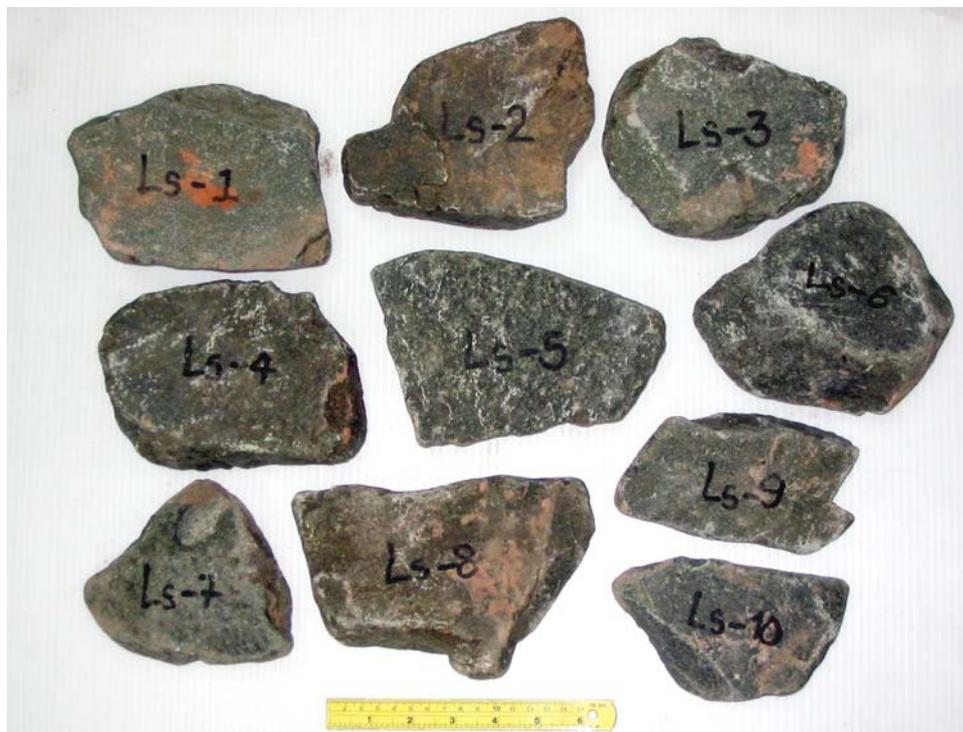
Appendix B-9 Characteristics of ten rock specimens of Lom Sak volcanic complex (lithologic unit Ls) before point load testing

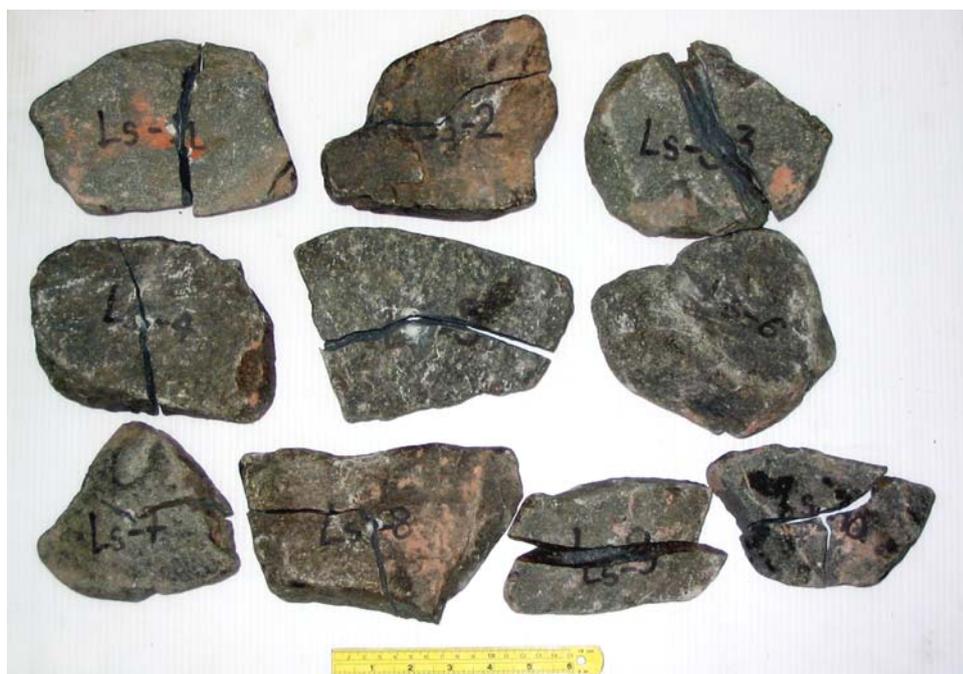
Appendix B-10 Characteristics of ten rock specimens of Lom Sak volcanic complex (lithologic unit Ls) after point load testing

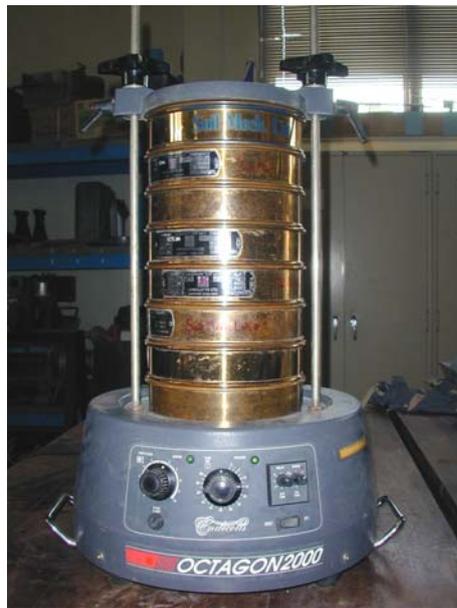
Appendix C-1 Sieve Analysis used for grain size distribution

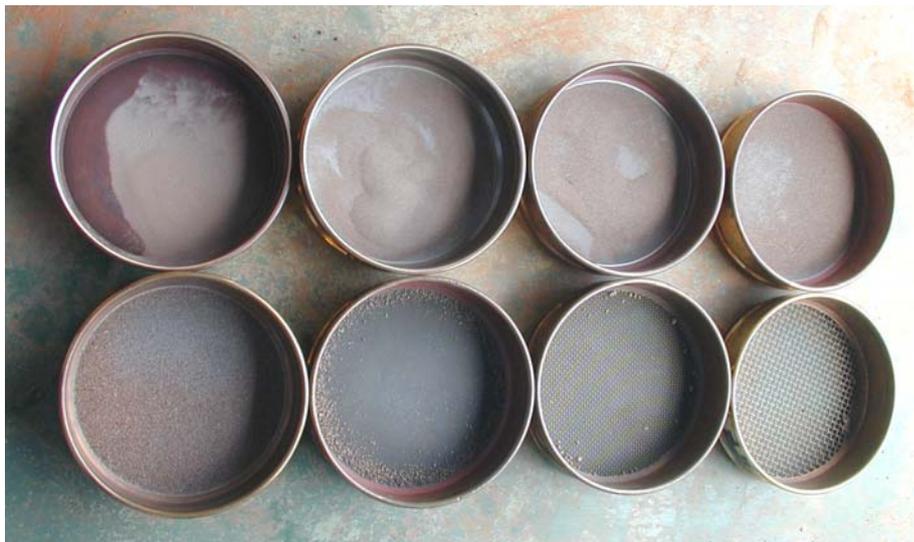
Appendix C-2 Retained soils from each sieve class

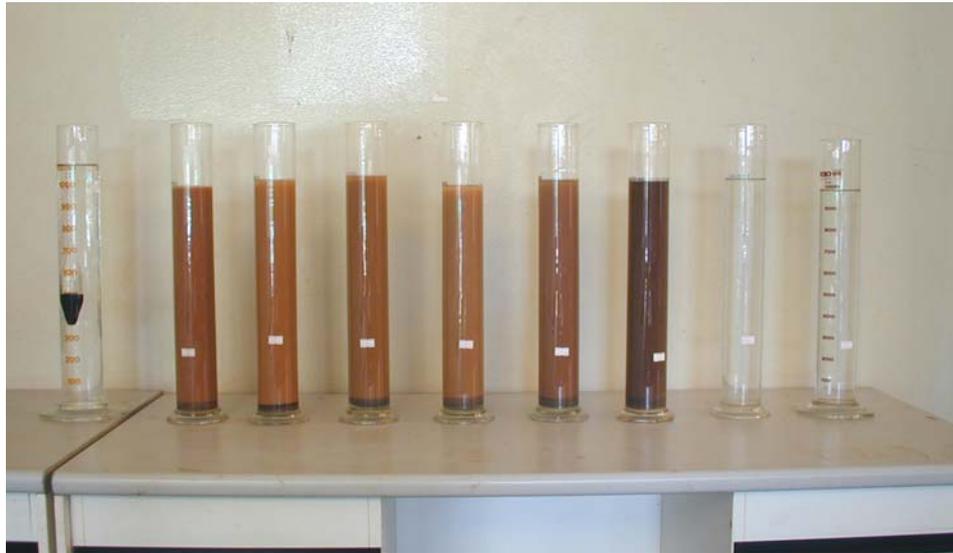
Appendix C-3 Grain size distribution of soils from sedimentation by Hydrometer Test

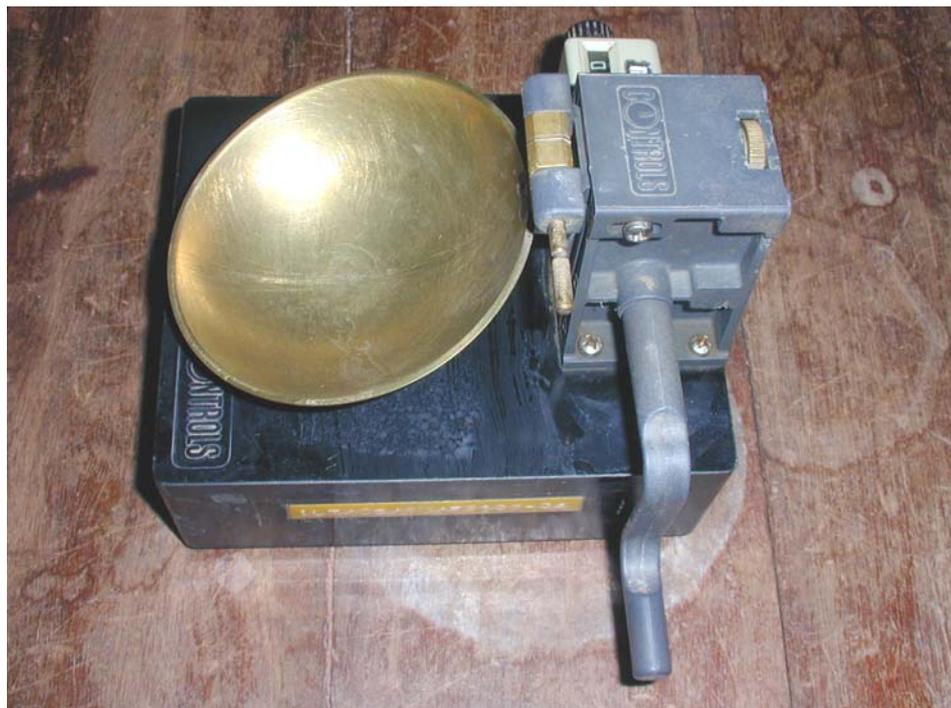
Appendix C-4 Copper bowl apparatus for liquid limit of soil samples

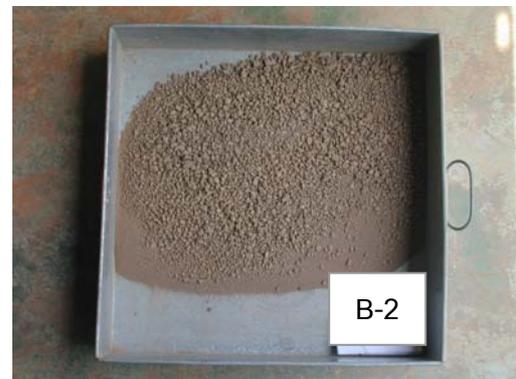
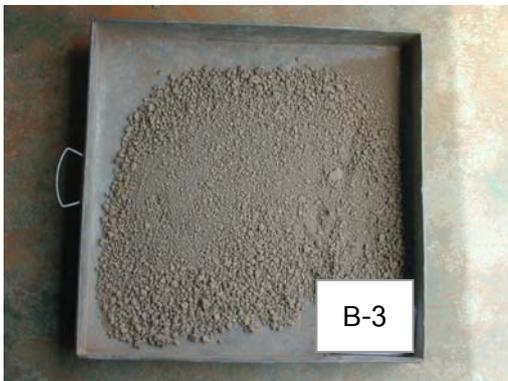
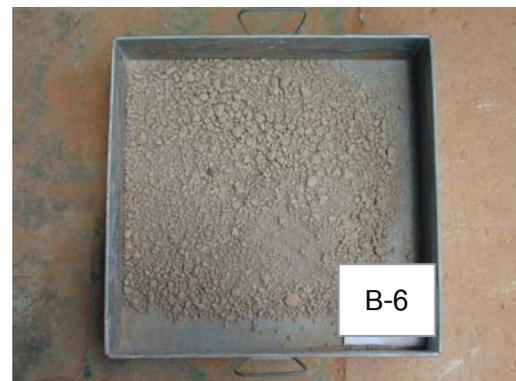
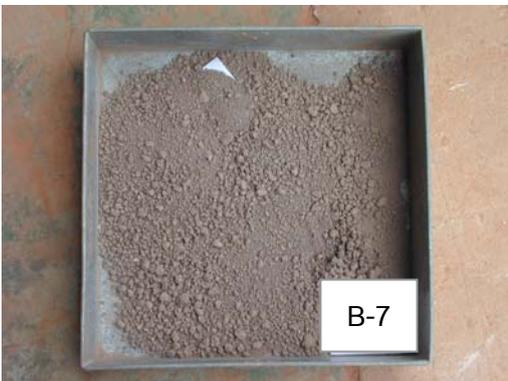
Appendix C-5 Dried and crushed soil samples (number A-1, B-2, B-3, B-6, B-7 and B-10) used for soil-geotechnical testing

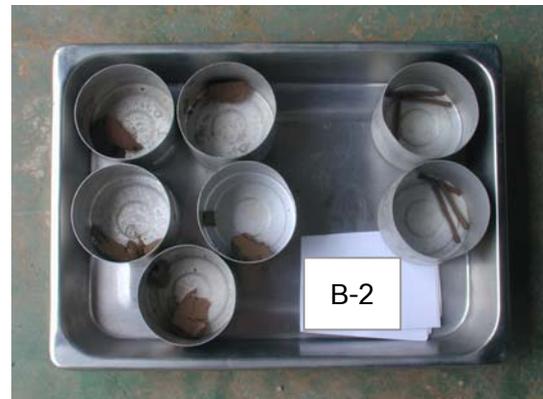
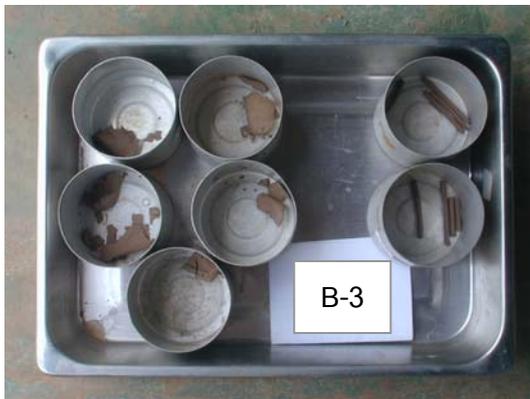
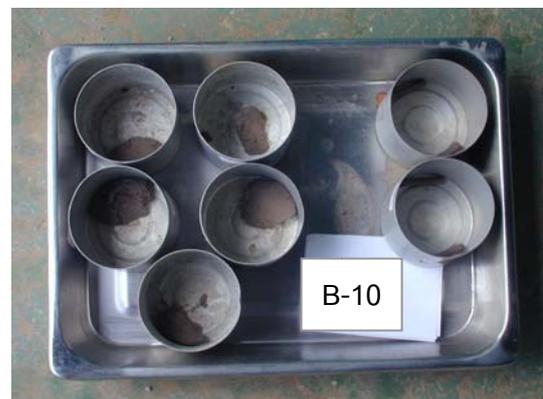
Appendix C-6 Oven-dried soil samples (number A-1, B-2, B-3, B-6, B-7 and B-10) used for Plastic Limit (w_p) and Liquid Limit (w_L) testing

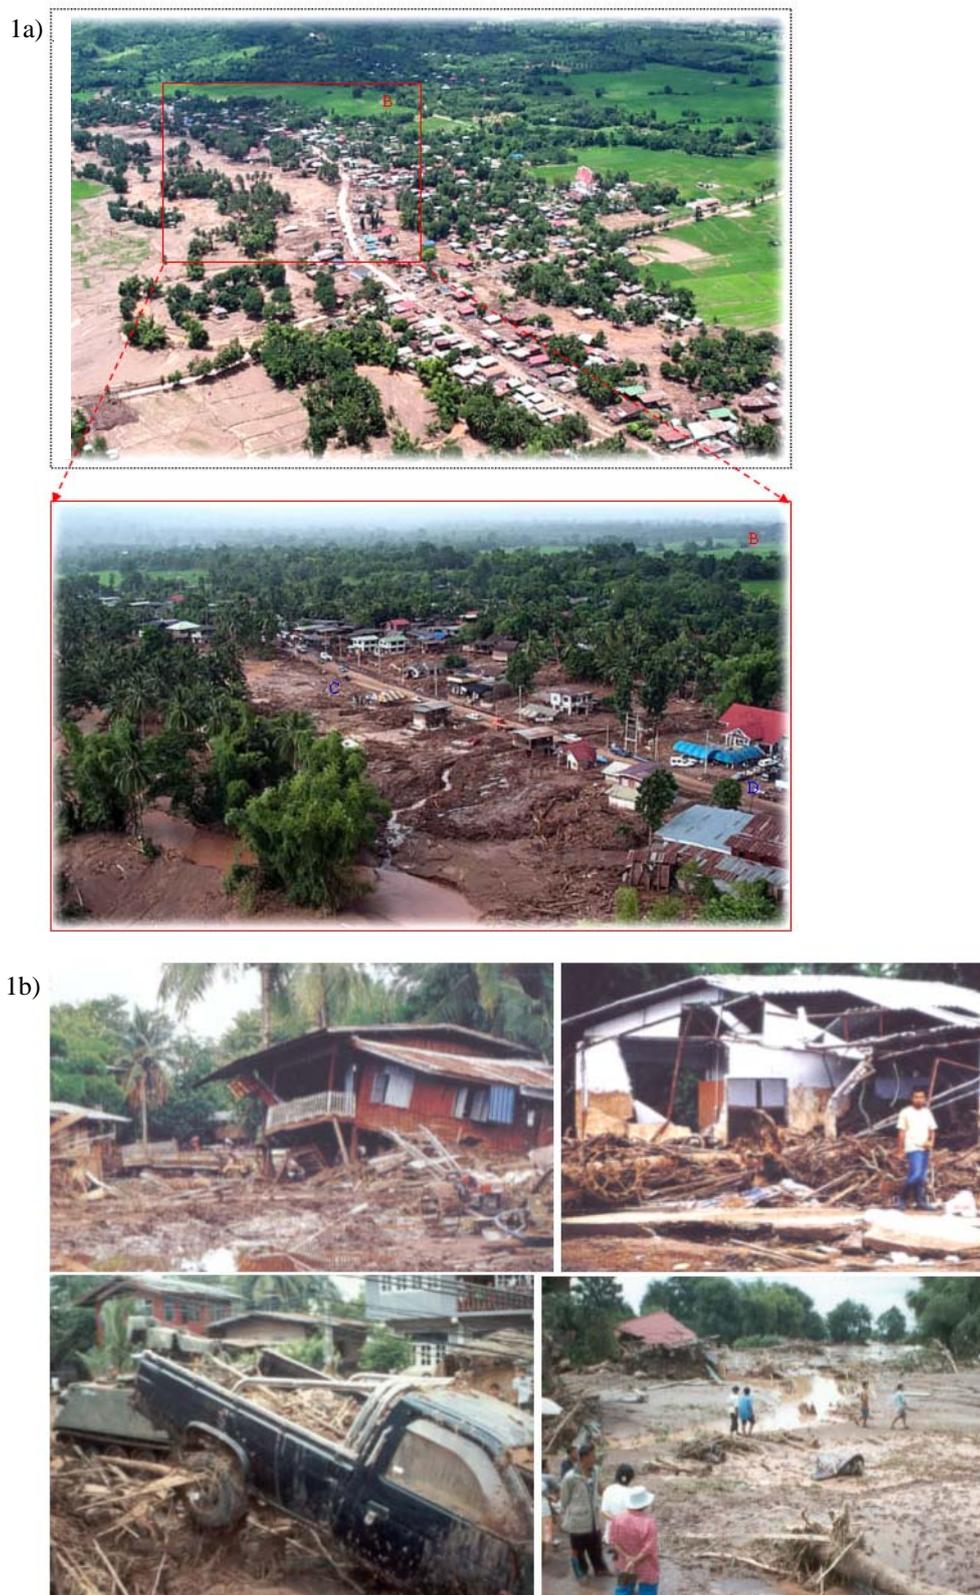
Fig. 1 1a) Two oblique aerial photographs perceptibly illustrating the characteristics and extension of a large volume of deposited sediments; and 1b) four closed-up photographs illustrating the seriously battered structural damage of houses, orchard trees and other infrastructures in Nam Ko Yai village caused by the fast-moving debris flow-flood occurrence on 11 August 2001 (8/11)

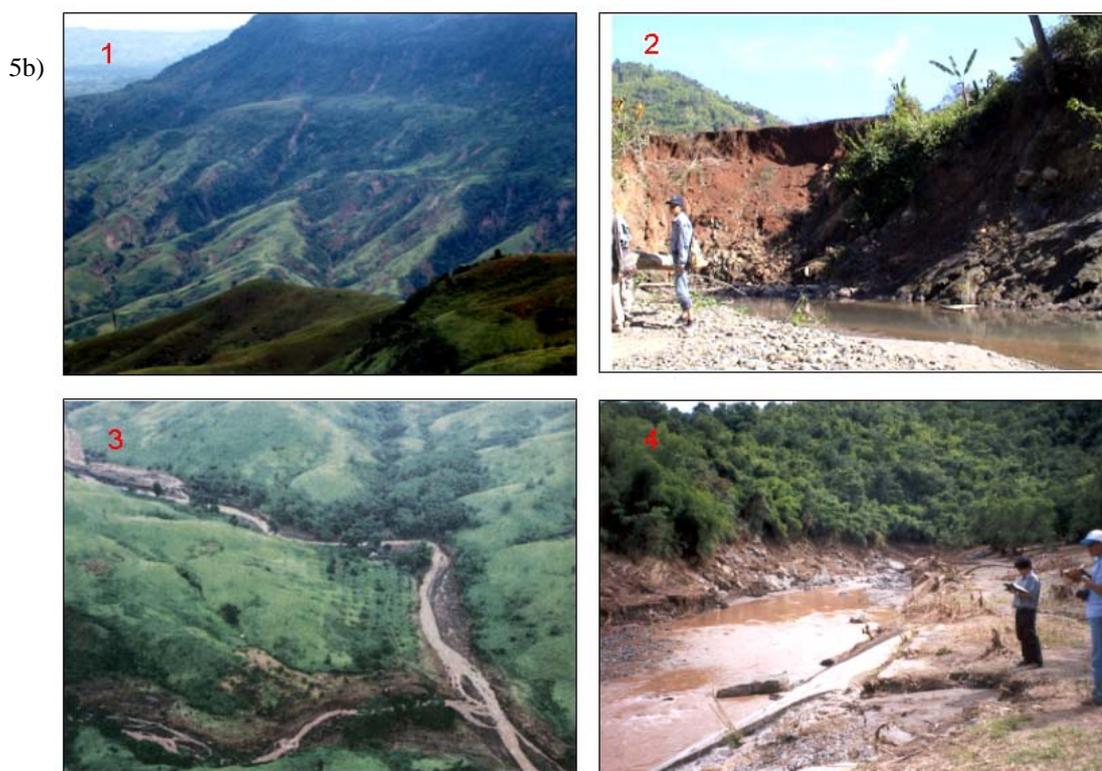
Figure 5

Fig. 5 5a) The significant change of NDVI (from Fig. 4) overlain on the orthophotograph rectified image acquired on 9 January 2002 (after the debris flow-flood occurrence); and 5b) the photographs of four locations (number referred to the location in the map) taken a few days in Nam Ko Yai sub-catchment after the 8/11 event showing the ground truth evidences

The scar-scouring and depositional locations were identified and validated. Classification accuracy was determined by comparing a sample of classified pixels with ground-truth information derived from the rectified orthophotographs and field observation (Fig. 5). The validity of the classified results was tested through the identified ground-truth information of the scar-scouring and depositional locations.

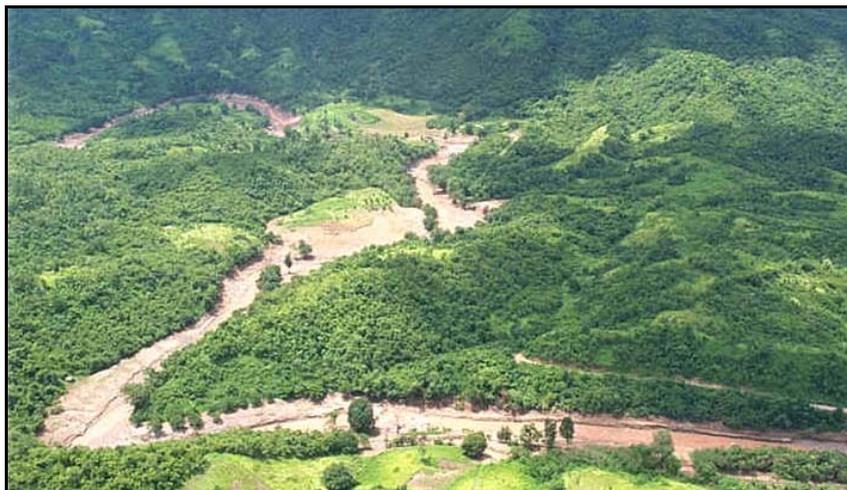
Figure 14

Fig. 14 The oblique aerial photograph (taken on 22 August 2001, 11 days after the event) along the channel of Nam Ko Yai stream with the high sinuosity characteristic illustrating the debris flow-flood track along plant debris and soils had been strongly eroded and transported from its banks before reaching the canyon mouth outlet of the stream

From the field evidences and the oblique aerial photographs taken immediately after the 8/11 occurrence, the plant debris and soils transported from the sinusoidal stream banks (Fig. 14) were spread out onto the alluvial fan at the toe of the mountain front. This fan was concluded to have been formed by several similar debris flow-flood activities in the past.

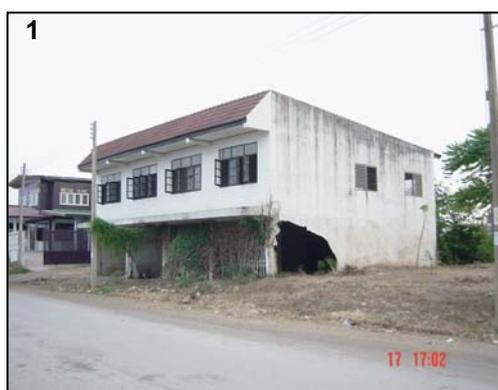
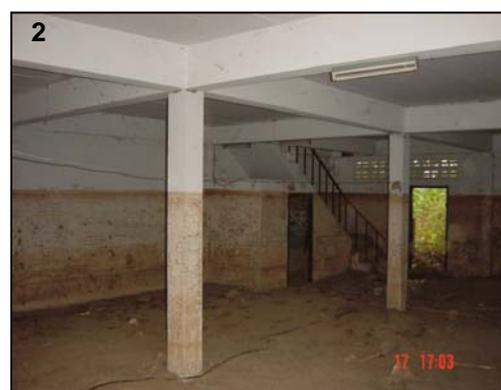
Figure 17

Fig. 17 The expanded orthophotograph rectified image (1:25,000 scale) acquired on 9 January 2002 (red outline in Fig. 16) showing the contours of debris flood levels (in cm) above the ground surface (detected from the thin brown film left at house-walls and trees) in the strongly damaged area of Nam Ko Yai village caused by the 8/11 debris flow-flood

In the multi-spectral Landsat 7 ETM+ imageries analysis, evidences of the alluvial fan deposit from the 8/11 event were analyzed using NDVI value. NDVI value was also used to detect the depositional locations on the alluvial fan (Fig. 16). Oblique aerial photographs taken after the flood were used to characterize the extent of the deposit and validate analyzed result. The high value of NDVI change (56-107) in Figure 16 generally conformed the areas of the most serious damage in Figure 17.

The oblique aerial photographs of the severely damaged settlement areas (Fig. 1) illustrate characteristics and extent of a large volume of an active alluvial fan deposit. The flood levels were established from mud traces on house walls and trees. The highest level of the debris flood, 190-200 cm above the ground level, was located in the most severely damaged zone at locations A and B (Fig.17). The two locations faced the straight course of Nam Ko Yai stream before the channel changed direction abruptly further downstream. Here, the flood jumped over-bank to destroy houses and orchards and claim lives.

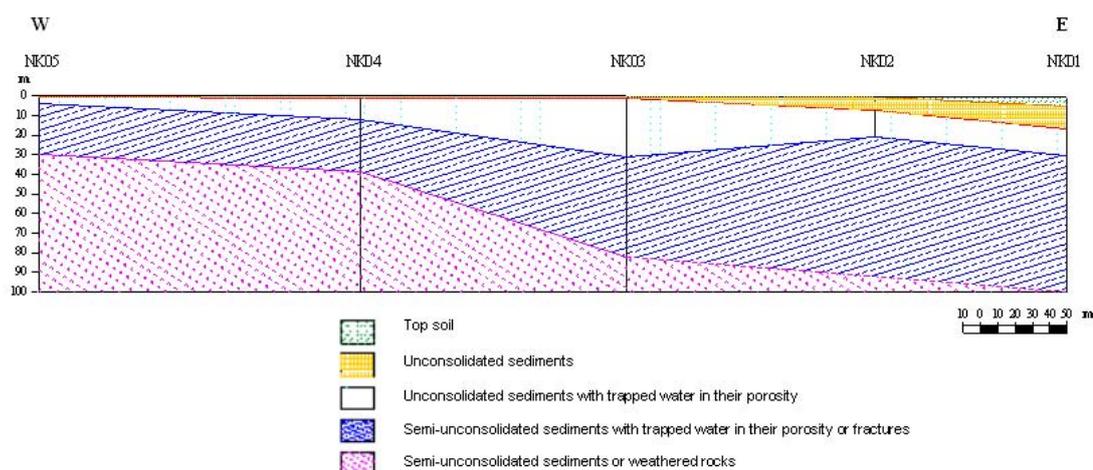
Fig. 18 The cross-section of the resistivity survey interpreted from the five survey points (NK 01 – NK 05) as shown in Fig. 19) that revealed four sedimentary units lying less than 100 m below ground surface
