CHAPTER 5

EVIDENCES AND PARAMETERS AFFECTING DEBRIS FLOW-FLOOD PROCESSES IN NAM KO YAI SUB-CATCHMENT

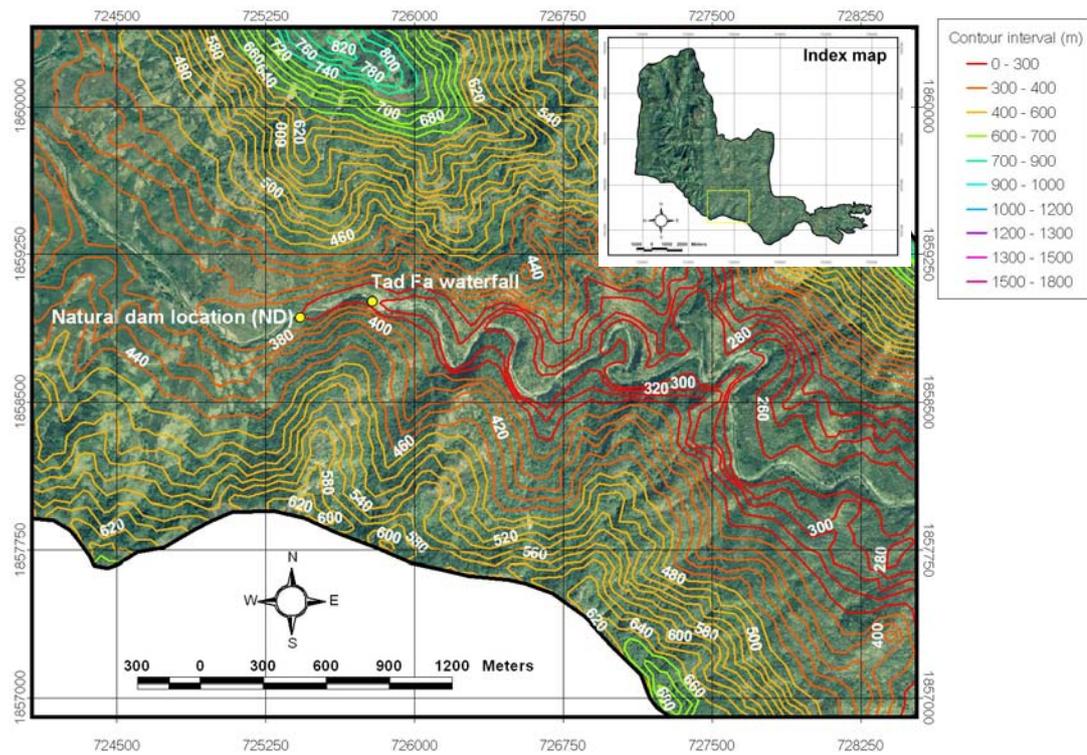
From the field investigations and orthophotograph interpretation, there was a specific location along the course of Nam Ko Yai stream in the central part of the study area that was looked suspiciously. Here the stream issues from a flat open land behind (upstream) to a very narrow V-shape channel with a sudden change of elevation at Tad Fa waterfall (Figure 5-2). It could be hypothesized that this specific location is suitable for an accumulation of sediments composed of plant debris, soils, and rock boulders to form a natural landslide dam of at least 10 m high (Figures 5-3, 5-4 and 5-5). A field check revealed fallen trees and vegetation traces. This probably indicated that the temporary natural dam was broken, sending the debris and water to flood further downstream, eroding the channel along the way, and finally dropping its loads on the alluvial fan at the canyon mouth.

Figure 5-2 Orthophotograph (1:25,000 scale, 9th January 2002 after the 8/11 event) illustrating the specific configuration of Nam Ko Yai stream in the central part of the study area.

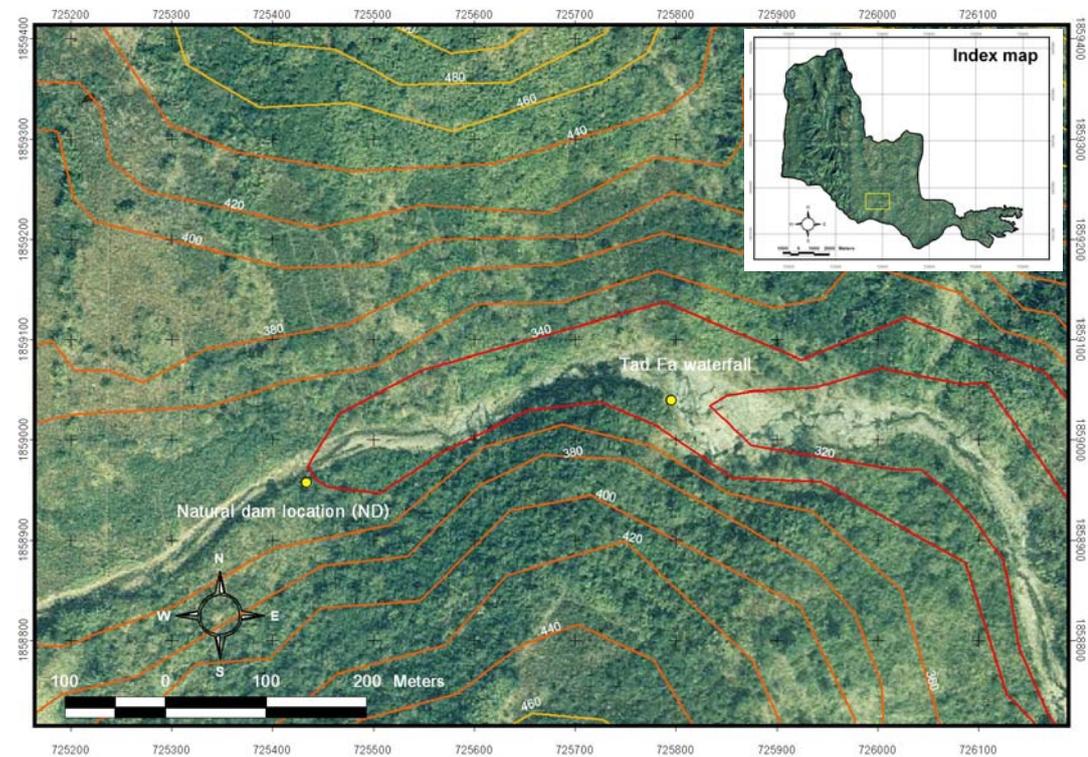
Figure 5-3 Closed-up orthophotograph in Figure 5-2 illustrating the local geography of Nam Ko Yai stream that is suspected to be a natural temporary landslide dam location (ND) in front of the location of Tad Fa waterfall.

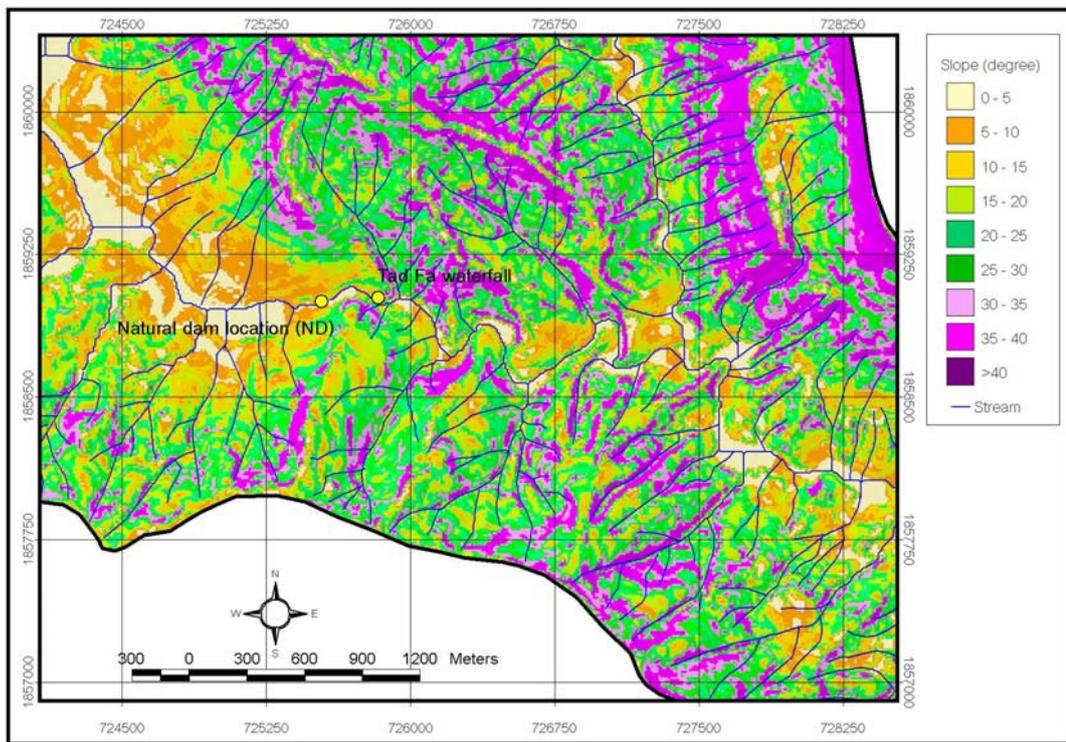
Figure 5-6 Slope map of the upstream and downstream area above and below the suspected natural landslide dam location (ND) in Nam Ko Yai stream channel.

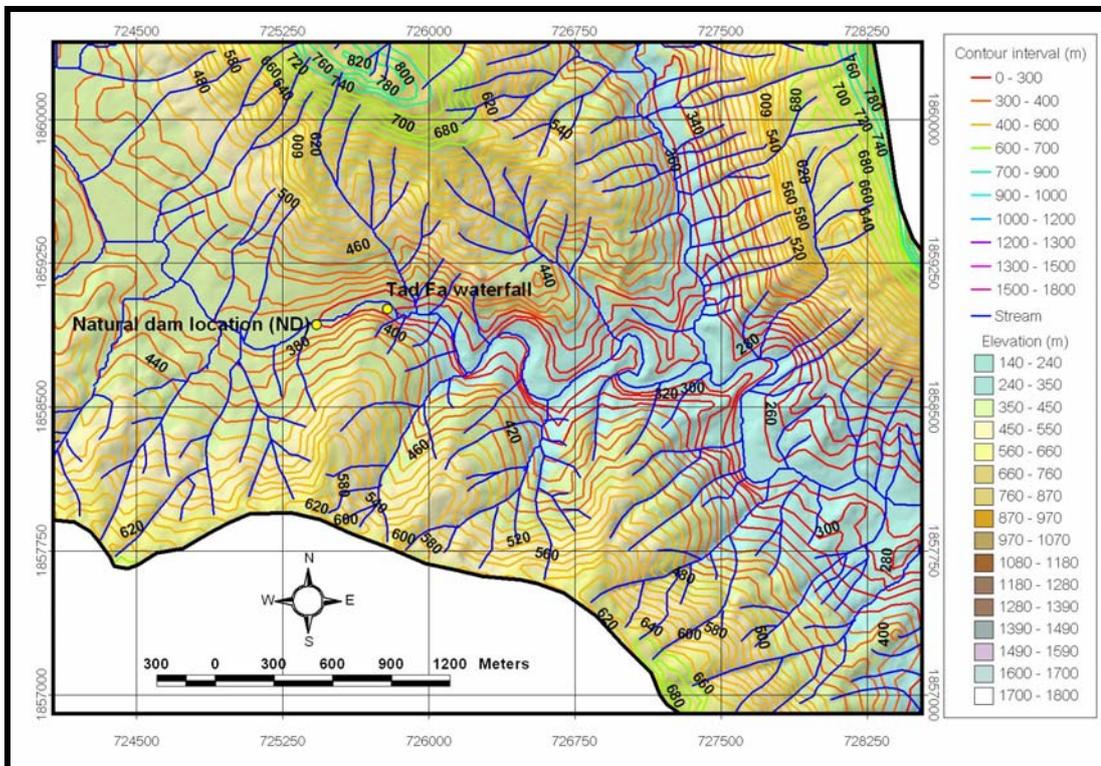
Figure 5-7 Elevation map of the upstream and downstream area above and below the suspected natural landslide dam location (ND) in Nam Ko Yai stream channel.

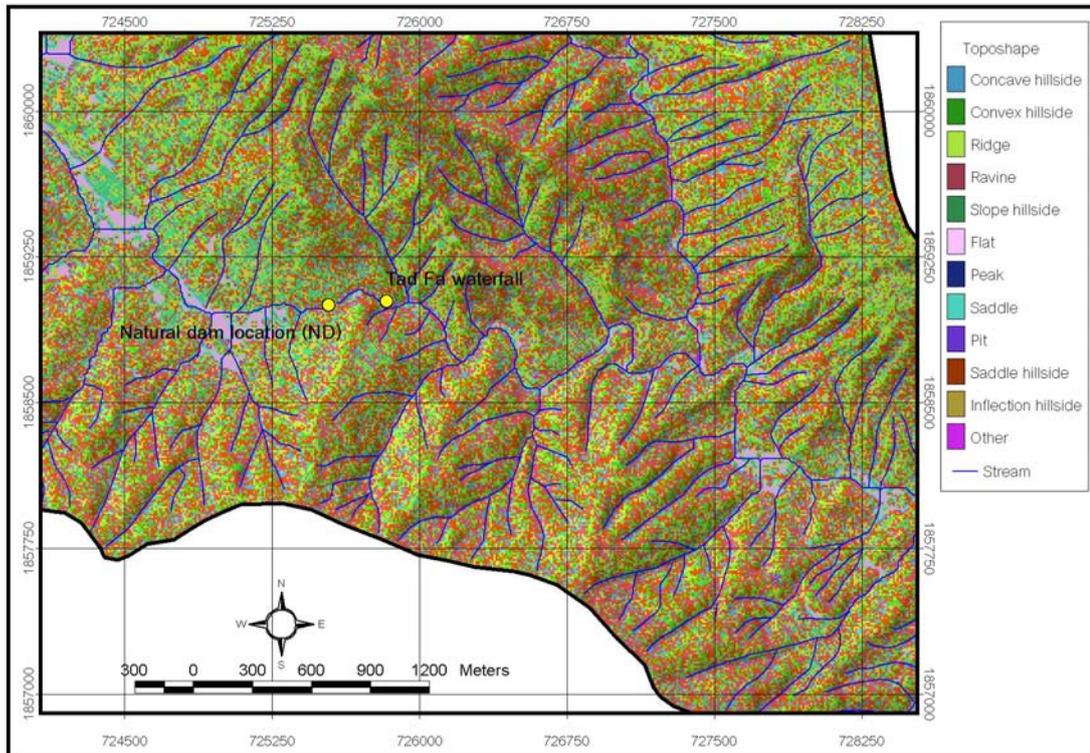
Figure 5-8 Topographic shape of upstream and downstream area away from the suspected natural landslide dam location (ND) in Nam Ko Yai stream channel.

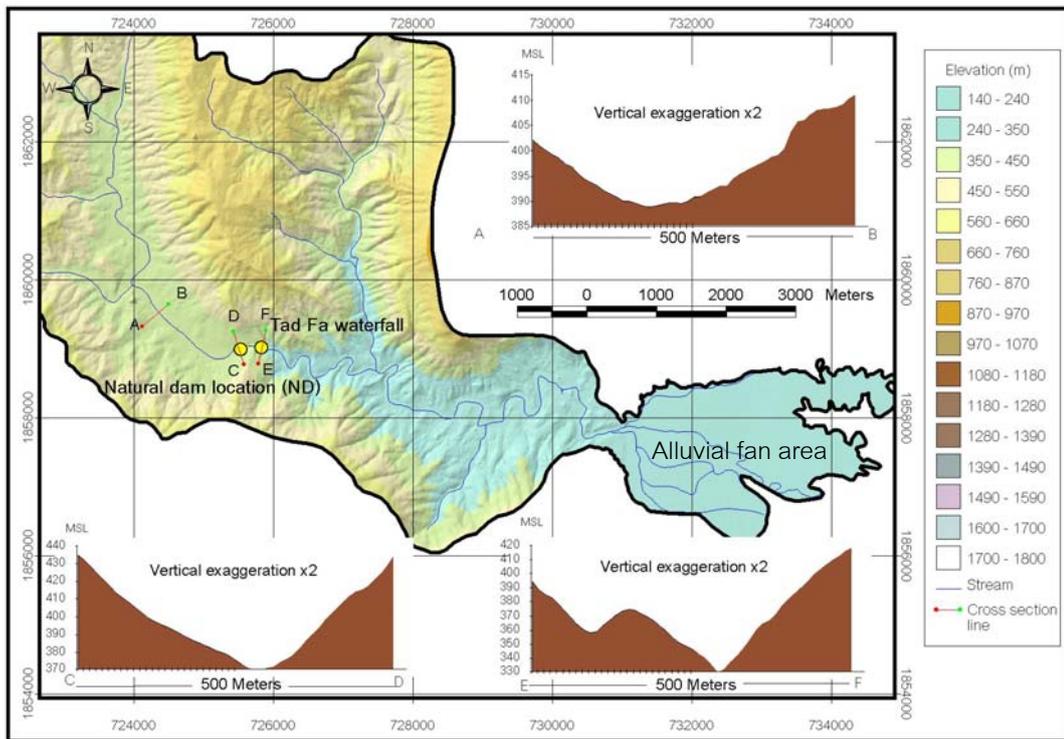
From the channel configuration of Nam Ko Yai stream up- and downstream from the suspected natural dam location (Figure 5-10), the 8/11 flow-flood should follow the pre-existing drainage way. Downstream from the dam, the stream has a V-shape or nearly rectangular cross-section as shown in the cross-section lines of G-H and I-J (Figure 5-11). This narrow V-shape and strong sinuosity channel configuration of Nam Ko Yai stream here also indicates as one of the most influent parameters that allow increasing energy for the torrent stream caused from the broken natural dam to be formed as a severe flow-flood. This destructive form of mass movement strongly eroded and transported sediments (plant debris, soils and rock boulders) along the downstream

Figure 5-10 Three cross-sections (line A-B, C-D and E-F) across Nam Ko Yai stream channel and its valley at the upstream area, the suspected natural landslide dam location, and Tad Fa waterfall, respectively.

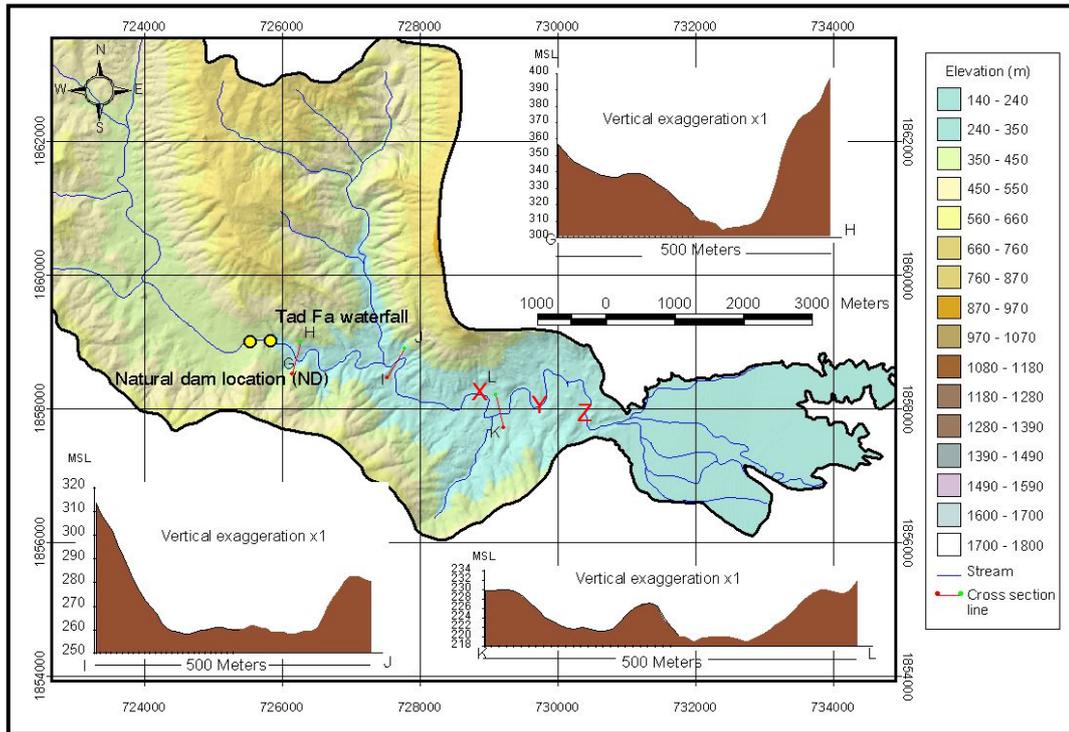
channel, especially in the outer-curvature bank of steep slope and incorporated them into the flow-flood. The evidences of 8/11 event could be observed in the field visit where Nam Ko Yai stream had a steep V-shape cross-section downstream. The traces of the erosional feature in the outer curving-bank were common. Some huge logs or intertwined bamboo clumps were left in the channel or up high on the tree splices as they were not all transported by the torrent stream flows (Figure 5-12).

Figure 5-11 Three cross-sections (line G-H, I-J and K-L) across Nam Ko Yai stream channel and its valley at the downstream areas from the suspected natural landslide dam location (ND).
