2001 debris flow and debris flood in Nam Ko area, Phetchabun province, central Thailand

Abstract The factors of the debris flow and debris flood (debris flow-flood) occurrence on 11 August 2001 on the active Nam Ko alluvial fan in Phetchabun province, central Thailand, were studied. Evidences of past activity registered in the alluvial fan, and the debris flow-flood event were reconstructed. The disastrous debris flow-flood event was not the work of the unusual high amount of rainfalls alone, as previously theorized, but is a work of combined factors from the terrain characteristics with specific land covers to the time delay for accumulation of debris and sedi-

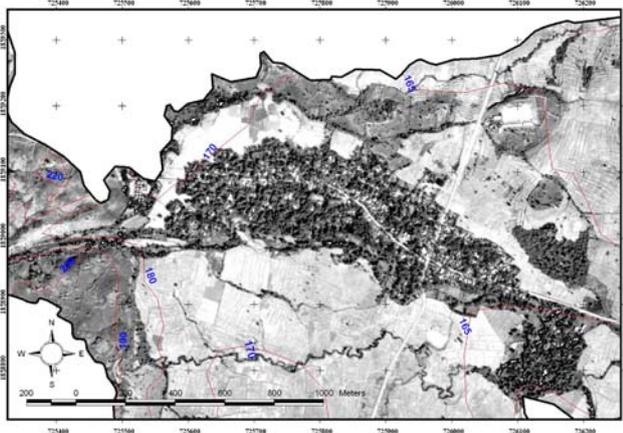
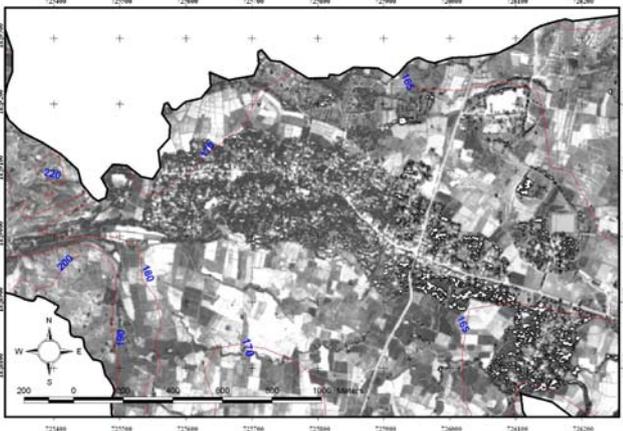
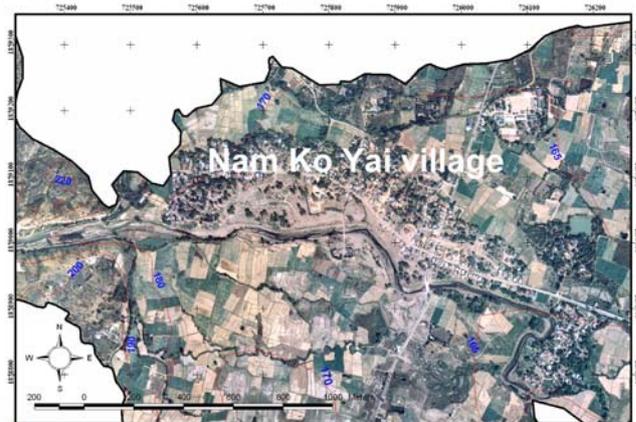
The available multi-temporal low-altitude images of aerial photographs (1:15,000 scale) taken on 24 December 1974, rectified orthophotograph (1:50,000 scale) taken on 6 January 1996, and rectified orthophotograph (1:25,000 scale) taken on 9 January 2002 (Fig. 15) were used to characterize the Nam Ko Yai canyon mouth and its downstream depositional fan before and after the 8/11 event. The topographic apex of Nam Ko Yai alluvial fan had only minor changes between 1974 and 1996. A clear activeness of erosion and deposition was presumed to be from the 8/11 flow-flood event.

Fig. 15 The multi-temporal low-altitude images of aerial photograph and orthophotograph (with contour intervals in red line) acquired on three different periods: **a** 24 December 1974, **b** 6 January 1996, and **c** 9 January 2002 showing the distinct identification of the topographic apex of Nam Ko Yai stream in the alluvial fan that was slightly modified from 1974 until 1996. Pronounced and still active changes are evident following the 8/11 debris flow-flood

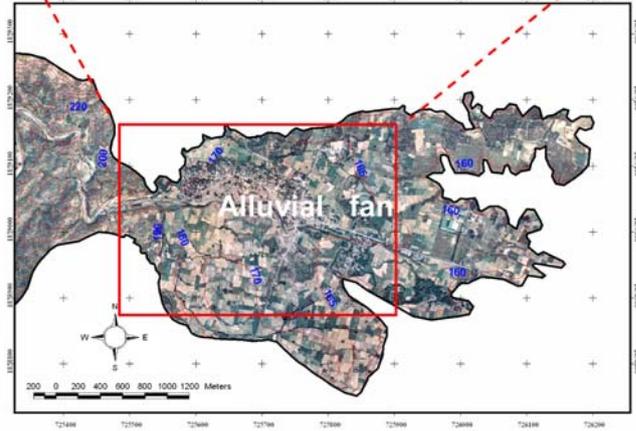
In the multi-spectral Landsat 7 ETM+ imageries analysis, evidences of the alluvial fan deposit from the 8/11 event were analyzed using NDVI value. NDVI value was also used to detect the depositional locations on the alluvial fan (Fig. 16). Oblique aerial photographs taken after the flood were used to characterize the extent of the deposit and validate analyzed result. The high value of NDVI change (56–107) in Fig. 16 generally conformed the areas of the most serious damage in Fig. 17.

Fig. 16 The detection change of NDVI in the depositional location of the alluvial fan (expanded from Fig. 4) overlain on the orthophotograph rectified image (1:25,000 scale) acquired on 9 January 2002. The *brown-colored zones* are new traces of fan deposit after 1996

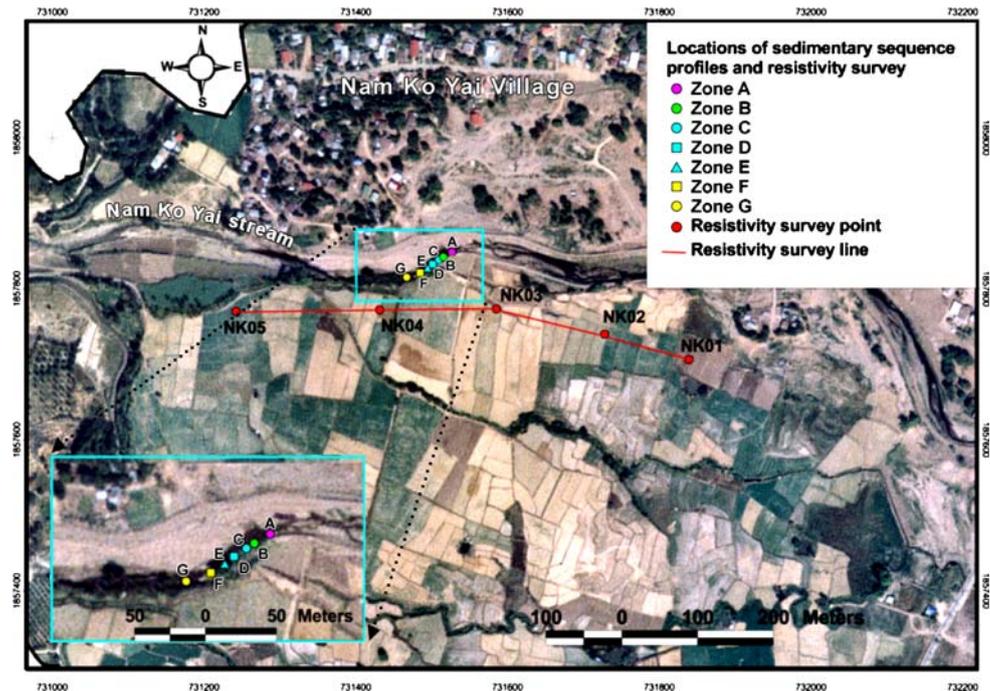
5 × 70 m eroded bank of Nam Ko Yai stream near where the resistivity survey had been performed. Seven stratigraphic profiles were studied to reveal sedimentary sequences in both terms of vertical and lateral stratigraphic correlation. The location map of the measured stratigraphic columns and the line of resistivity survey points are shown in Fig. 19 and the actual profiles in Fig. 20.

Fig. 19 The location map of seven measured stratigraphic profiles (A, B, C, D, E, F, G) along the eroded bank of Nam Ko Yai stream, and a line of five resistivity survey points (NK01–NK05) used for investigating the stratigraphy, sedimentology and subsurface geology of the older alluvial fan deposits
