APPENDICES

2001 debris flow and debris flood in Nam Ko area, Phetchabun province, central Thailand

Abstract The factors of the debris flow and debris flood (debris flow-flood) occurrence on 11 August 2001 on the active Nam Ko alluvial fan in Phetchabun province, central Thailand were studied. Evidences of past activity registered in the alluvial fan, and the debris flow-flood event were reconstructed. The disastrous debris flow-flood event was not the work of the unusual high amount of rainfalls alone, as previously theorized, but is a work of combined factors from the terrain characteristics with specific land covers to the time-delay for accumulation of debris and sediments. This combination of factors could lead to a debris flow-flood after a high amount of precipitation. The process could also be worse if a landslide formed a natural dam, then the dam was destroyed under the weight of impounded water. After such a disastrous event, it would take time for more plant debris and sediments in the sub-catchment area to accumulate before the next debris flow-flood.

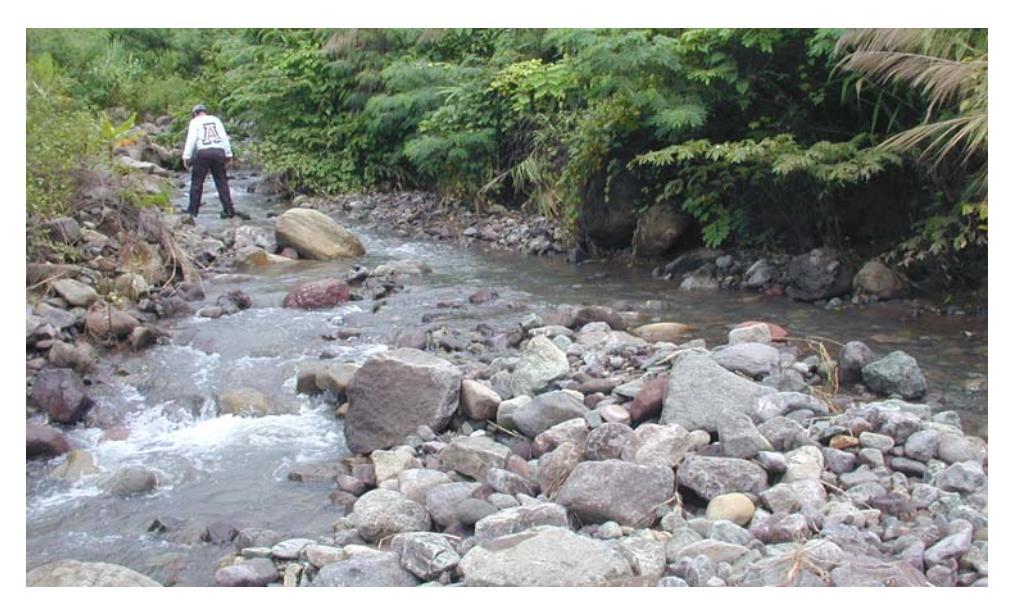
Appendix B-1 Field location along a stream (location B-2 as shown in Figure 5-1) from where rock specimens were collected for point load testing

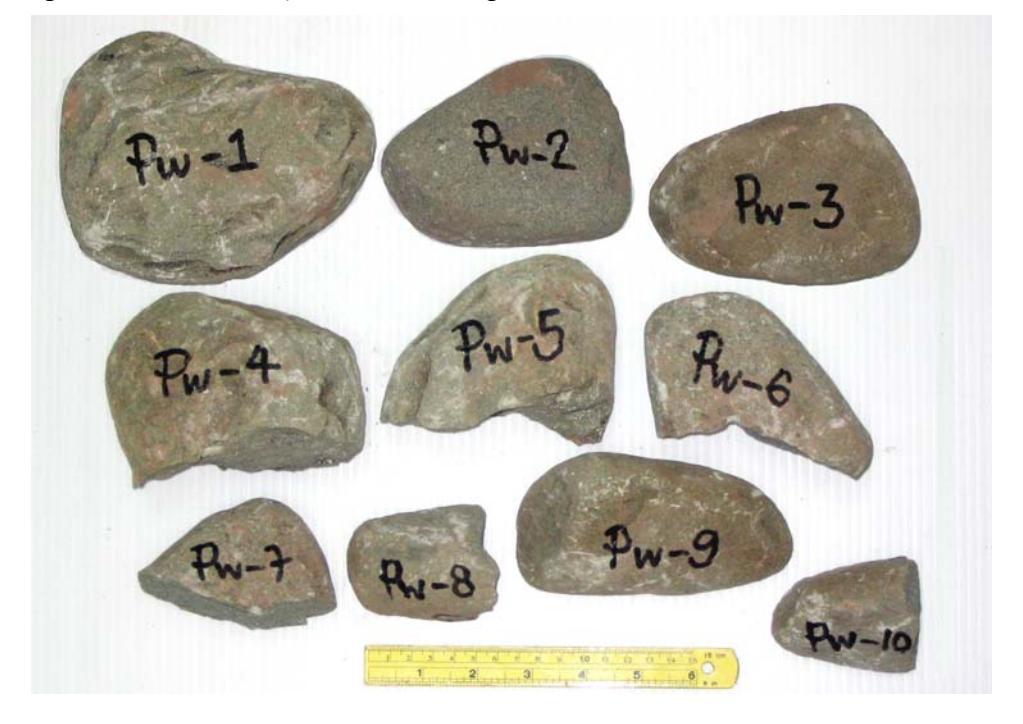
Appendix B-5 Characteristics of ten rock specimens of Phra Wihan sandstone/siltstone (lithologic unit Pw) before point load testing

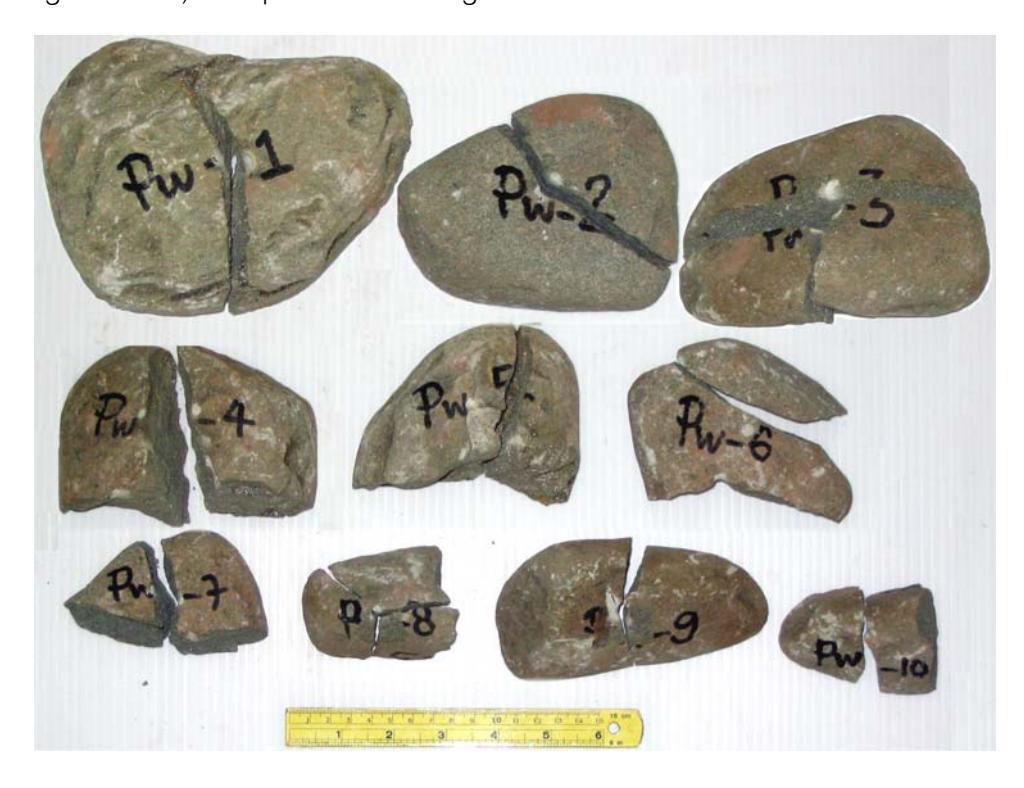
Appendix B-6 Characteristics of ten rock specimens of Phra Wihan sandstone/siltstone (lithologic unit Pw) after point load testing

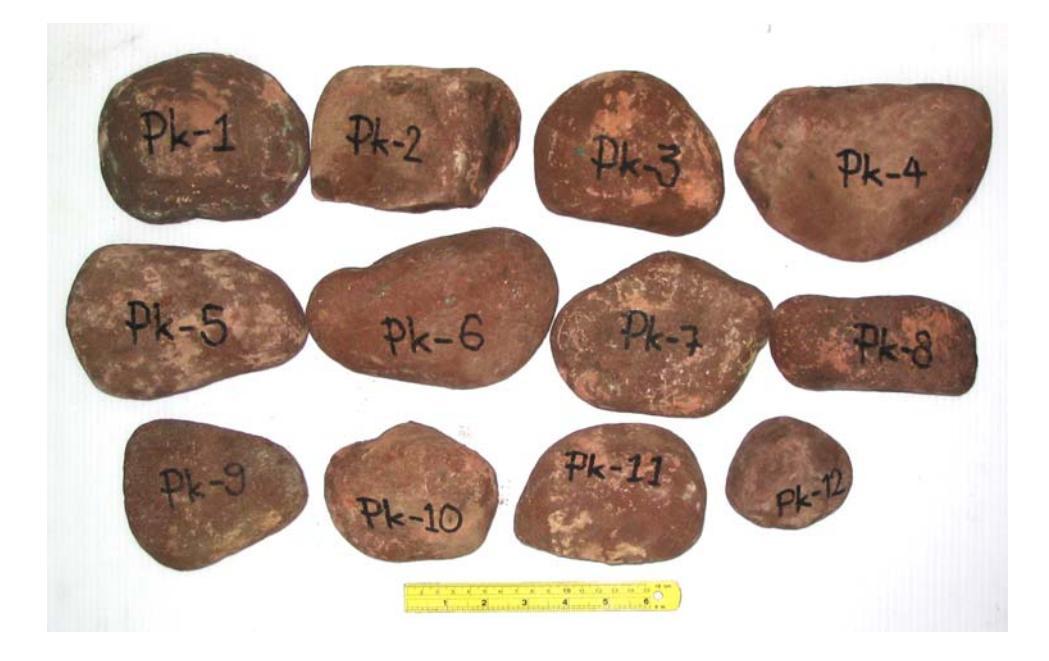
Appendix B-7 Characteristics of twelve rock specimens of Phu Kradung sandstone/siltstone (lithologic unit Pk) before point load testing

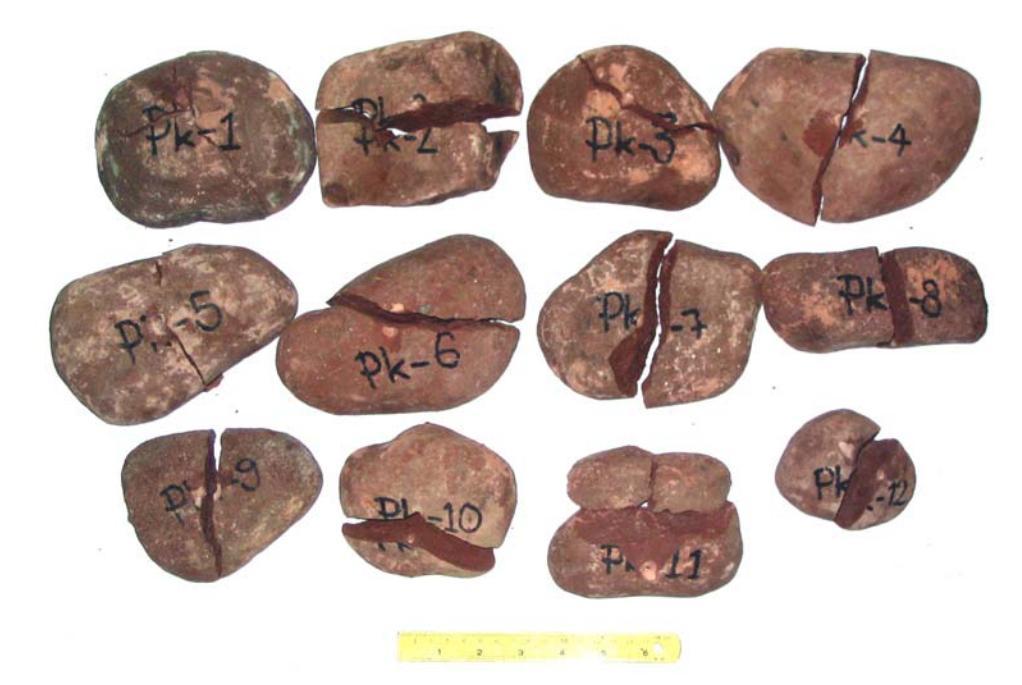
Appendix B-8 Characteristics of twelve rock specimens of Phu Kradung sandstone/siltstone (lithologic unit Pk) after point load testing

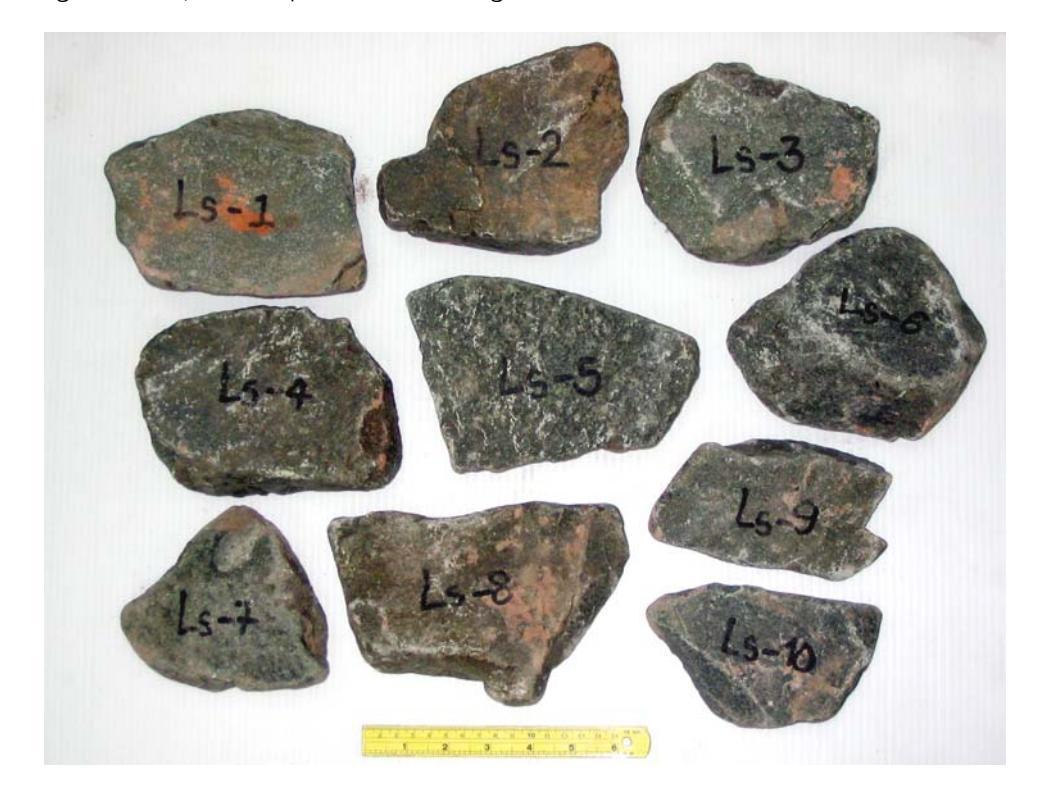
Appendix B-9 Characteristics of ten rock specimens of Lom Sak volcanic complex (lithologic unit Ls) before point load testing

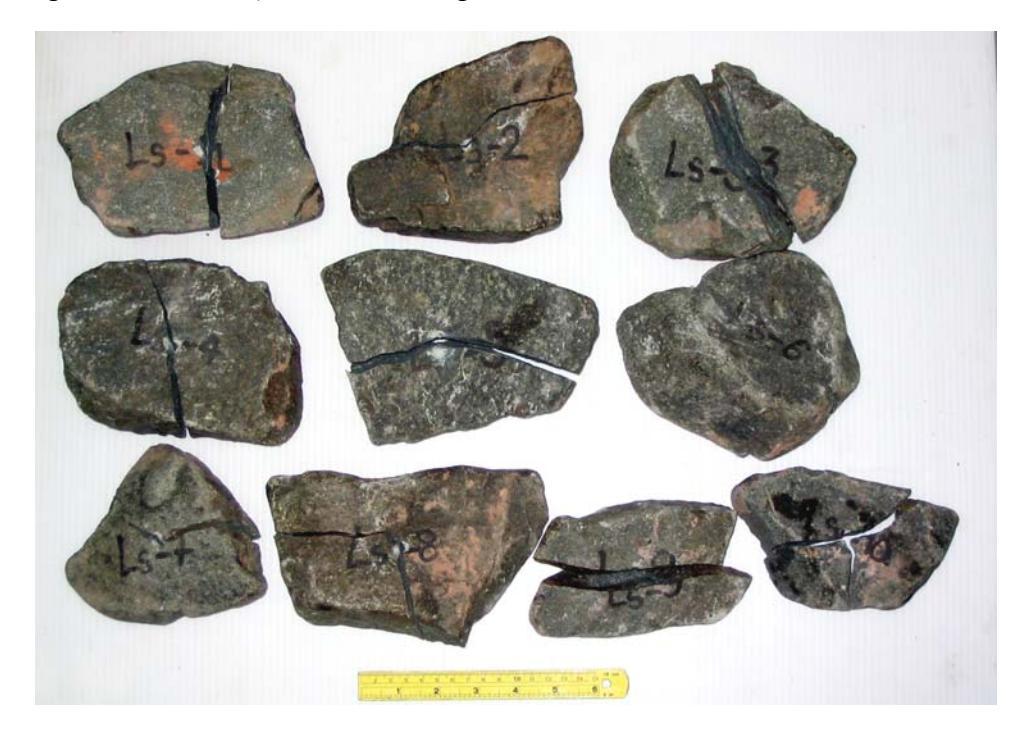
Appendix B-10 Characteristics of ten rock specimens of Lom Sak volcanic complex (lithologic unit Ls) after point load testing

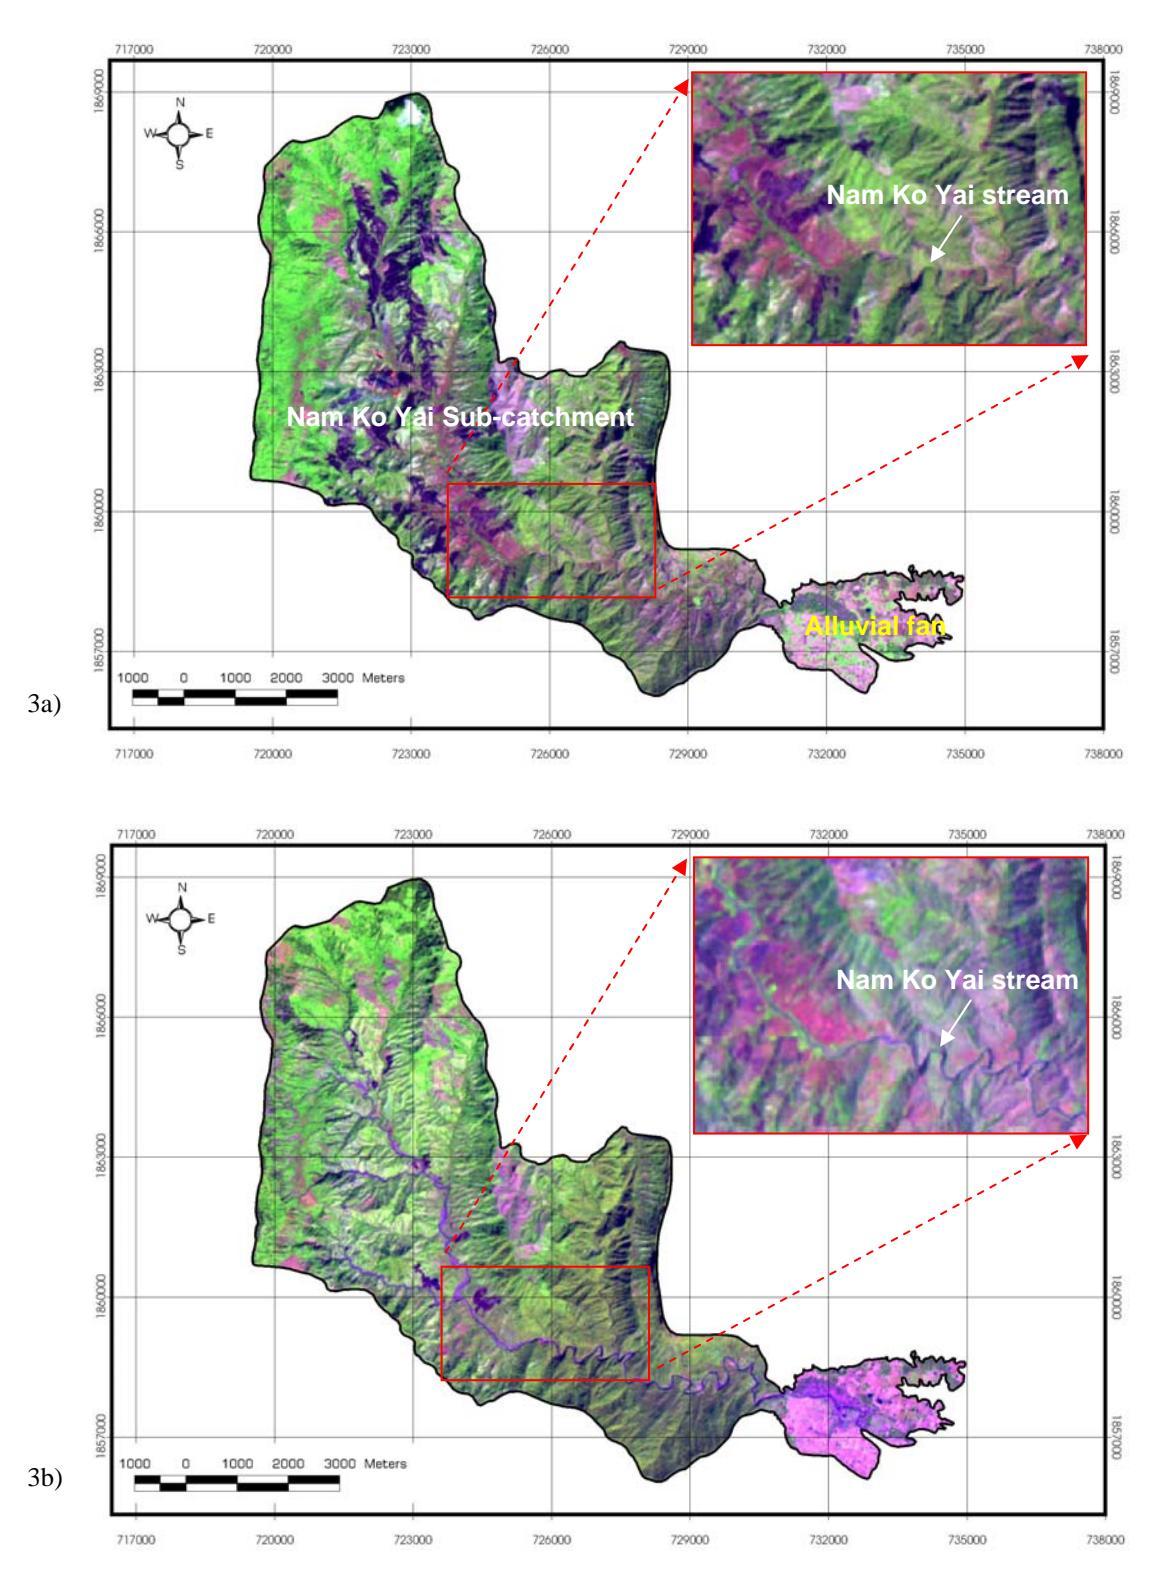
Two sets of multi-spectral Landsat imageries of different periods, one on 5 January 2001 (before 8/11) and the other on 21 November 2001 (after 8/11), were classified (Fig. 3). Preprocessing of the six spectral bands of these Landsat imageries involve an atmospheric correction based on the standard atmosphericmodel approach. Orthorectification was accomplished using GIS vectors of roadand stream data, as well as a DEM interpolated from contour vectors (1:25,000 scale). Slope and terrain aspect were calculated from the DEM. A Normalized Different Vegetation Index (NDVI) was created from the red and infrared spectral bands. NDVI was used to establish a threshold of vegetated and unvegetated pixels in the images for change detection at the scar-scouring and depositional locations (Fig. 4).

Fig. 3 3a) False color composite of Landsat 7 ETM+ (R=5, G=4, B=3) of the study area acquired on 5 January 2001 (before the debris flow and debris flood occurrence); and

3b) false color composite of Landsat 7 ETM+ (R=5, G=4, B=3) of the study area acquired on 21 November 2001 (after the occurrence) that show the distinctively changed features, especially in the main channels of Nam Ko Yai stream and its alluvial fan just below the canyon mouth

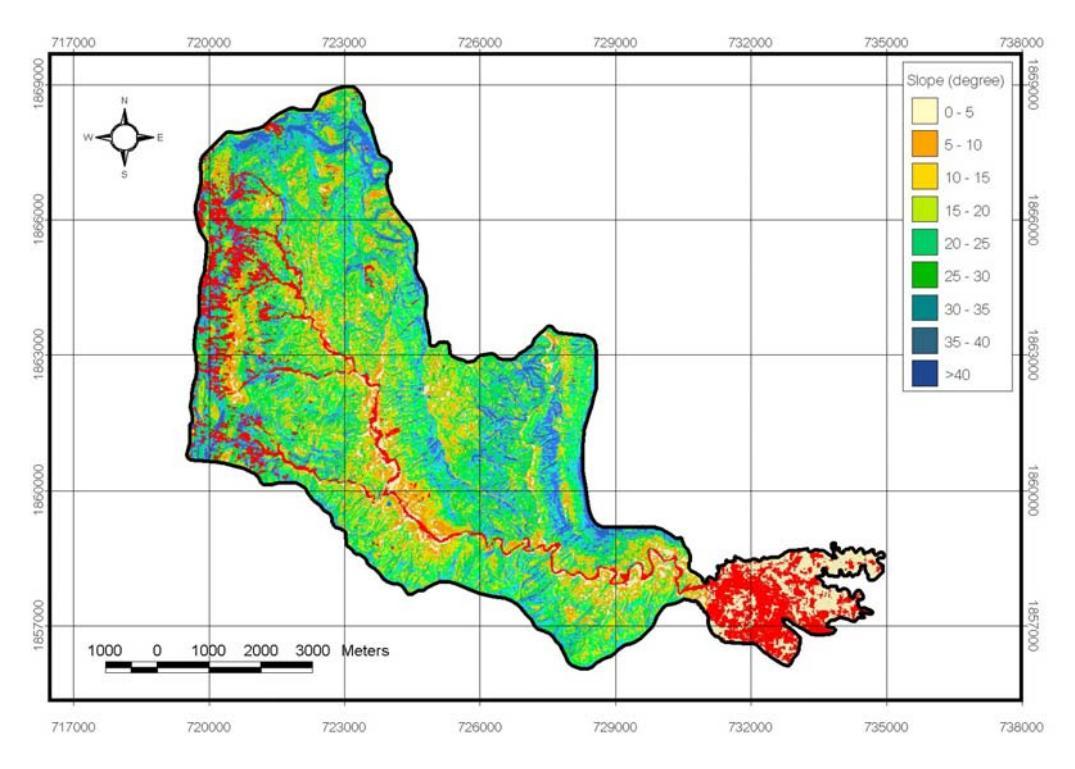
For slope configuration (Fig. 6), it was concluded that the steeper the slope, the greater the landslide probability was. For the slope inclination of 35-40° and more than 40°, the ratios were 1.57 and 1.70, respectively, indicating a slightly high probability for the scar-scouring occurrence in both cases.

Fig. 6 Slope map overlain with scars-scouring and depositional locations (in red) in the study area

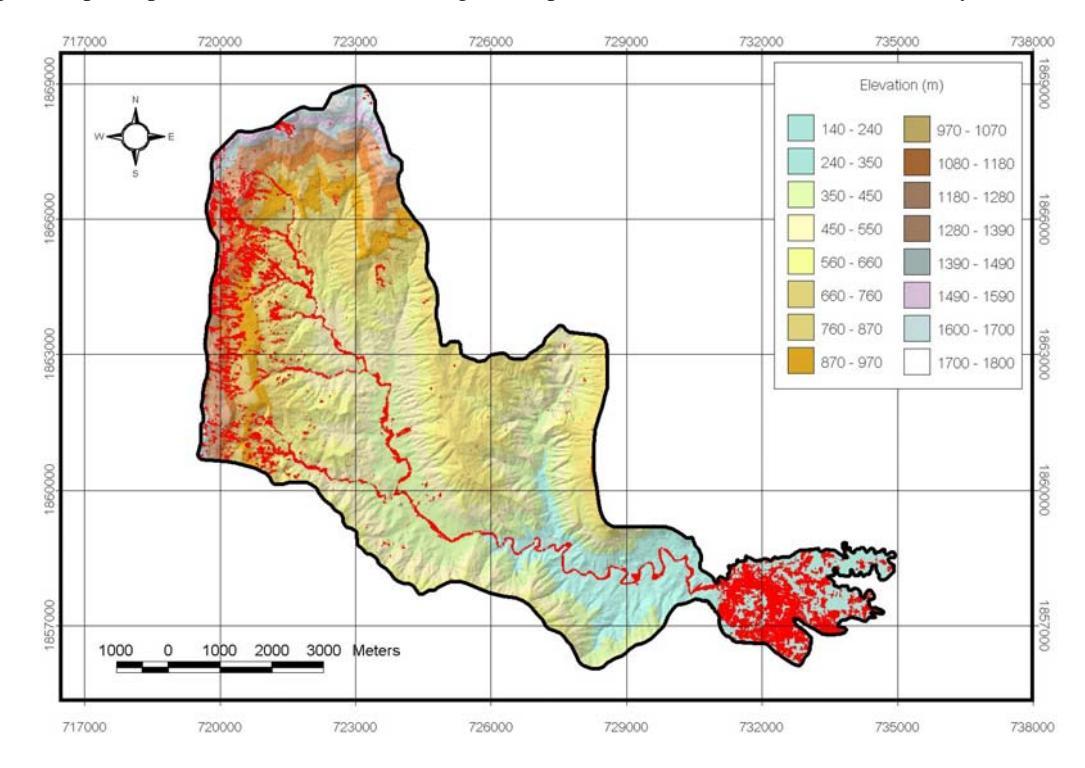
For elevation above mean sea level (Fig. 7), the higher elevation, the greater the scar-scouring probability. For elevations between 1,000-1,100; 1,100-1,200; 1,200-1,300; and 1,300-1,400 m, the ratios were 3.16, 3.41, 3.99, and 2.54, respectively, indicating a very high probability for scar-scouring. Similar elevation ranges were observed in the steep-cliff areas.

Fig. 7 Elevation map overlain with scar-scouring and depositional locations (in red) in the study area

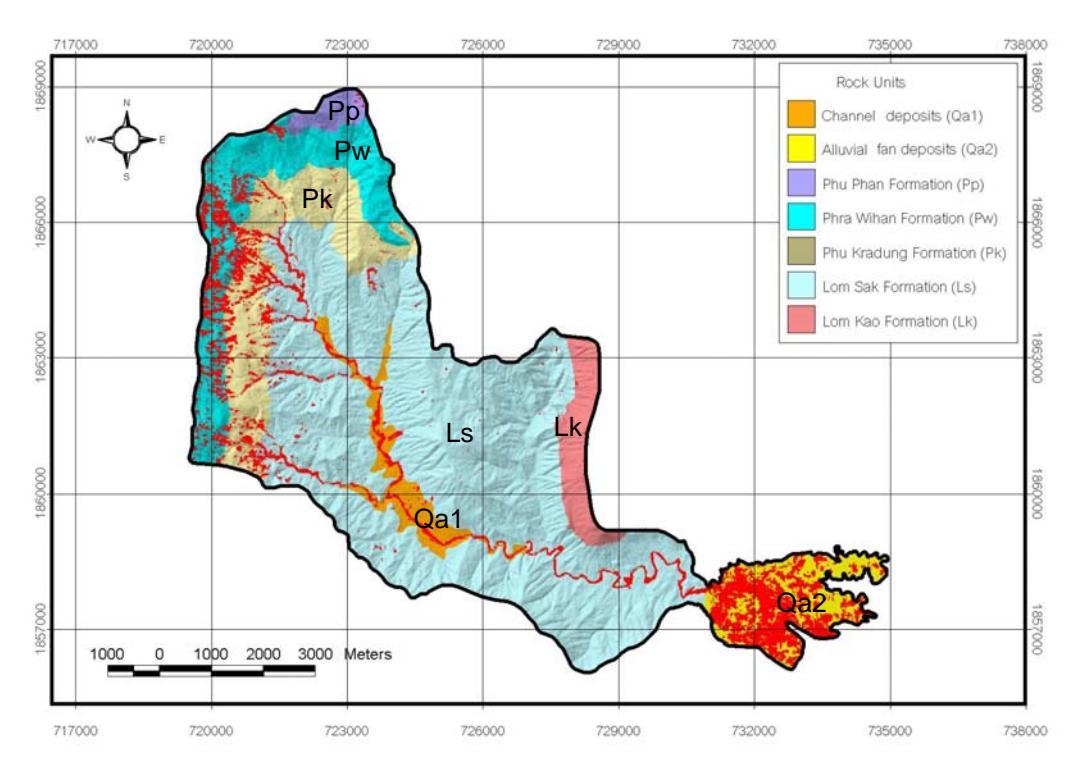
The different topographic units, peak, ridge, saddle, flat, ravine, pit, convex hillside, concave hillside, slope hillside, inflection hillside, saddle hillside, seemed to be less significant. The frequencies of scar-scouring locations for any specific topographic shape were varied. The frequencies of scar-scouring as related to the lithologic groups (Fig. 8) were determined for the different stratigraphic units. In the alluvial deposits (Qa1), Phra Wihan (Pw), Phu Kradung (Pk) and Lom Sak (Ls) Formations, the ratios were 3.188, 3.079, 2.302, and 2.713, respectively, indicating very high probabilities for scar-scoring occurrence in all units.

Fig. 8 Rock unit map overlain with scar-scouring and depositional locations (in red) in the study area

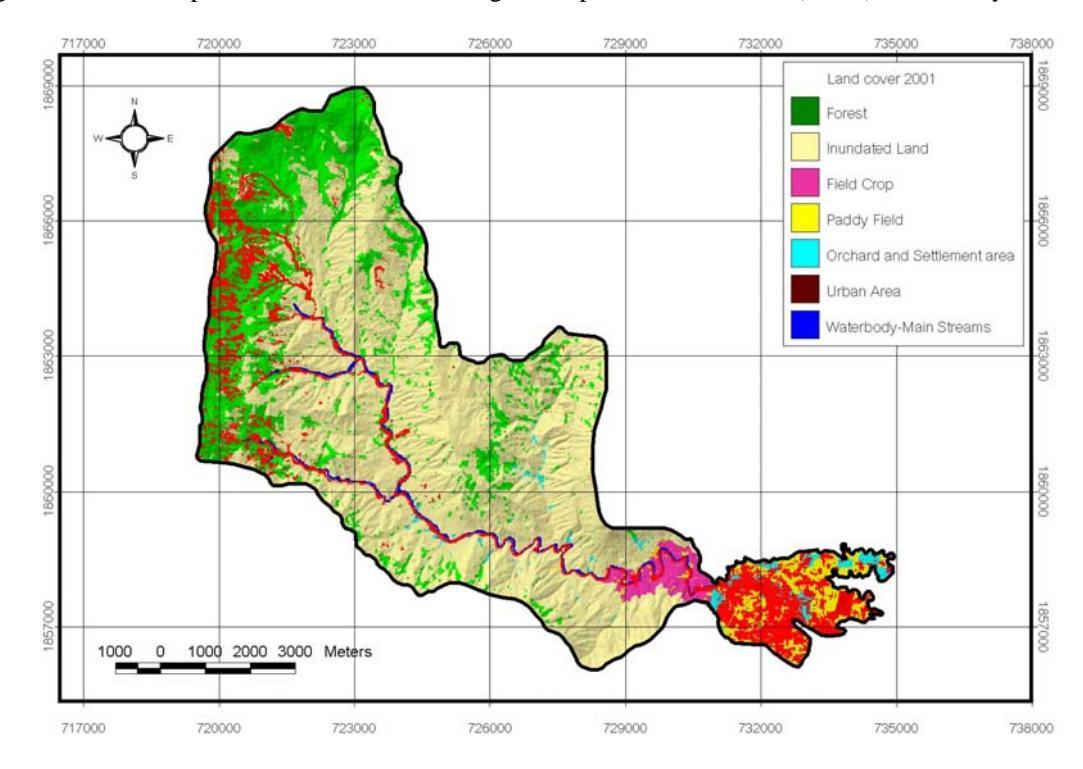
The relationship between the scar-scouring and different types of land cover (Fig. 9) was also determined. The study revealed a high probability value on the banks close to the stream course and in forest areas further away, but lower in the cultivated flat areas. This is contrary to a general belief that cultivated lands played a major role in this event. The explanation could be that the debris flow-flood occurred close to the main stream where there was high energy for erosion and transportation of sediments, and in the forested areas where water could be accumulated and retained to introduce more effective transport when the catastrophic event occurred.

Fig. 9 Land cover map overlain with scar-scouring and depositional locations (in red) in the study area

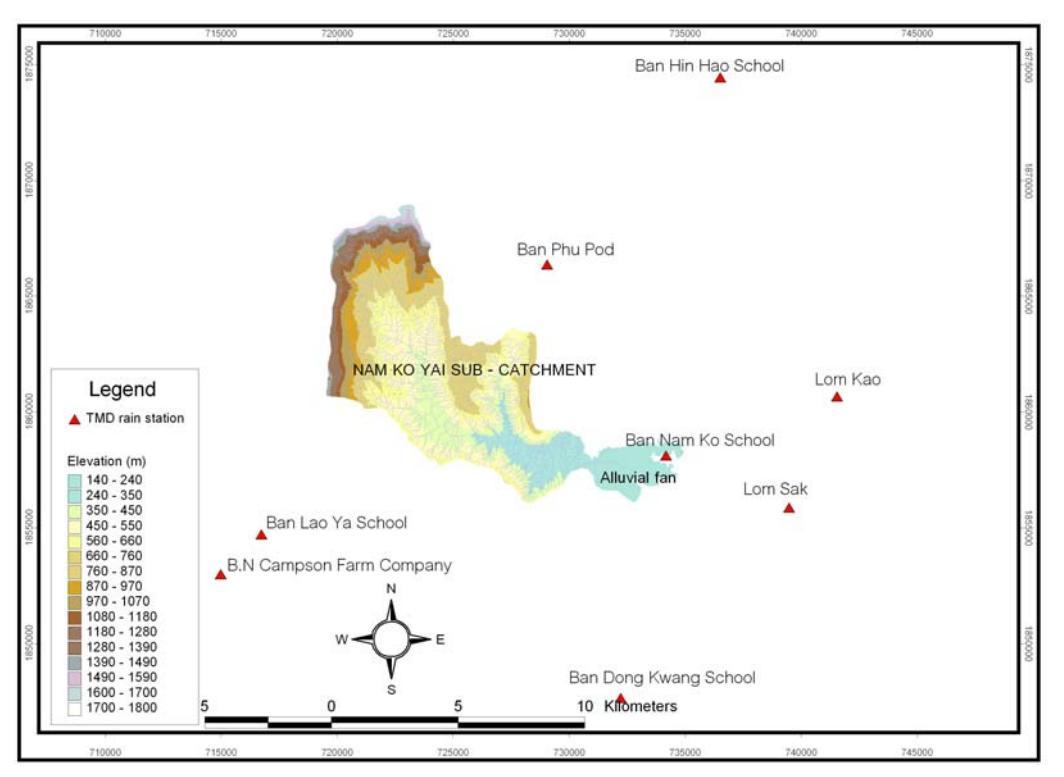
Fig. 10 Location of seven TMD (Thai Meteorological Department) rainfall measurement stations (red triangles) near the study area

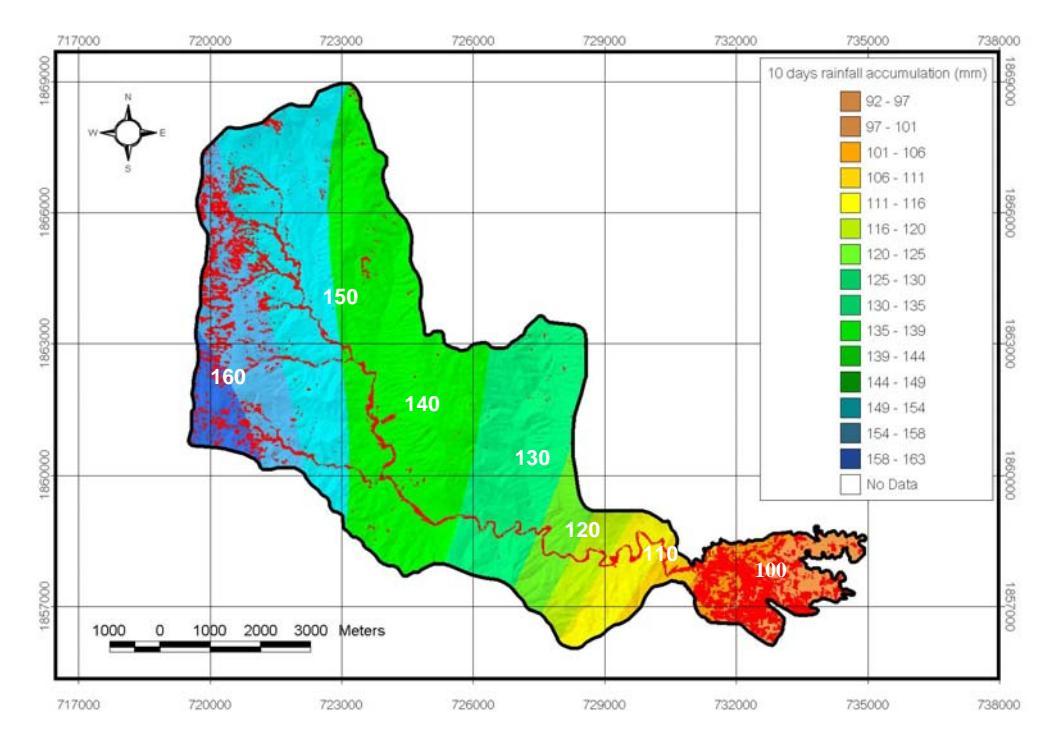
The rainfall records during 1-10 August 2001, a period of 10 days before the 8/11 occurrence, were collected from seven surrounding rain-gauge stations (Fig. 10). The frequency of scar-scouring was determined by counting the scar-scouring locations in each isohyet range of rainfall accumulation. The results revealed a high probability value of scars-scouring locations in the western areas where the rainfall accumulation was over 150 mm during this period (Fig 11).

Fig. 11 Rainfall accumulation in the period of 1-10 August 2001 (before the 8/11 debris flow and debris flood occurrence) overlain with scar-scouring and depositional locations (in red) in the study area

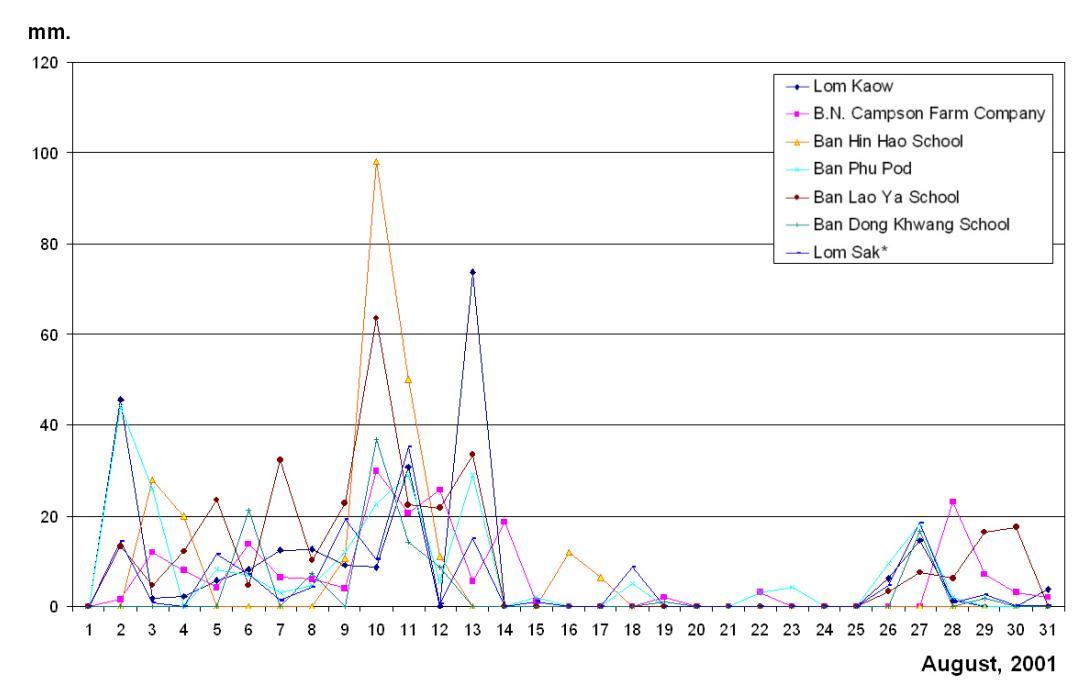
In addition, the rainfall data and the inflow hydrograph from rainfall data of 1-10 August 2001 (pre-8/11 period) in related to the configuration of sub-catchment and channel characteristics were analyzed. The result was used as one of the most critical factors to identify the potential for the debris flow-flood. The graph of rainfall measurements in August 2001 from seven surrounding locations (Fig. 10) is presented in Figure 12. The average 24-hour rainfall value of pre-8/11 period was 12.98 mm. The two highest values of about 60 and 100 mm recorded on 10 August 2001 at the Ban Lao Ya station (southwest of the study area) and Ban Hin Hao station (northeast of the study area), respectively. The pattern of rainfall during 1-11 August 2001 recorded in most stations was the same as that of continuous rainfall during 2 - 14 August 2002.

Fig. 12 The graph showing the pattern distribution of rainfall measurements in August 2001 recorded from the seven locations (Fig. 10) near the study area

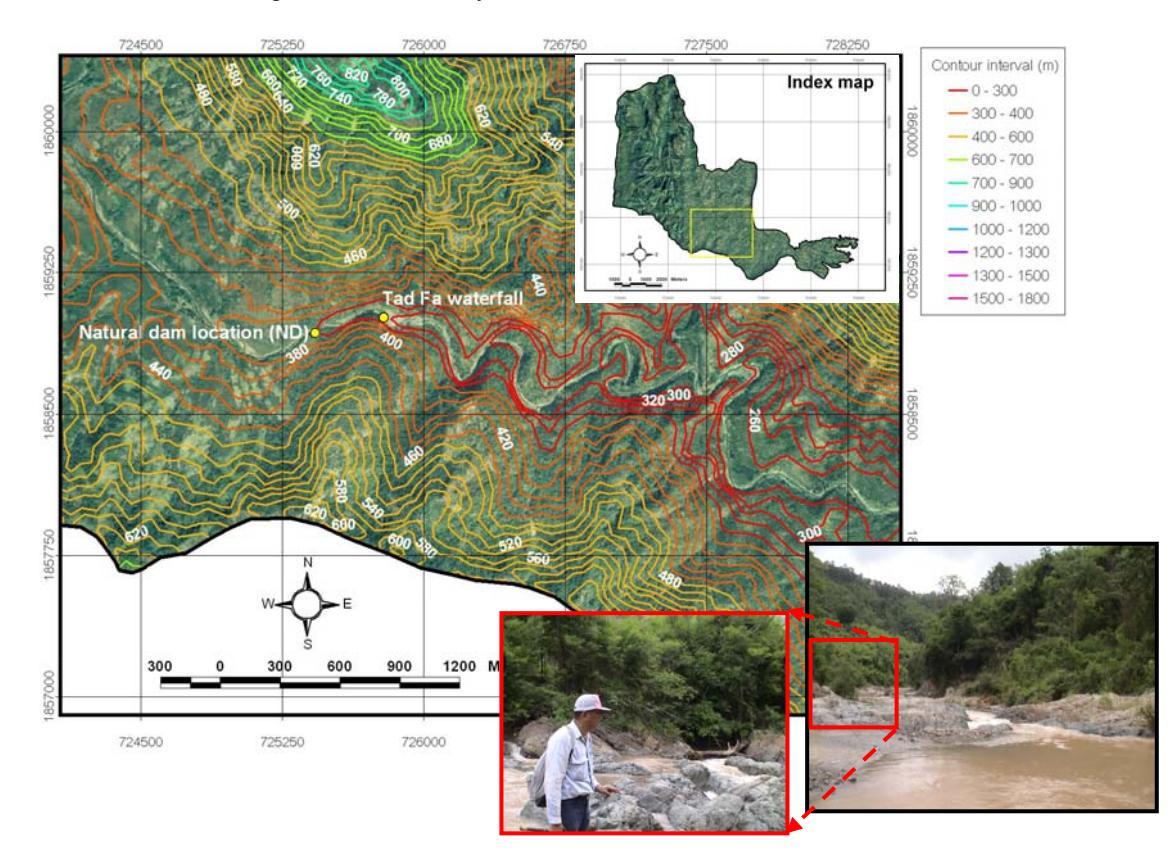
From field investigations and rectified orthophotograph interpretation at a point along the course of Nam Ko Yai stream in the middle of the study area, the stream here issues from a flat open land to a very narrow V-shape channel with a sudden change of elevation at Tad Fa waterfall (Fig. 13). It could be hypothesized that this specific location is suitable for an accumulation of sediments composed of plant debris, soils, and rock boulders to form a natural dam. A field check revealed fallen trees and vegetation traces. This probably indicated that the temporary natural dam was broken, sending the debris and water to flood further downstream, eroding the channel along the way, and finally dropping its load on the alluvial fan at the canyon mouth. The evidences of 8/11 event could be observed where Nam Ko Yai stream had a steep V-shape cross-section. The traces of the erosional feature in the outer curving-bank were common. Some huge logs or intertwined bamboo clumps were left in the channel. Newly deposited large boulders were found in the channel where the gradient of stream bed changes from steep to flat. Eroded soil banks were also common.

Fig. 13 The orthophotograph rectified image (1:25,000 scale, January 9, 2002 after the 8/11 event) overlain with the contour intervals (20 m) showing the specific configuration of Nam Ko Yai stream located in the lower central part of the study area proposed to be the natural dam location (ND) in front of the location of Tad Fa waterfall

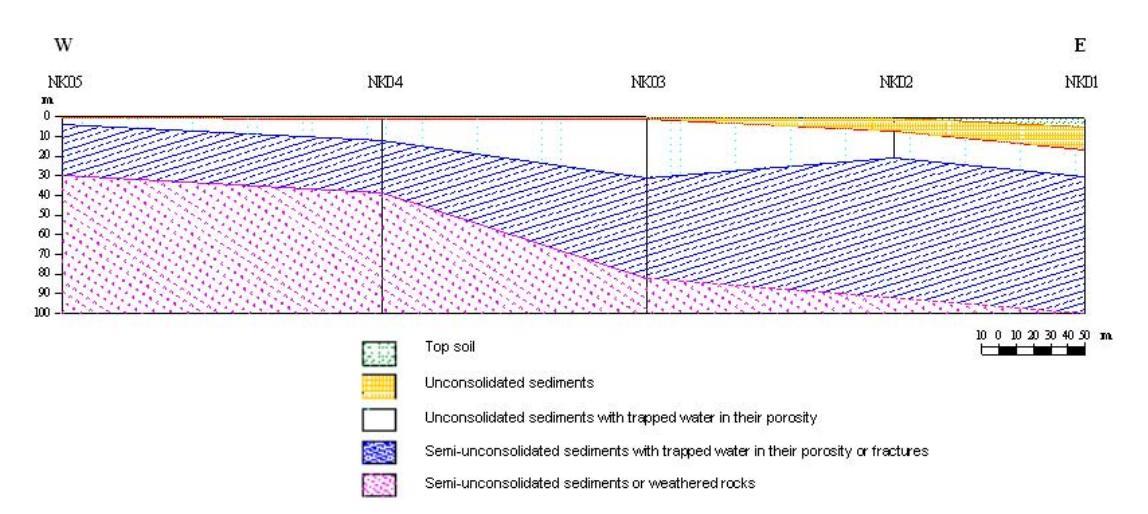
The results of the resistivity survey investigated along the lines NK 01 - NK 05 (Fig. 18) to identify the local three-dimensional geology (thickness and depth of the older alluvial deposits), revealed four sedimentary units at a total depth of less than 100 m below the ground surface. The lowest unit was semi-unconsolidated sediments or weathered rocks of at least 70 m thick to the west with the bed top at a depth of about 30 m below ground surface (Fig. 18), and much thinner, less than 10 m to the east, with the bed top be noted at a depth of about 80 m below the ground surface. The overlying second unit was semi-unconsolidated sediments with trapped water in the bed openings. Thickness was 25-70 m and increased to the east. Its shallow horizon was 5 m below ground surface in the

Fig. 18 The cross-section of the resistivity survey interpreted from the five survey points (NK 01 - NK 05 as shown in Fig. 19) that revealed four sedimentary units lying less than 100 m below ground surface

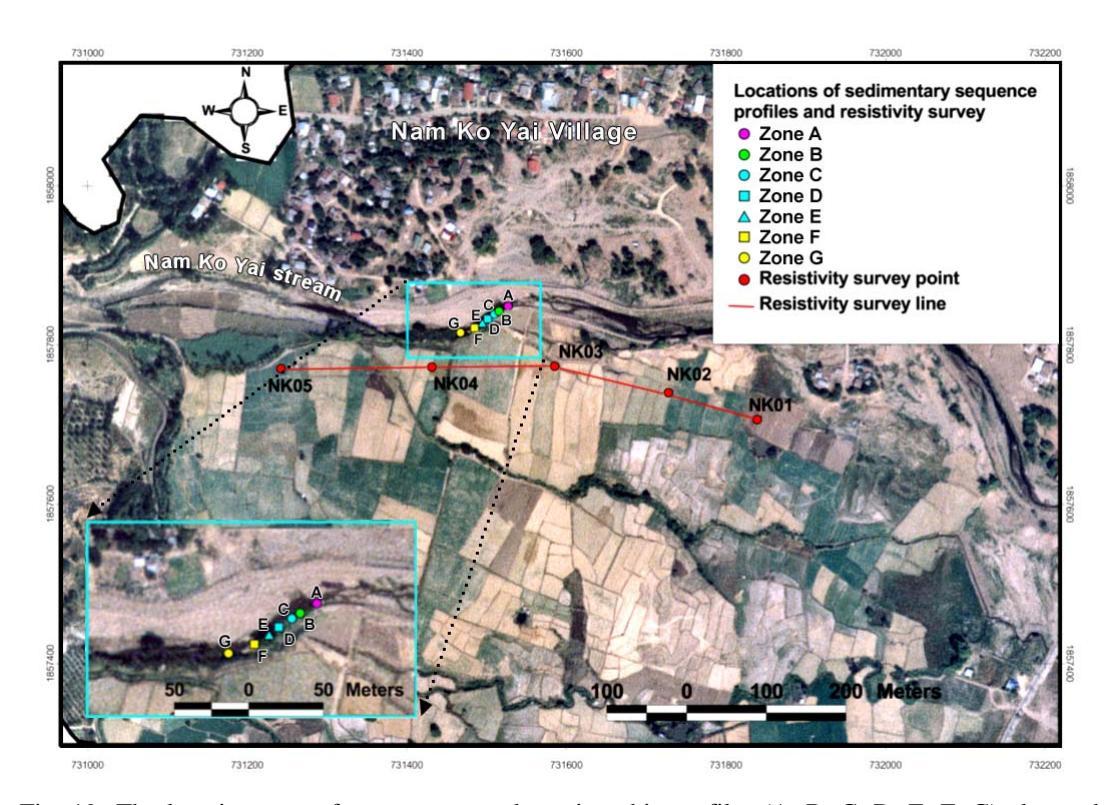
A detailed field study of the previous alluvial fan deposits in the fourth unit was conducted along a 5x70 m eroded bank of Nam Ko Yai stream near where the resistivity survey had been performed. Seven stratigraphic profiles were studied to reveal sedimentary sequences in both terms of vertical and lateral stratigraphic correlation. The location map of the measured stratigraphic columns and the line of resistivity survey points are shown in Figure 19 and the actual profiles in Figure 20.

Fig. 19 The location map of seven measured stratigraphic profiles (A, B, C, D, E, F, G) along the eroded bank of Nam Ko Yai stream, and a line of five resistivity survey points (NK01 – NK05) used for investigating the stratigraphy, sedimentology and subsurface geology of the older alluvial fan deposits

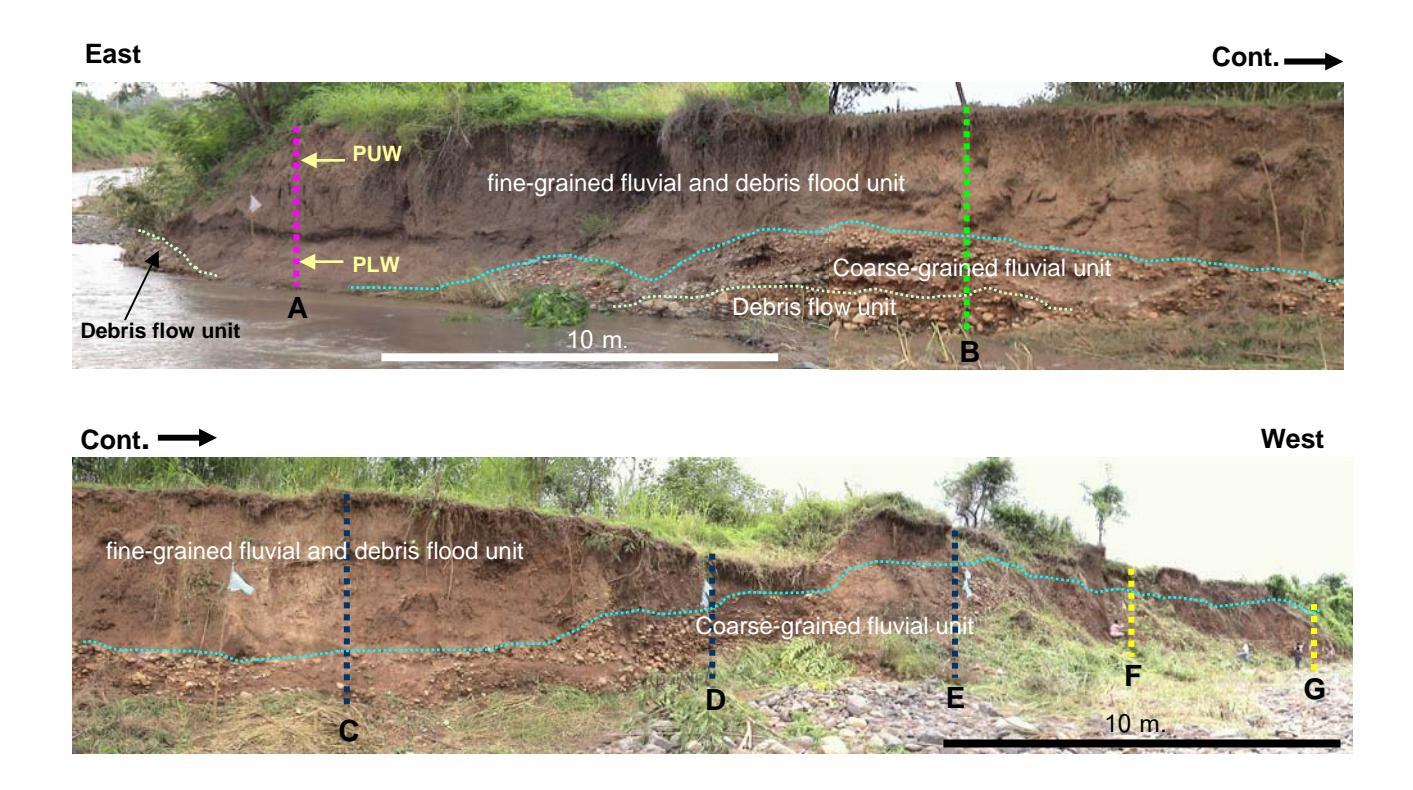
In the observed sections, the lowest sedimentary unit of the older alluvial fan deposits was a debris flow unit of floating texture, unsorted, and un-stratified material that was exposed in the stream-bed only in the eastern part. The coarsegrained fluvial unit of clast-supported texture and fining-upward graded bedding was transitionally deposited on top of the debris flow unit, especially in the middle part, and extended westward (upstream). This coarse-grained fluvial unit was the thickest in the western part and became thinner to the east. The uppermost part of this eroded-bank profile was a fine-grained fluvial and debris flood unit that was dominantly deposited to form a sharp contact on top of the coarse-grained fluvial unit. The uppermost unit is thicker to the east, especially in the eastern part. The representative and complete detailed sedimentary and stratigraphic characteristics in vertical succession are shown in Figure 21, from bottom to top, the debris flow unit, the coarse-grained fluvial unit, and the fine-grained fluvial and debris flood unit, respectively.

Fig. 20 The lateral and vertical stratigraphic characteristics of debris flow and debris flood deposits of older alluvial fan along the eroded-bank of Nam Ko Yai stream with the locations of those seven measured stratigraphic profiles (A, B, C, D, E, F, G)

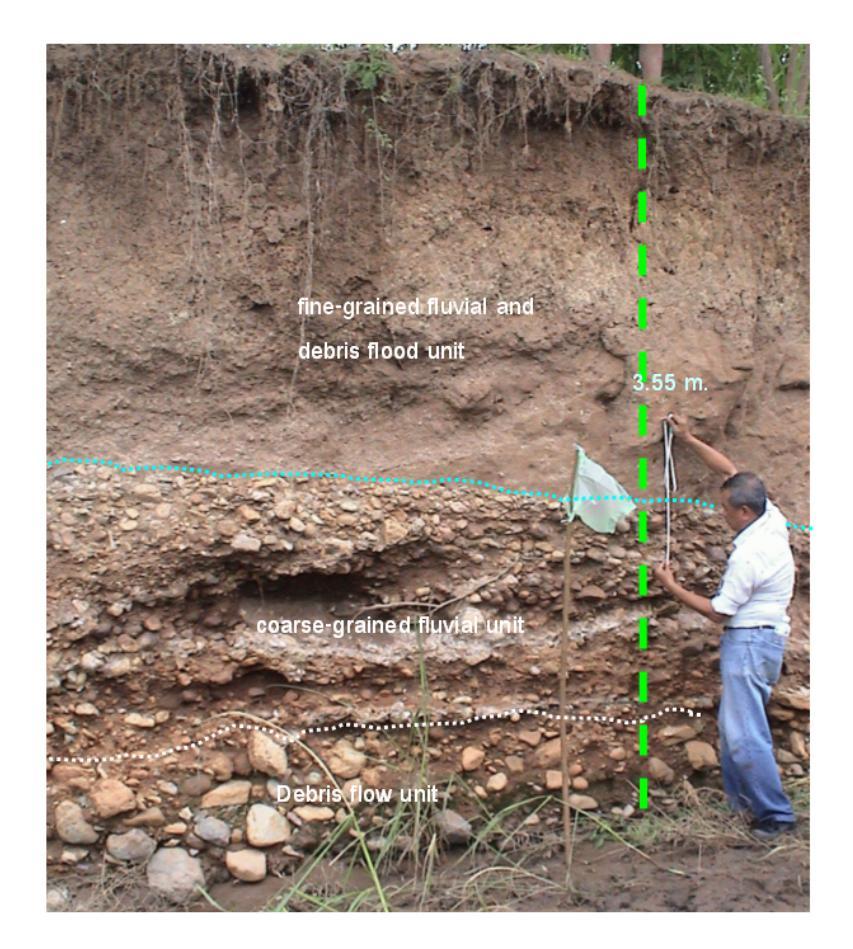
Fig. 21 The measured stratigraphic profile B showing the debris flow unit underlain by the coarsegrained fluvial unit with the transitional contact, and the uppermost fine-grained fluvial and debris flood unit overlying on top of the coarse-grained fluvial unit with a sharp contact
