CHAPTER 6

EVIDENCES OF DEBRIS FLOW-FLOOD ACTIVITIES IN THE ALLUVIAL FAN

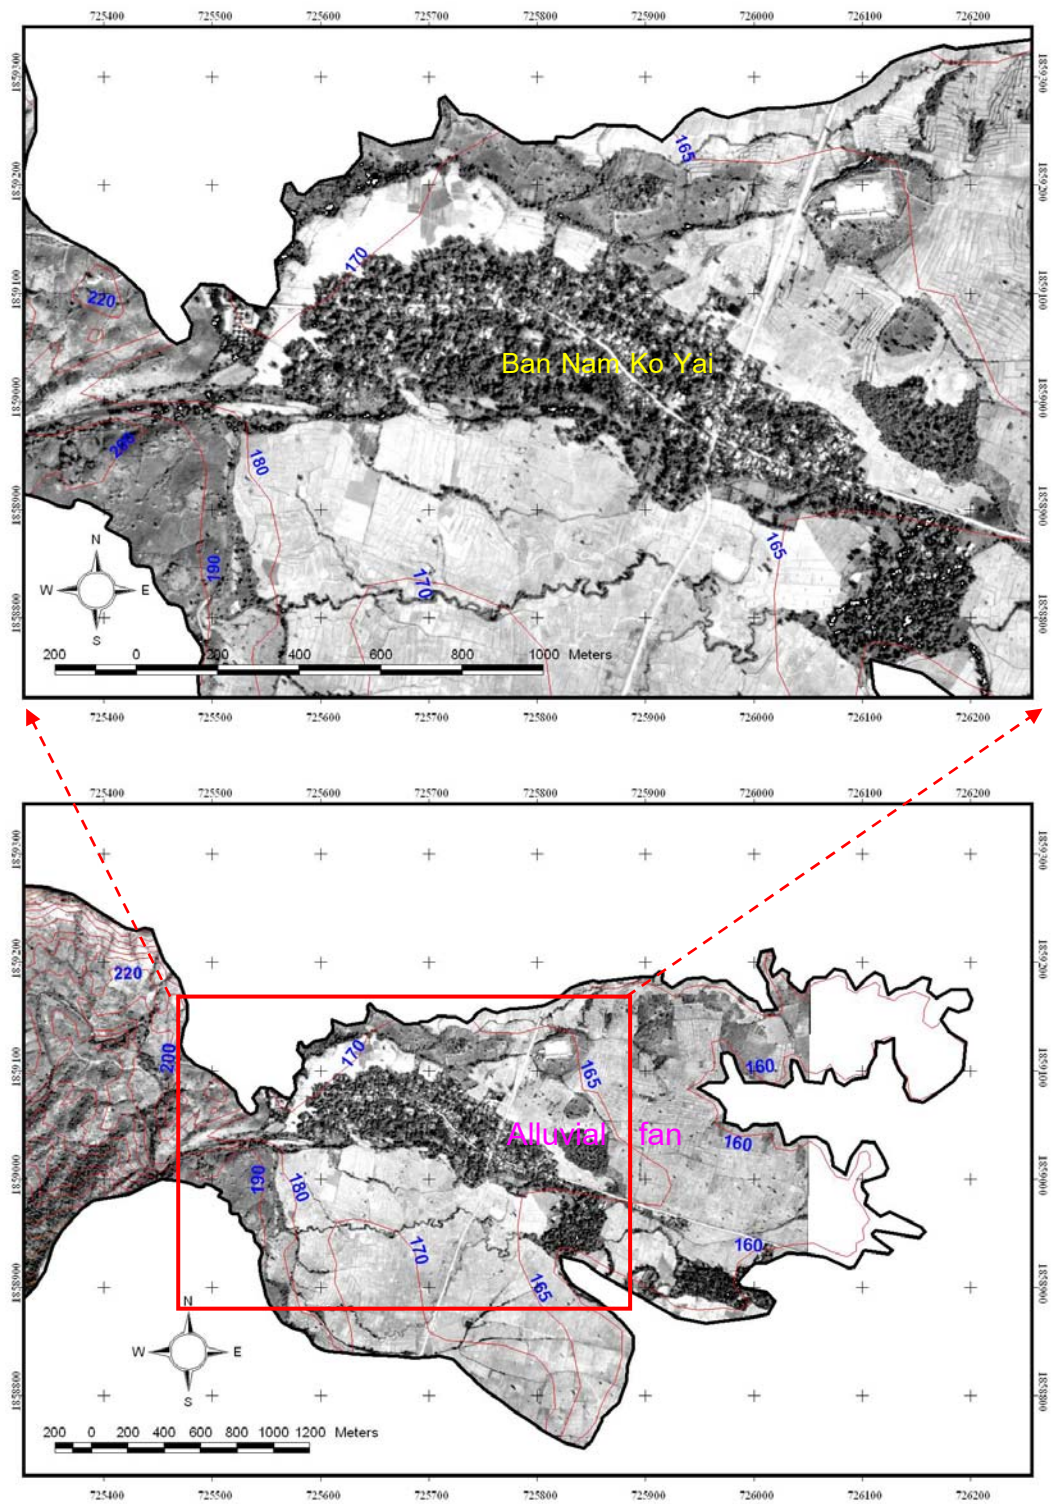
Figure 6-1 Aerial photograph (1:15,000 scale) acquired on 24th December 1974 showing characteristics of the alluvial fan at the canyon mouth of Nam Ko Yai stream with contour intervals (in the solid red-line block).

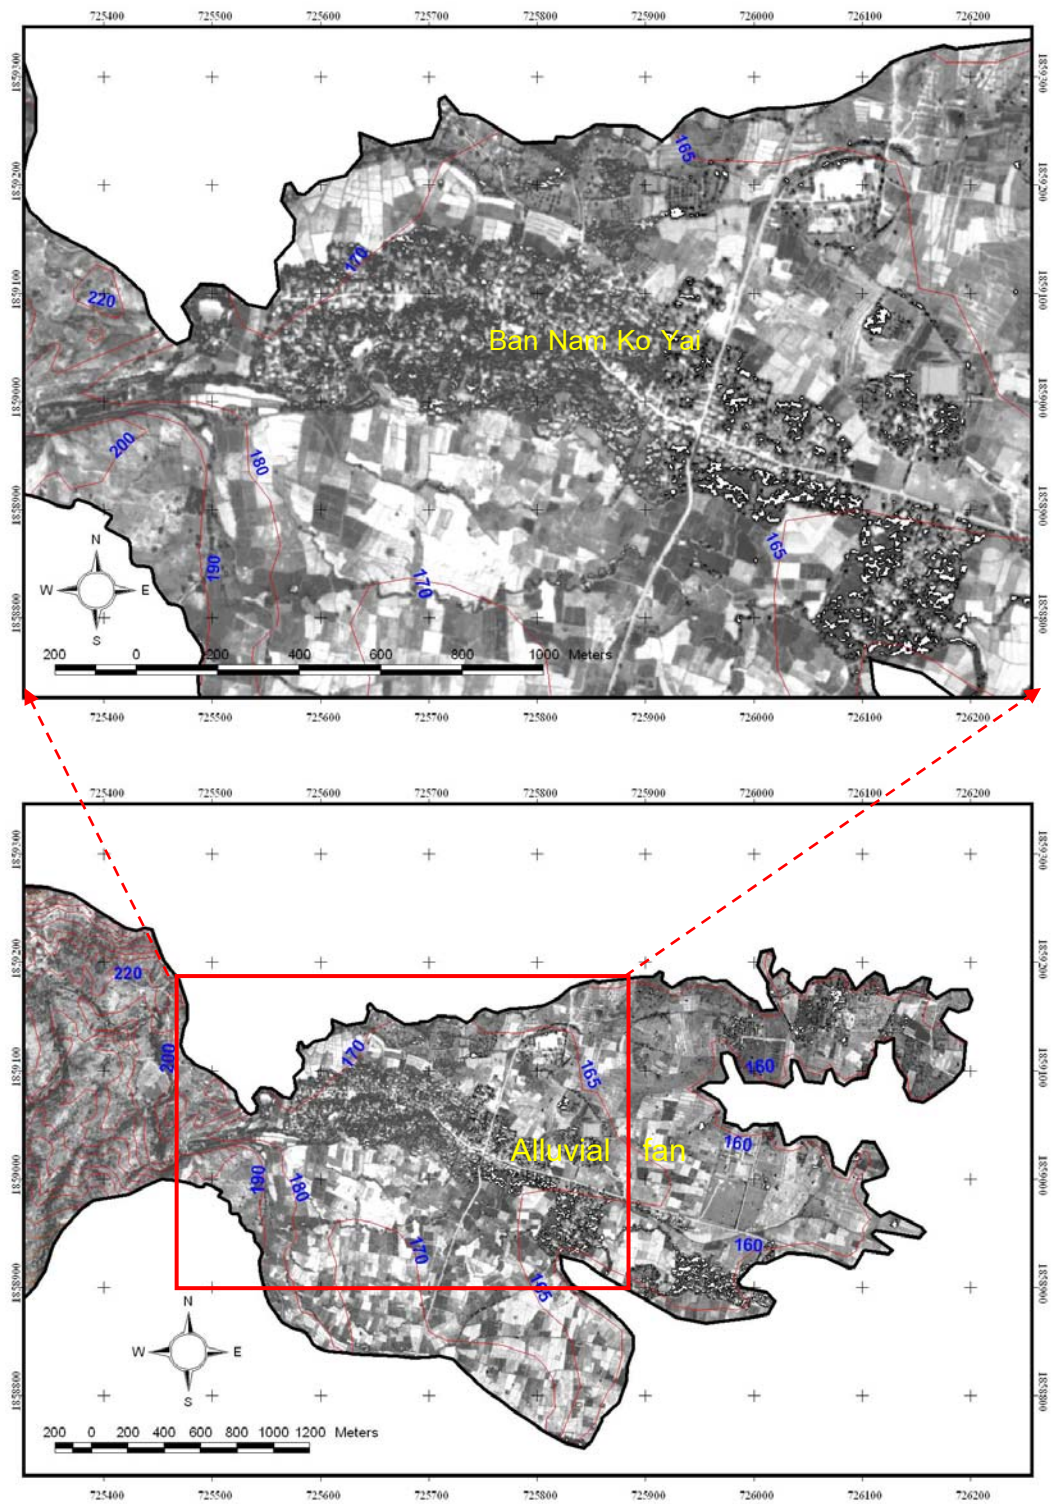
Figure 6-2 Orthophotograph (1:50,000 scale) acquired on 6th January 1996 showing characteristics of the alluvial fan at the canyon mouth of Nam Ko Yai stream without significant change in land cover.

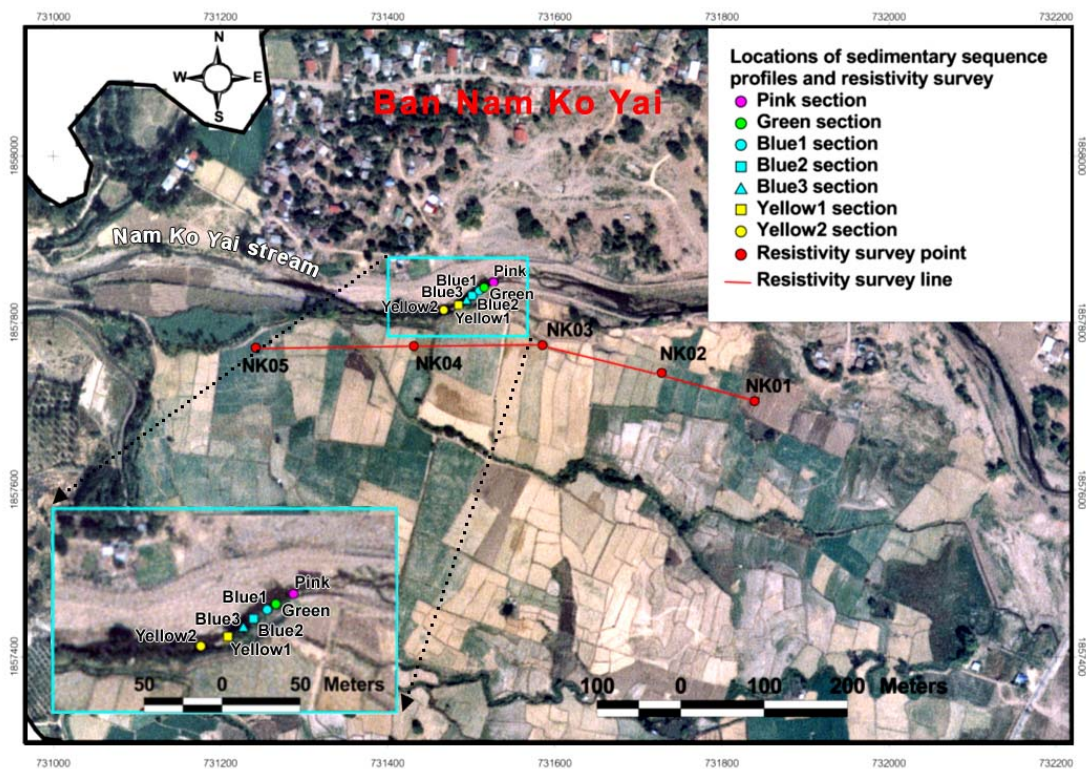
Figure 6-9 Location map of the seven measured stratigraphic profiles and a line of five resistivity survey points used for investigating the stratigraphic recognition and local subsurface geology of the previous alluvial fan deposits.

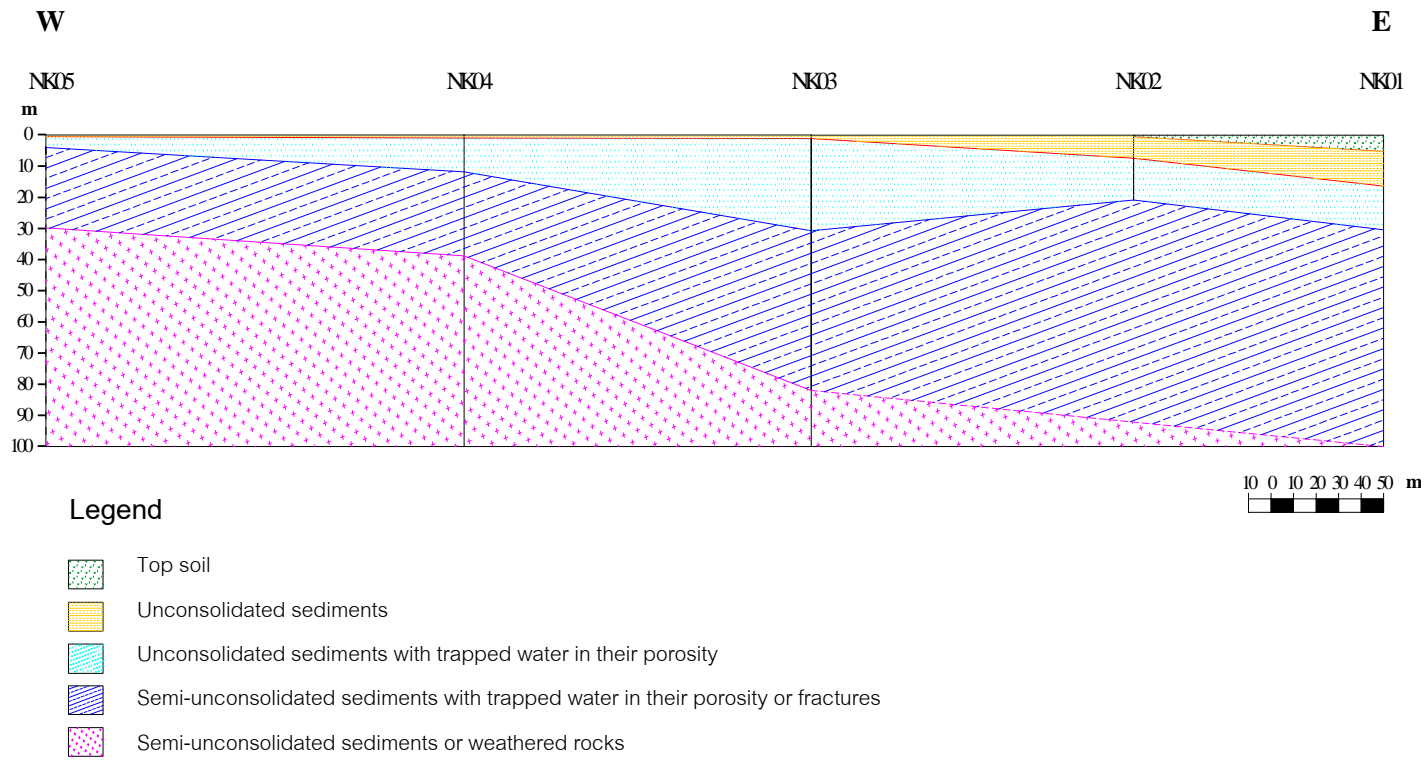
According to the resistivity survey in the alluvial fan along the lines NK 01 – NK 05 (as shown in Figure 6-9) to identify the local subsurface geology (thickness and depth of the previous alluvial fan deposits), the results revealed four sedimentary units at a total depth of less than 100 m below ground surface (Figure 6-10). The lowest unit was semi-unconsolidated sediments or weathered rocks of at least 70 m thick to the west with the bed top be noted at a depth of about 30 m below ground surface, and much thinner, less than 10 m to the east, with the bed top be noted at the depth of about 80 m below ground surface.

The overlying second unit was semi-unconsolidated sediments with trapped water in the bed openings. Thickness was 25-70 m and increased to the east. Its shallow horizon was 5 m below ground surface in the west to about 10-20 m to the east. These two lower units are never exposed near the site, but are at surface in the surrounding hills.

The third unit was unconsolidated sediments with trapped water. Thickness was in the range of 5-30 m. The thickest part of this third unit was near the NK 03 line in the central part, where the depth to the top of the unit was from a few meters down to 15 m below ground surface further to the east. The fourth and uppermost unit was of unconsolidated sediments with a thickness of a few meters in the west to 10 m in the east. The fourth unit was commonly exposed on the ground surface along all survey lines, except in the east where it was completely covered by recent topsoils.

Figure 6-10 Cross-section of the resistivity survey interpreted from the five survey points (NK 01 – NK 05 as shown in Figure 5-9) that revealed four sedimentary units lying less than 100 m below ground surface.

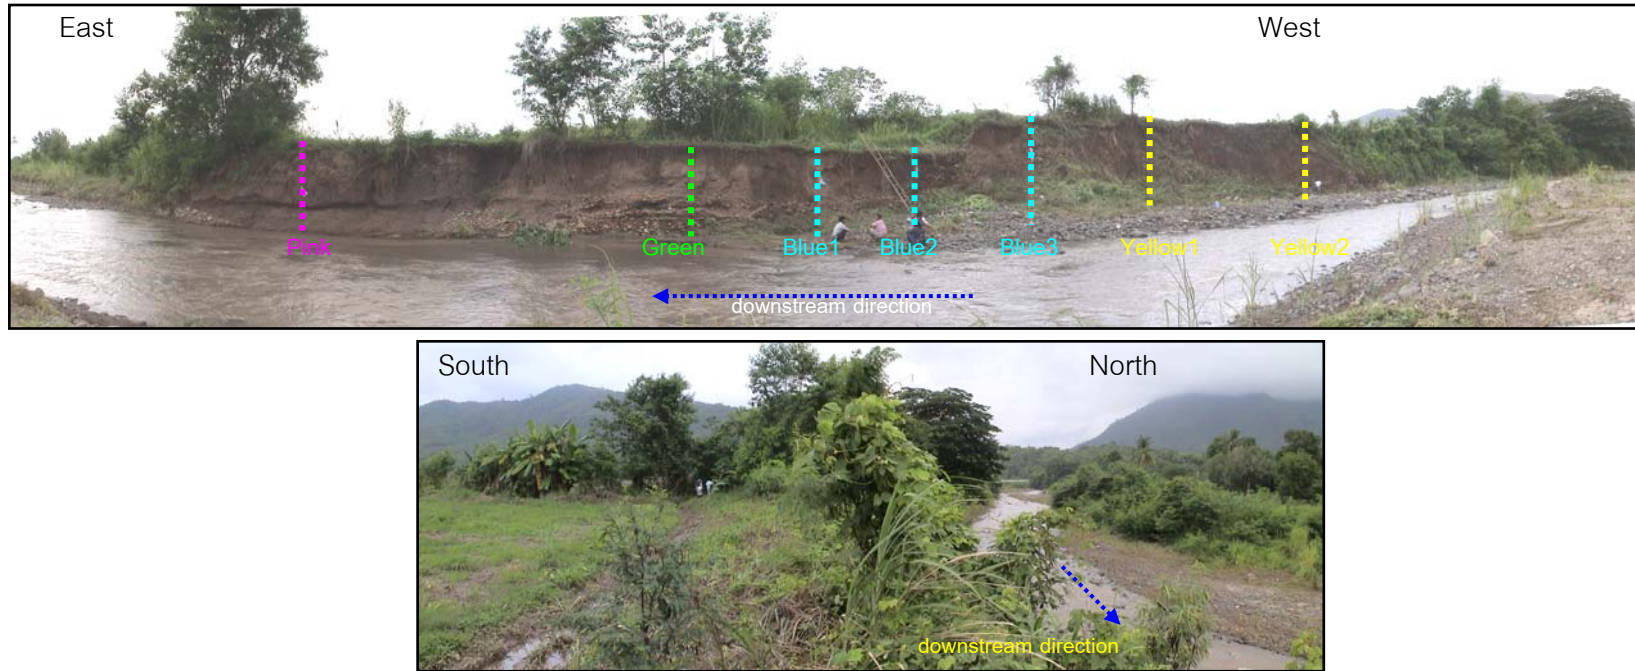
Figure 6-11 Photographs illustrating the actual location of the seven measured stratigraphic profiles (zones Pink, Green, Blue1, Blue2, Blue3, Yellow1 and Yellow2) along the eroded-bank of Nam Ko Yai stream.

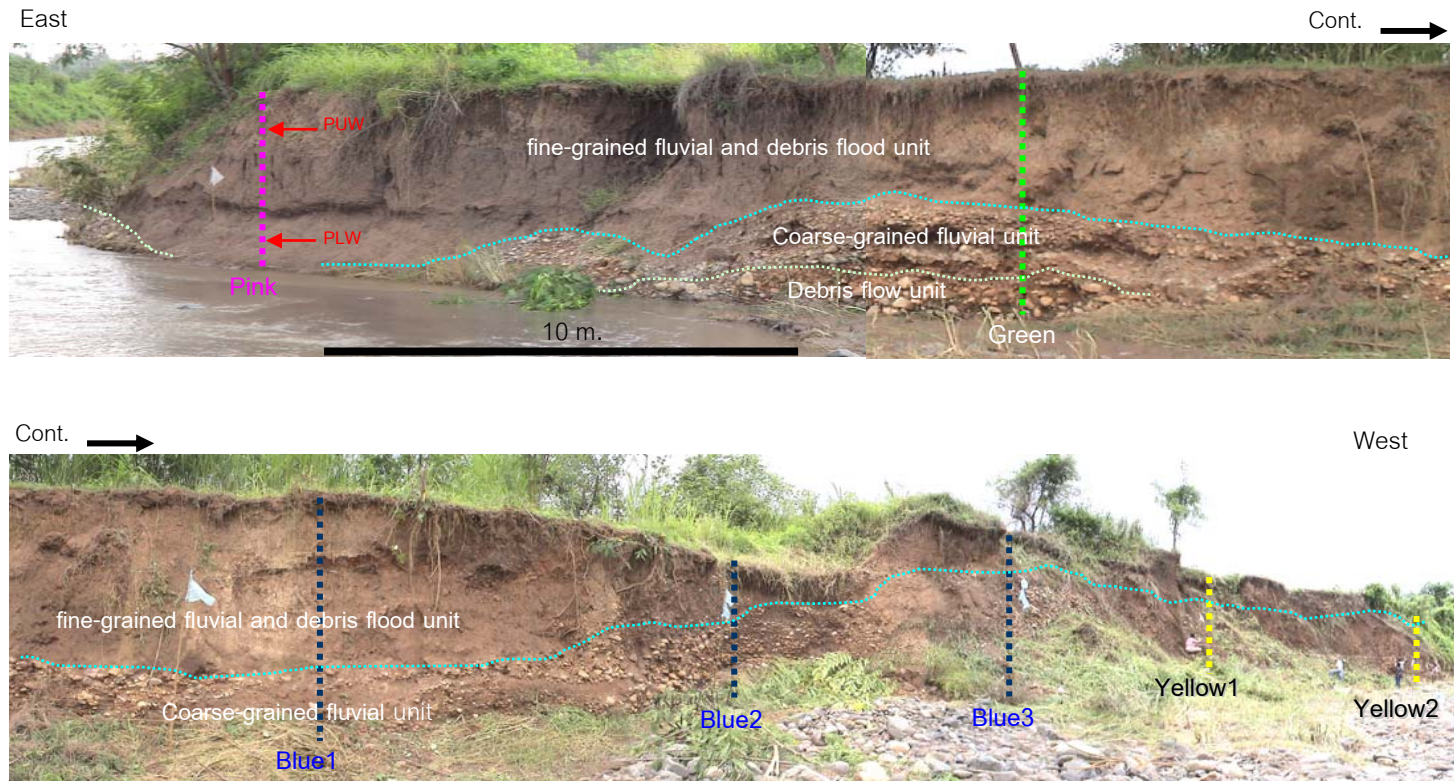
The uppermost part of this eroded-bank profile was a fine-grained fluvial and debris flood unit that was dominantly deposited to form a sharp contact on top of the coarse-grained fluvial unit (as shown in Figures 6-12 to 6-15). The uppermost unit is thicker to the east, especially in the eastern part of the zone Pink. The representative sedimentary and stratigraphic characteristics in completely detailed vertical succession are shown in the zone Green (Figure 6-13) and are from bottom to top the debris flow unit, the coarse-grained fluvial unit, and the fine-grained fluvial and debris flood unit, respectively.

Figure 6-12 Photographs illustrating lateral and vertical stratigraphic characteristics of three sedimentary units (debris flow unit, coarse-grained fluvial unit, and fine-grained fluvial and debris flow unit) of the previous alluvial fan that well exposed along the eroded-bank of Nam Ko Yai stream. (Note: locations of the seven stratigraphic profiles referred to Figures 6-9 and 6-11)

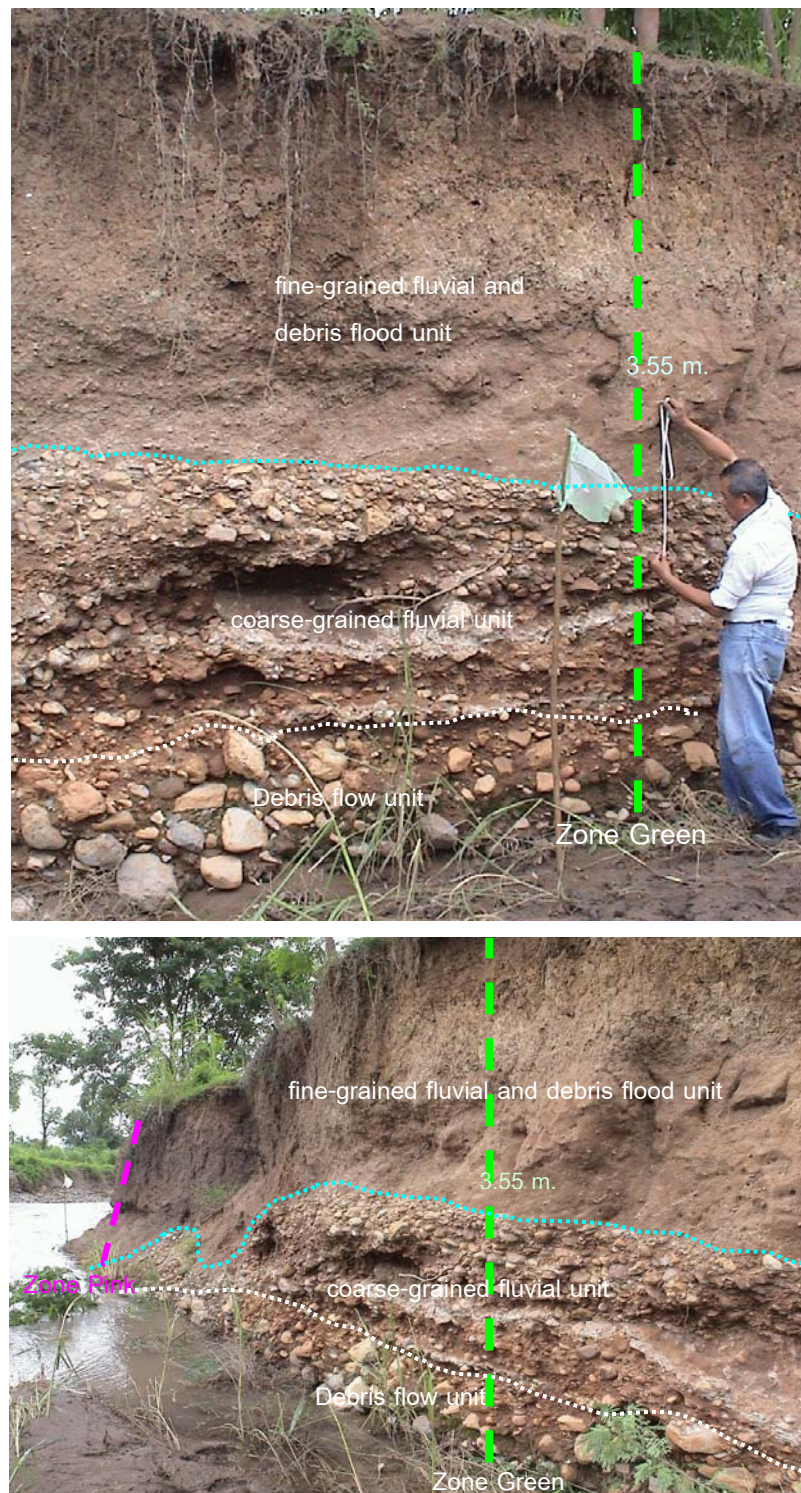
In the observed stream-bank profiles, the lowest sedimentary unit of the previous alluvial fan deposits was a debris flow unit of floating texture, unsorted, and un-stratified material that was exposed in the stream-bed only in the lowest part of the zone Green (Figure 6-13). The coarse-grained fluvial unit of clast-supported texture and fining-upward graded bedding was transitionally deposited on top of the debris flow unit, especially in the middle part of the zone Green, and extended westward (upstream) beyond the zone Yellow2 (Figure 6-14). This coarse-grained fluvial unit was the thickest in the western part and became thinner to the east.

Figure 6-13 Photographs illustrating detailed sedimentary and stratigraphic characteristics in vertical and lateral succession of three sedimentary units (debris flow unit, coarse-grained fluvial unit, and fine-grained fluvial and debris flow unit) of the previous alluvial fan deposits at the zone Green.

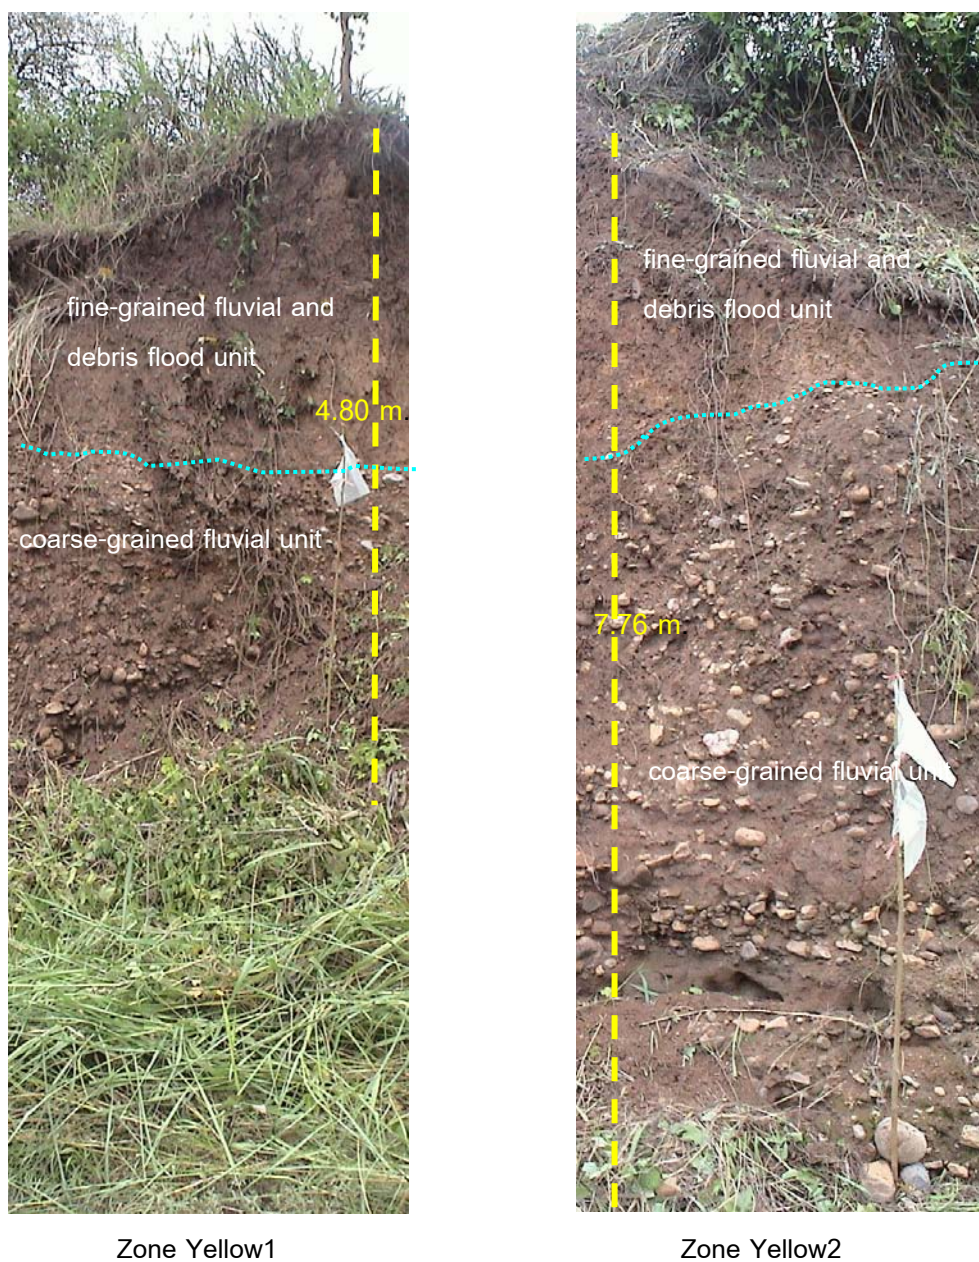
Figure 6-14 Photographs illustrating detailed sedimentary and stratigraphic characteristics in vertical succession of two sedimentary units (coarse-grained fluvial unit, and fine-grained fluvial and debris flow unit) of the previous alluvial fan deposits at the zones Yellow1 and Yellow2.

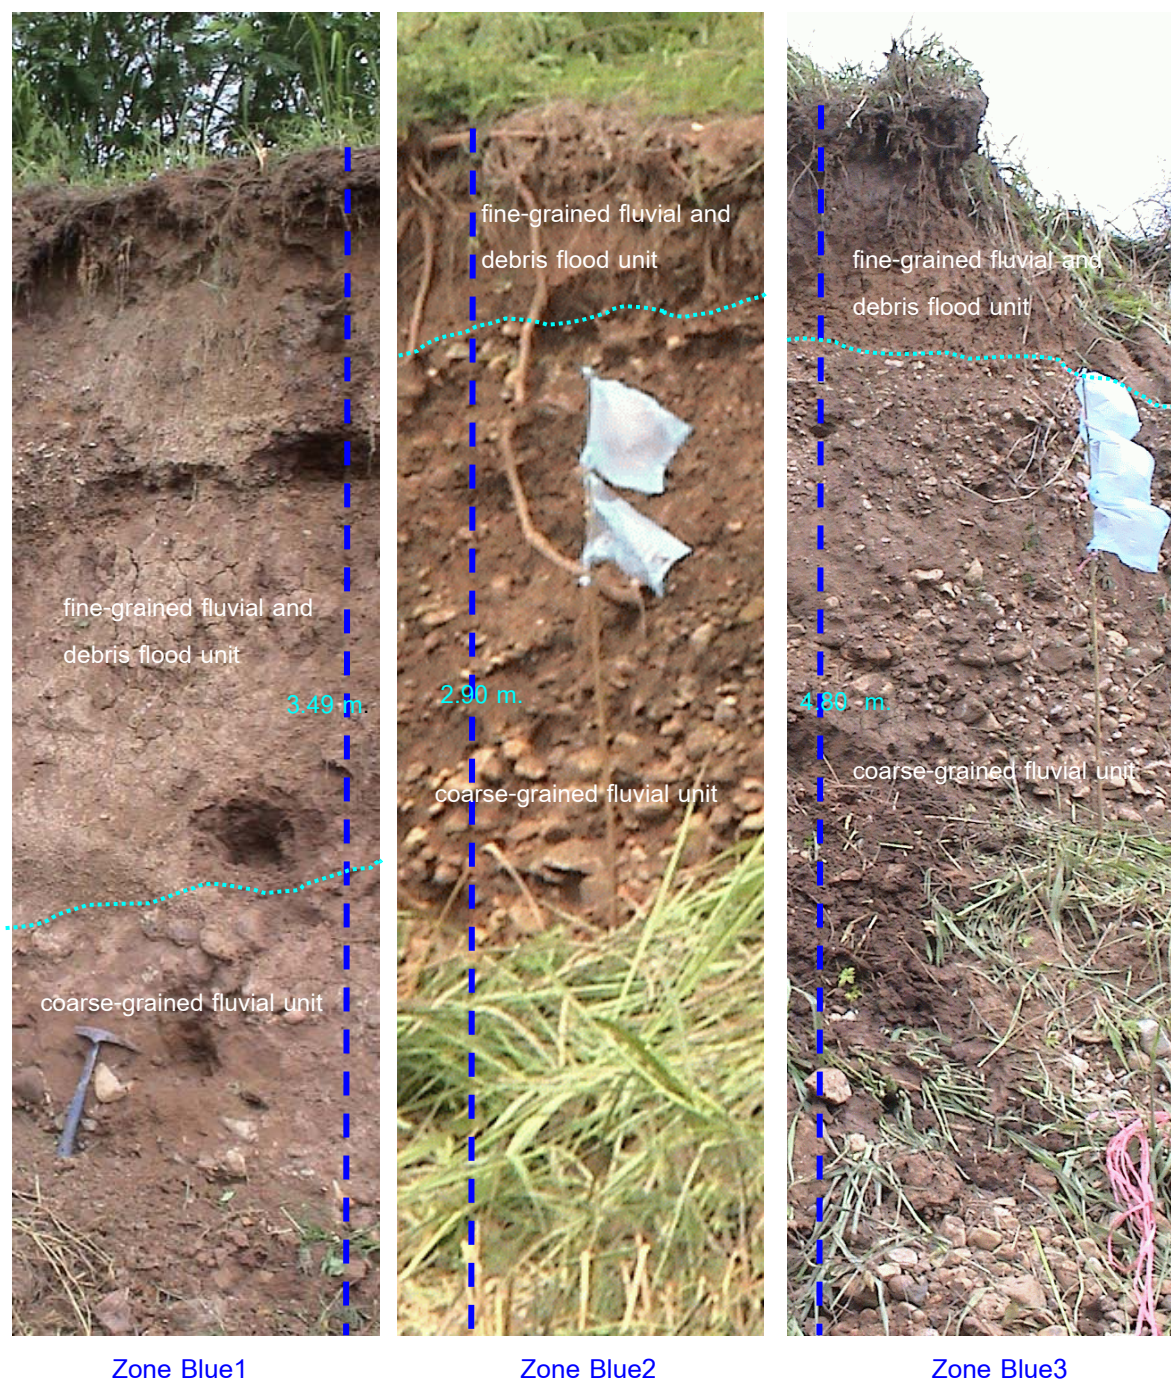
Figure 6-15 Photographs illustrating detailed sedimentary and stratigraphic characteristics in vertical succession of the fine-grained fluvial and debris flood unit that overlay with the sharp contact manner on top of the coarse-grained fluvial unit at the zones Blue1, Blue2 and Blue3.
